31 AUG 1945  
AIRCRAFT AND ARMAMENT EXPERIMENTAL ESTABLISHMENT  
BOSCOMBE DOWN

Fury Mk. I. NX.798  
(Centaurus 12 SM)

Brief handling trials with larger tail plane  
and modified wing root fairings.

A. & A.E.E. ref: 5705, g/1/REM.  
M.A.P. ref: SB.62632/RDIA(b),  
Period of tests: 2nd May - June 6th, 1945.

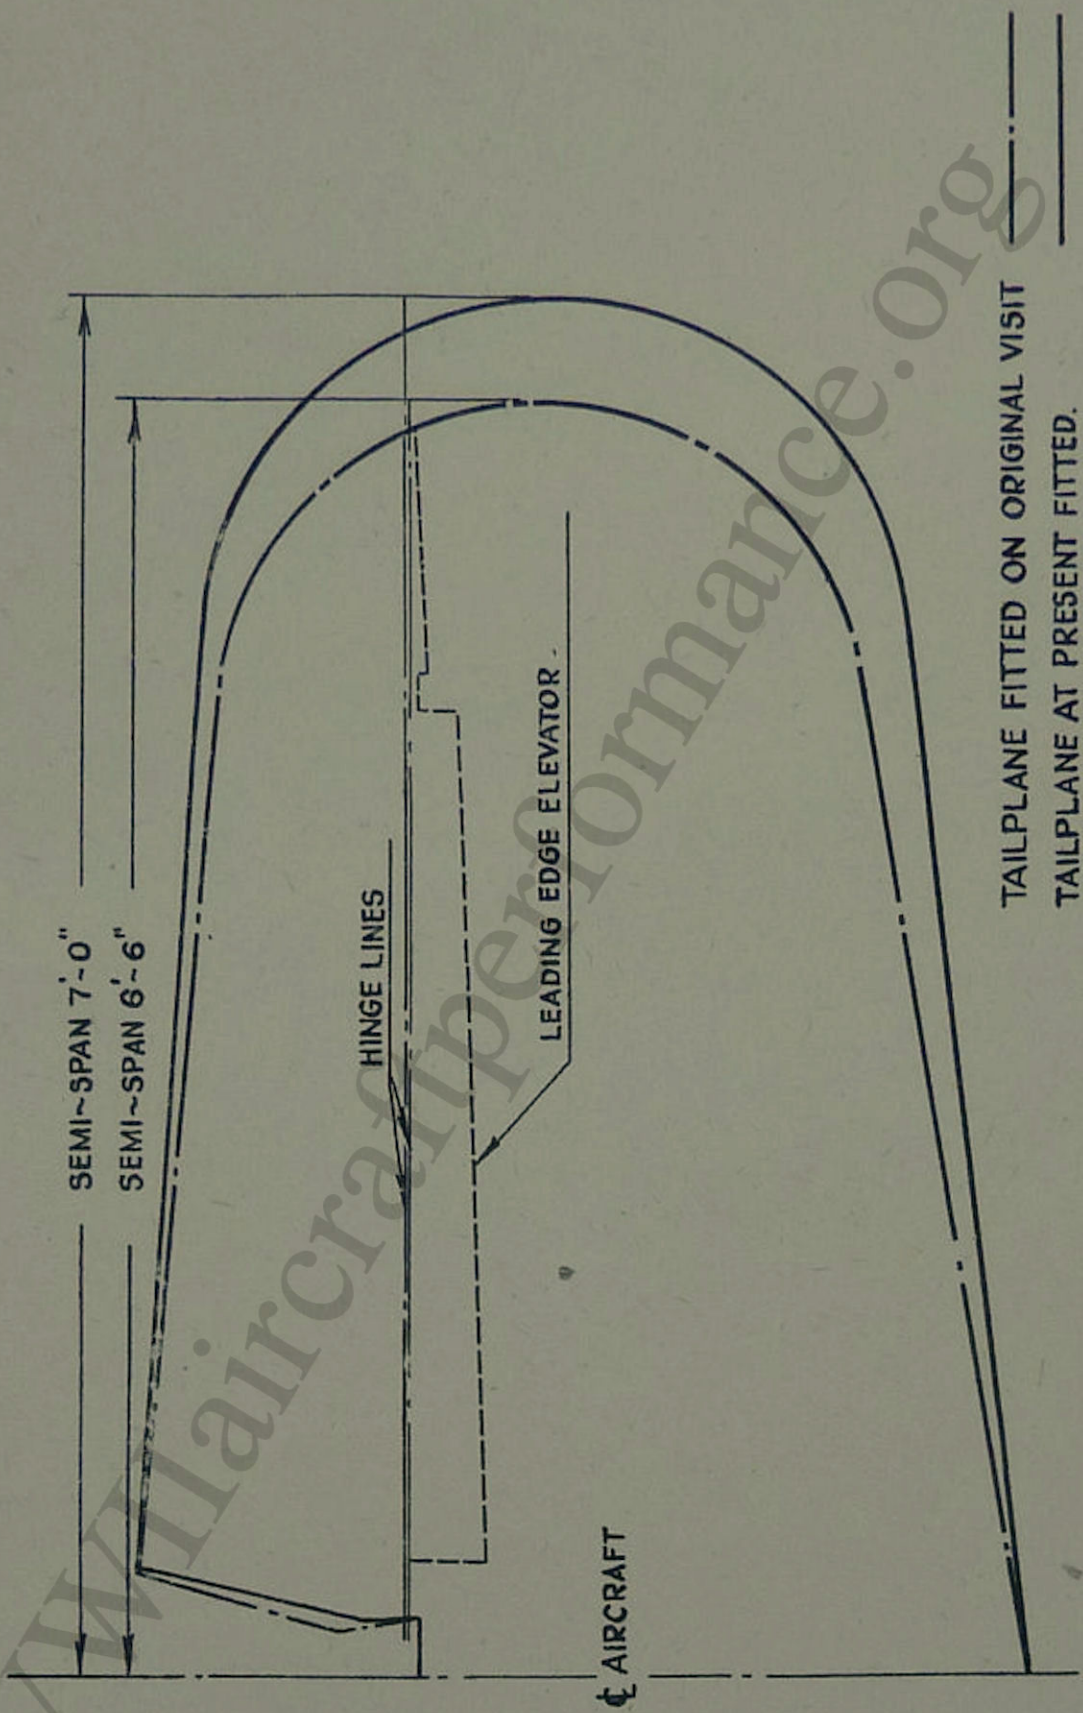
COMPARISON OF TAILPLANES.

- (i) Addition of gill and exhaust fairings at the wing roots, the two lower exhaust pipes being led through the under fuselage panel. (See photograph at end of Report).
- (ii) Oil cooler transferred to a similar position on the port wing.
- (iii) Fitting of a larger tail plane and elevator (see Fig.1 at end of the Report).
- (iv) Trimming mechanism incorporated in the rudder spring tab.

The practical aftmost c.g. position which occurs at take-off with full fighter load, is about 0.5 inches further aft than the similar loading with the aircraft in its previous condition (see 1st and 2nd parts of this Report). This 0.5 inch shift of the c.g. is accounted for by the additional weight of the larger tail plane.

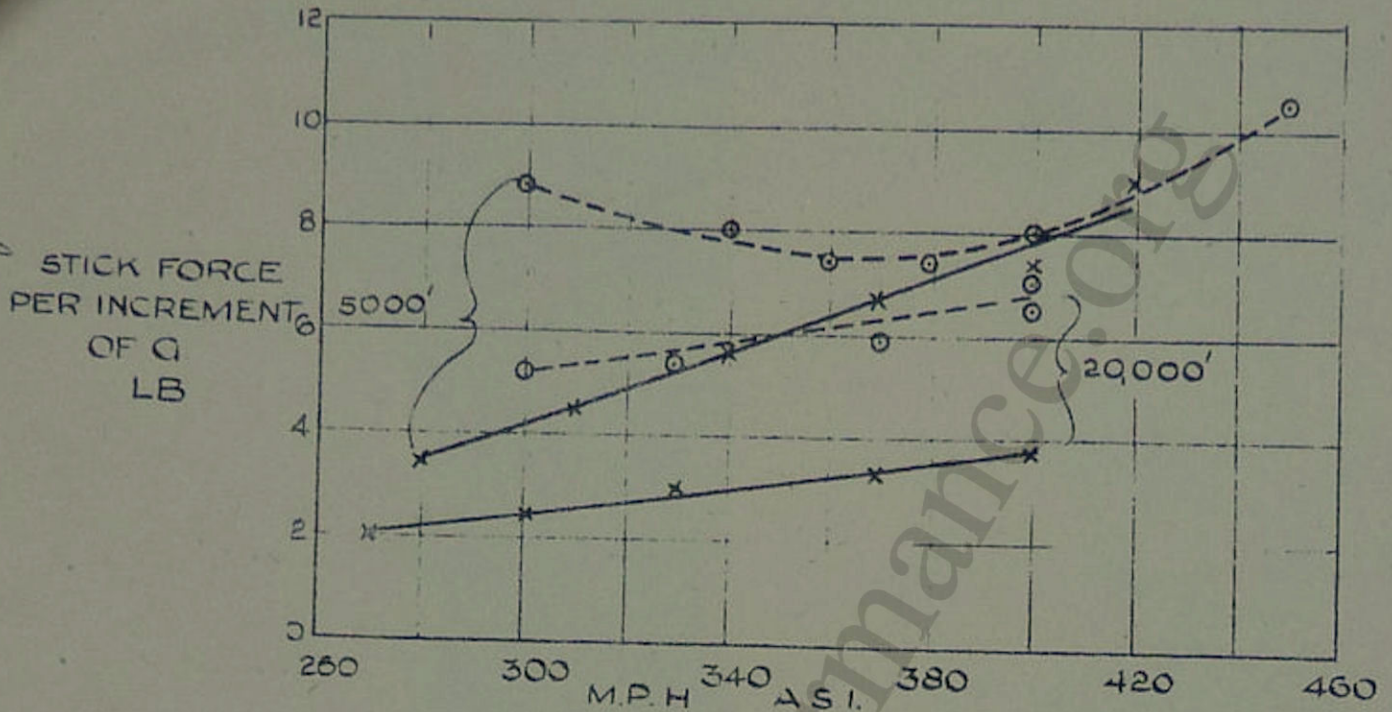
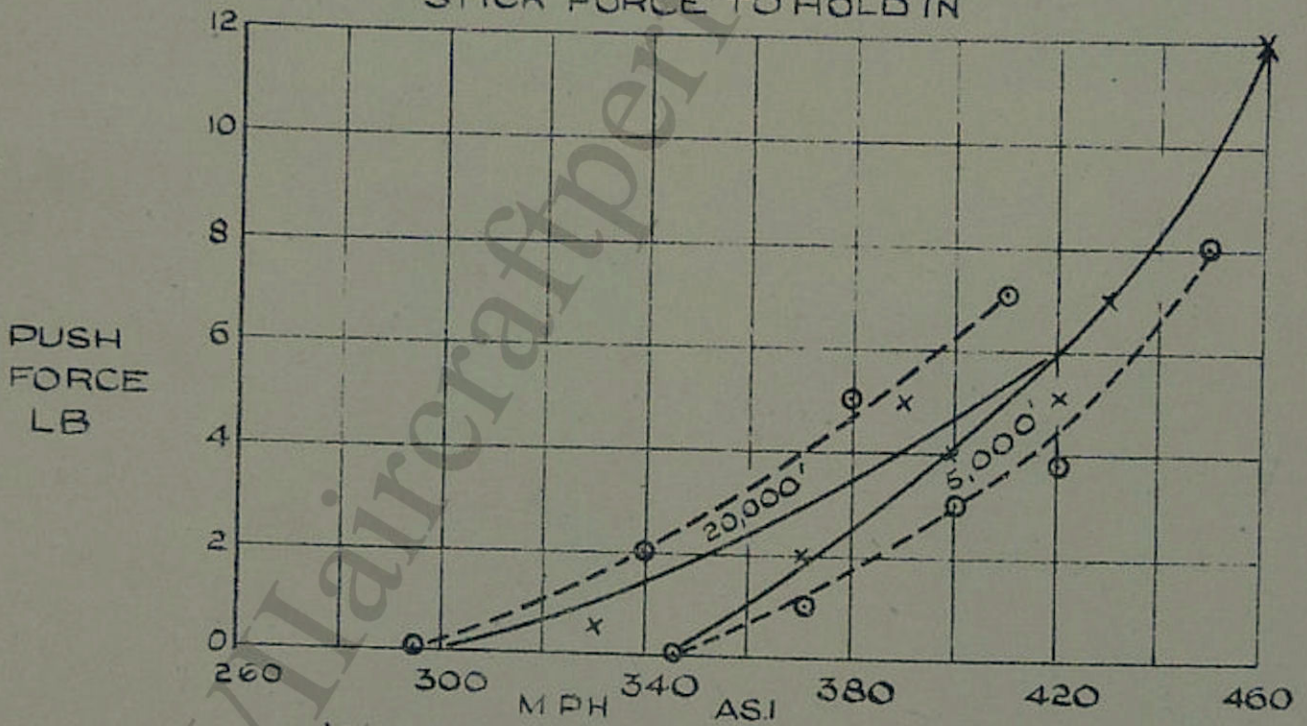
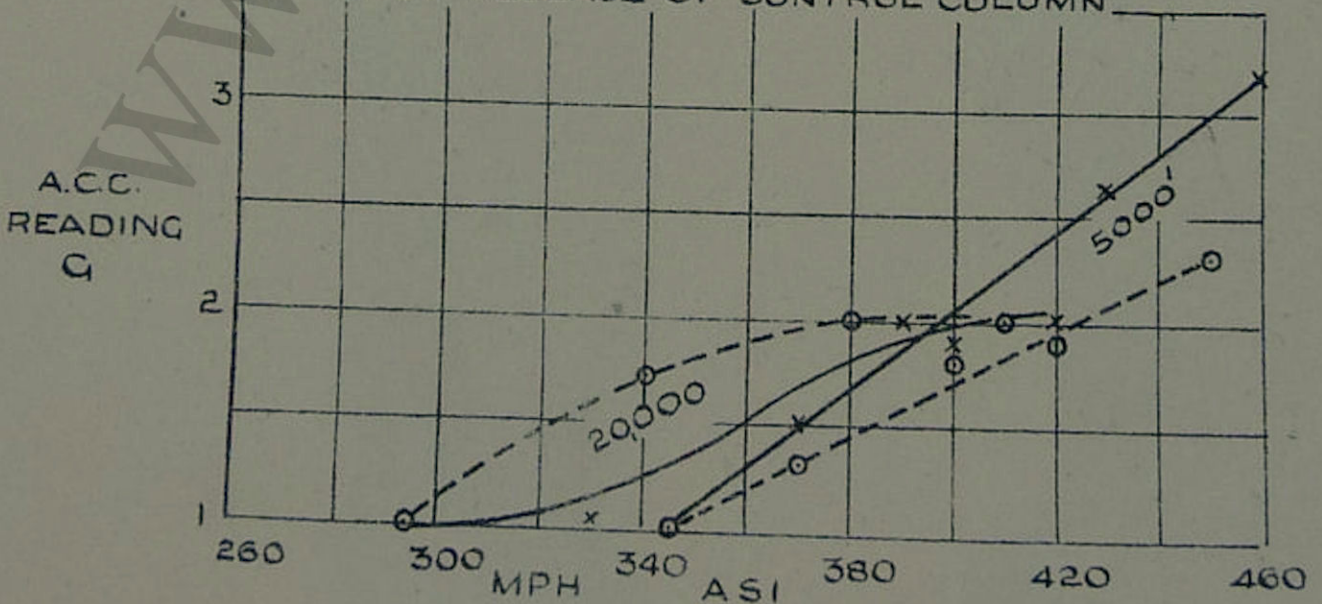
# MANEUVRABILITY TESTS FIG. 2.

The quantitative measurements of stick forces and accelerations during the diving tests are given in Fig.2 at the end of this Report and discussed in a later paragraph under manoeuvrability. (See para. 4.18).

4.18 Manoeuvrability. As will be seen from Fig.2, the manoeuvrability of the aircraft increased appreciably with altitude; that is, the stick force to produce a given value of normal acceleration decreased with altitude.

The values of stick force per increment of 'g' accelerometer reading obtained on recoveries from dives at a 5 'g' accelerometer reading varied appreciably with speed and with altitude from 2 lb/'g' at low speed at 20,000 ft. to 9 lb/'g' at high speed at 5000 ft. (See Fig.2). The lower value was considered too low as it is below the AP.970 requirements for new type fighters, whilst the higher value is on the top limit of these requirements.

stick force to hold the aircraft into the dive when trimmed for level flight at maximum climbing power was moderate up to the maximum speed measured at 480 mph ASI (See Fig.2). It was considered, however, that if the diving speed was raised from the present maximum reached by the contractor of 480 mph ASI, the stick forces in untrimmed dives to these higher speeds might be excessive. The accelerometer readings on releasing the control column in the out of trim dives were well within the requirements, the maximum recorded being 3.2'g'accelerometer reading at 5000 ft. at 480 mph ASI.

As will be seen from Fig.2 the manoeuvrability of the aircraft in terms of stick force to produce a given accelerometer reading was noticeably effected by the change of loading.

The values of stick force per increment of g accelerometer reading on recoveries from trimmed dives at 5'g'accelerometer reading and altitude from a minimum measured of 5.2 lb/g'at low speed at 20,000 ft. maximum of 10.2 lb/g'at high speed at 5000 ft. (see Fig.2) The higher requirements for a new type gunnery.

The stick forces to hold the aircraft into the dive when trimmed for level flight at maximum climbing power were satisfactory up to the maximum speed reached of 450 mph ASI at this loading. The accelerometer readings on the release of the control column in the out of trim dives were low, the maximum recorded being 2.3'g'accelerometer reading.

- (i) The change of longitudinal trim in terms of stick force to hold out of trim flight should be decreased.
- (ii) The manoeuvrability in terms of stick force per 'g' should be decreased to give a slightly smaller value at high speeds at low altitude and increased to give a higher value at low speeds at high altitude.
