20th September, 1943.

D.H. MOSQUITO MK.VI (Merlin 25) HJ.679.

Tests carried out at Hatfield to check the Maximum Level Speed obtained in previous tests

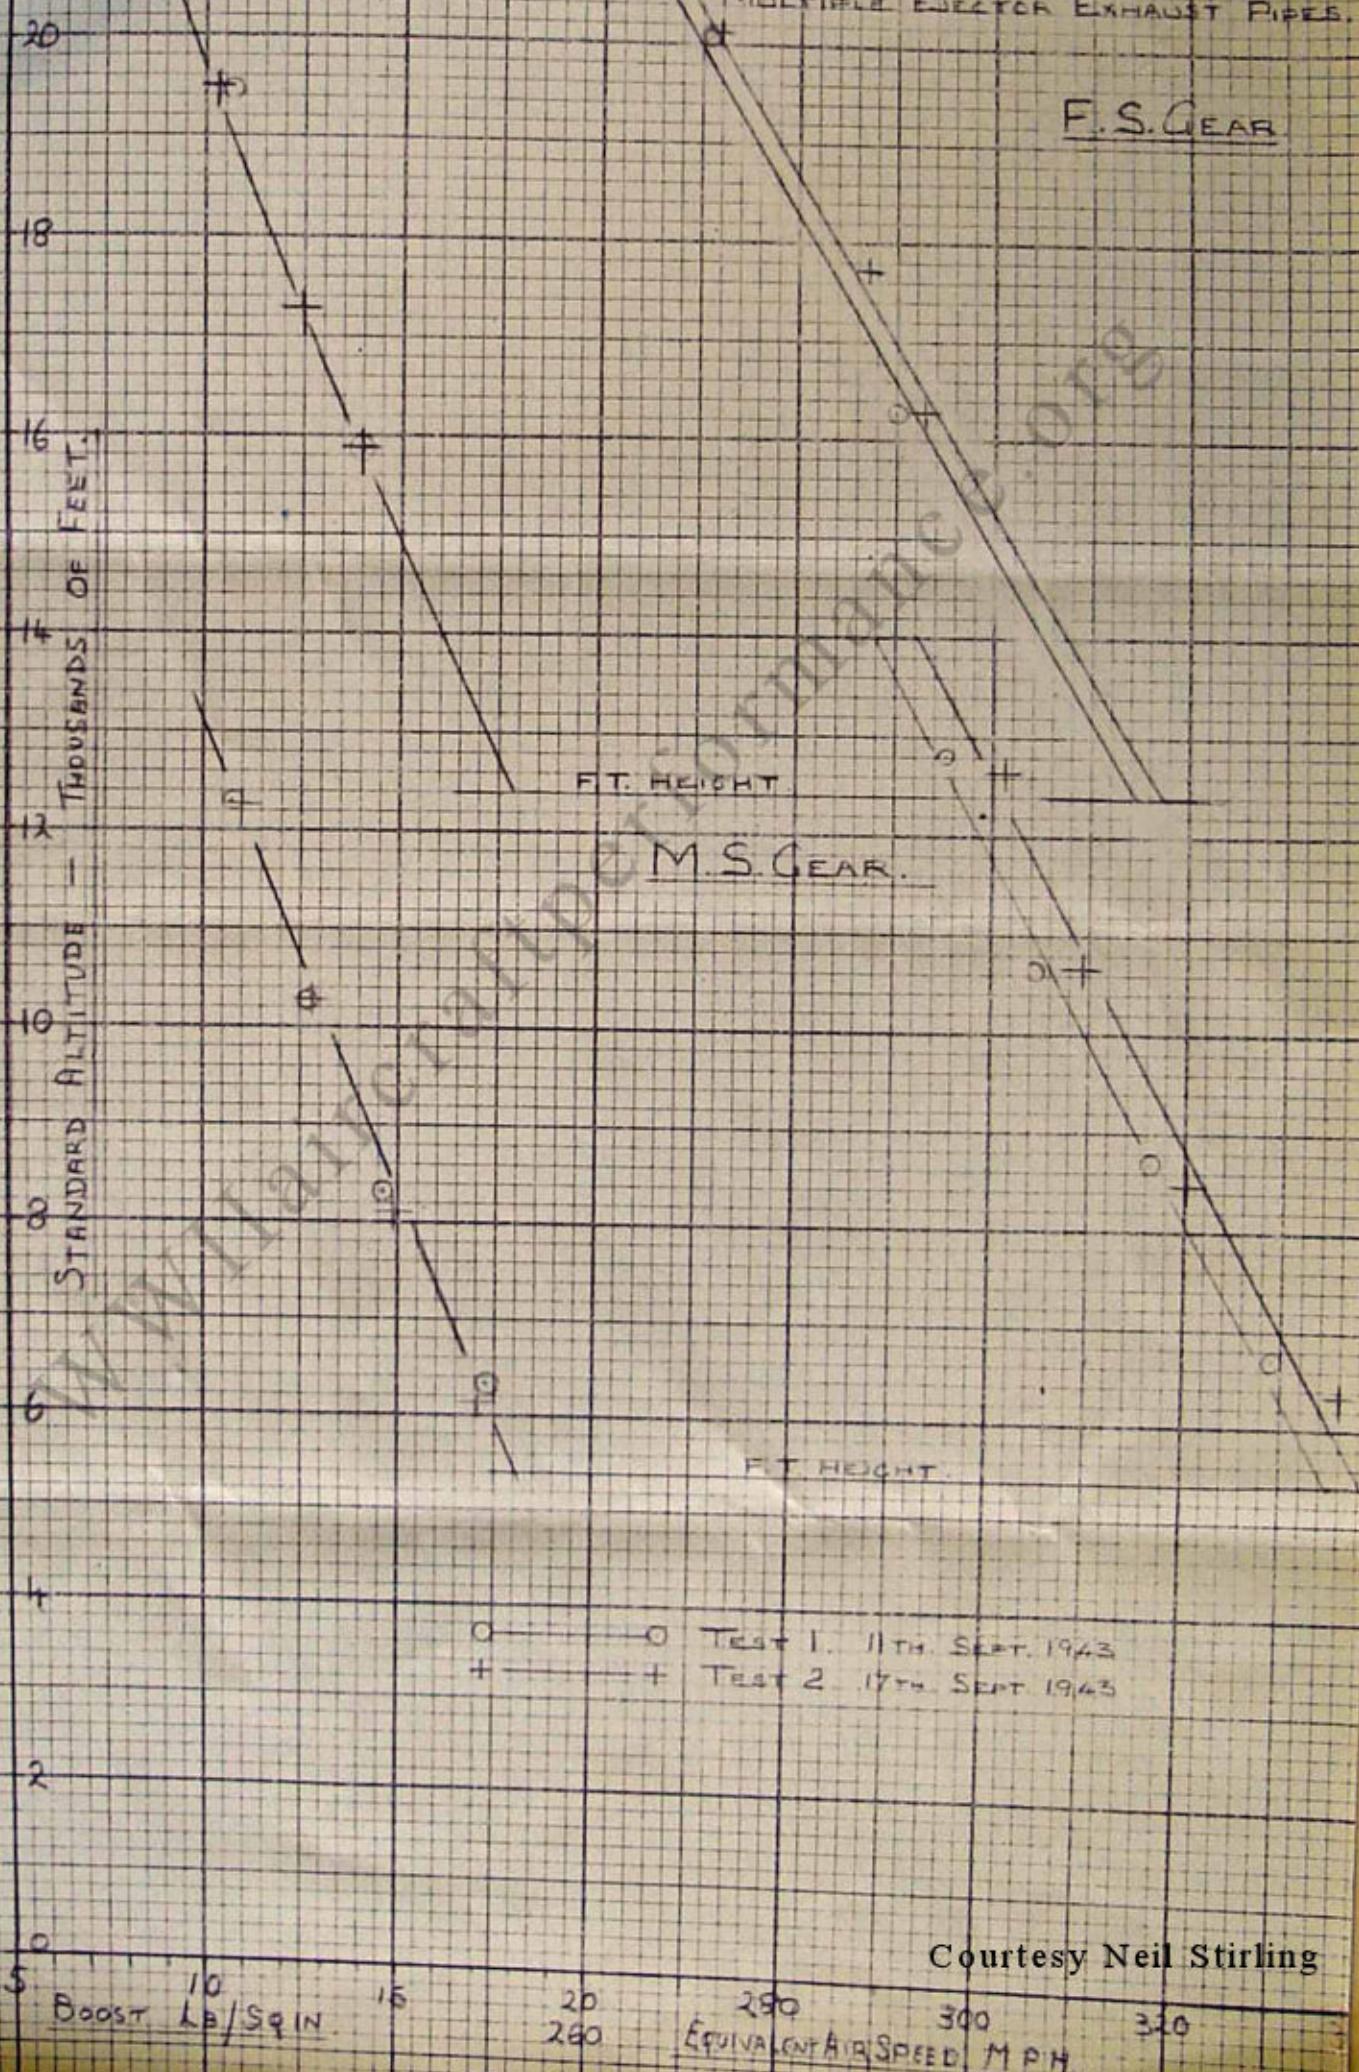
D.H. 98 MOSQUITO Mk VI Fig 2.
10 Decr 1943 H.A.T.

It will be seen that about 3 m.p.h. in maximum speed was picked up due to cleaning up the aircraft between Tests 1 and 2.

TEST 1. AS RECEIVED
FROM A&AEE

TEST 2. SPEEDS WITH
AILERONS RESET AND
COWLING CLEANED UP

PREVIOUS TEST. NO EXTERNAL TANKS
[APRIL 1943]

Ailerons re-rigged to correct settings, i.e. $\frac{1}{4}$ inch drop, starboard differential 26° , tab trailing edge and aileron trailing edge in alignment with ailerons neutral, connecting rod bolt of starboard aileron tab replaced.

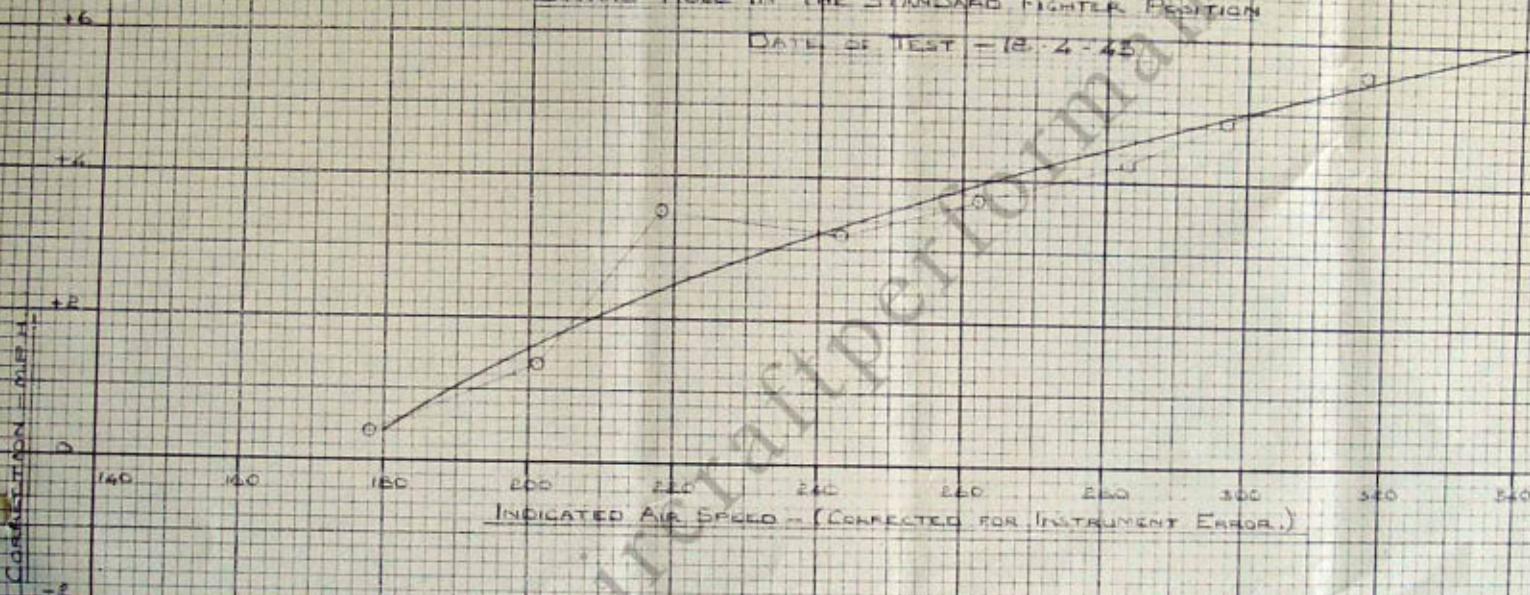
FIG. 3

The Position Error used in the corrections is that obtained in the original test in April 1943, and is shown in Fig. 3.

D.H. 98 MOSQUITO F. MK VI MERLIN 25 - HJ 679
POSITION ERROR DETERMINATION BY THE ANEROID METHOD.
STATIC HOLE IN THE STANDARD FIGHTER POSITION
