3rd Part of Report No. A. & A.E.E./819, a.

RESTRICTED
AIRCRAFT AND ARMAMENT EXPERIMENTAL ESTABLISHMENT
DOSCOMBE DOWN

Vampire I TG.274
(Goblin I)

Preliminary handling trials of first
production aircraft

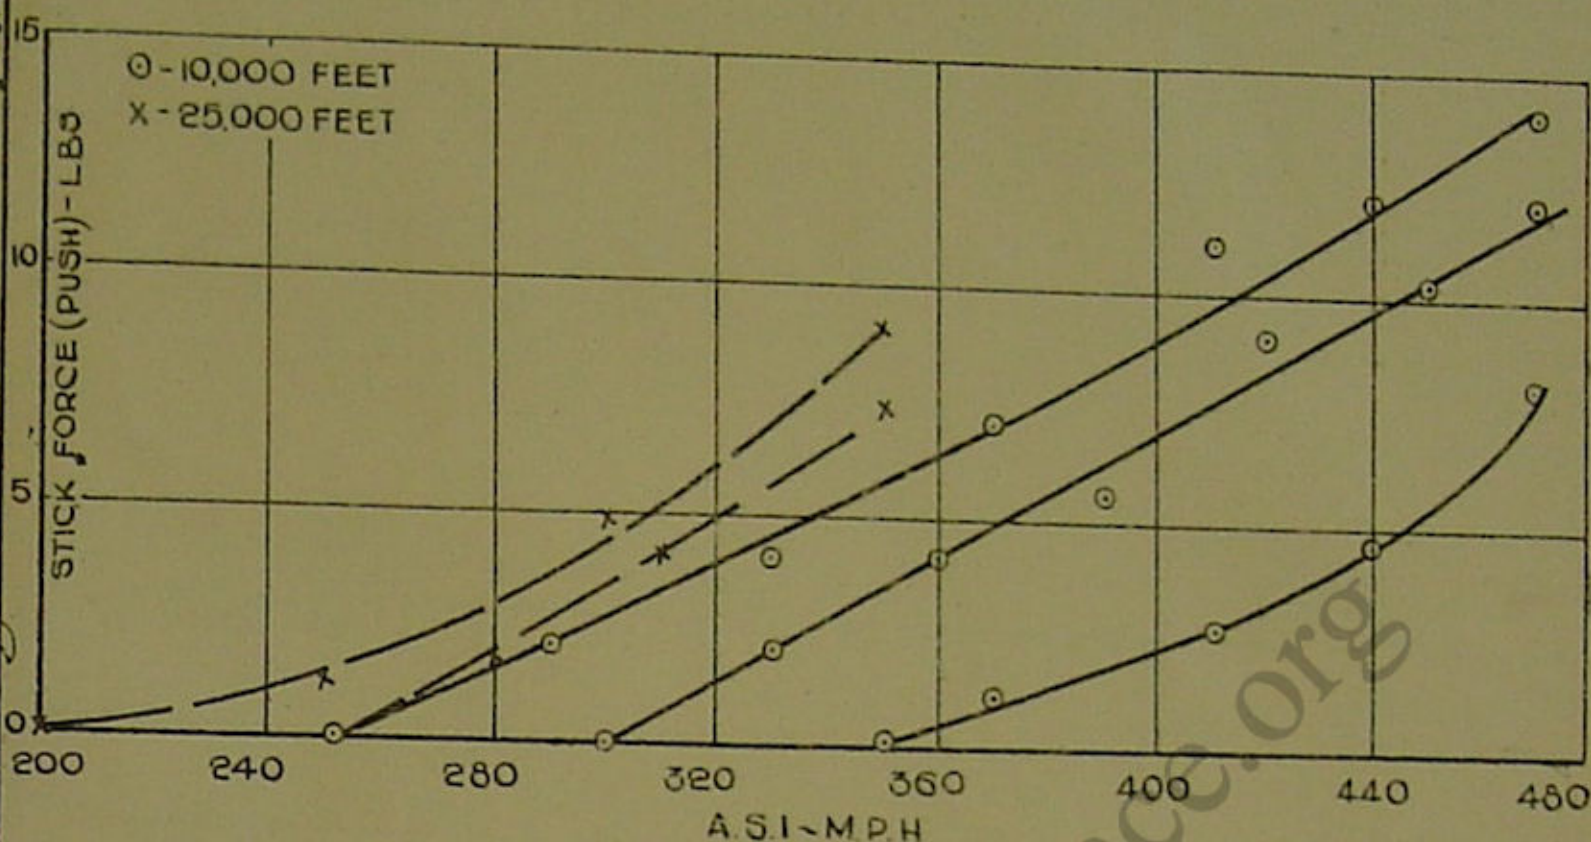
FIG. 4

The elevator forces to hold out of trim conditions in the dive were moderately light at both high and low altitudes (see Fig.4). The acceleration on releasing the control column from out of trim flight built up fairly rapidly especially at high altitude but only in one case (at 25,000 ft.) did the accelerometer reading exceed 5 'g'. At high Mach numbers, the magnitude of the normal acceleration obtainable fell off (see Fig.5).

STICK FORCE TO HOLD IN DIVE

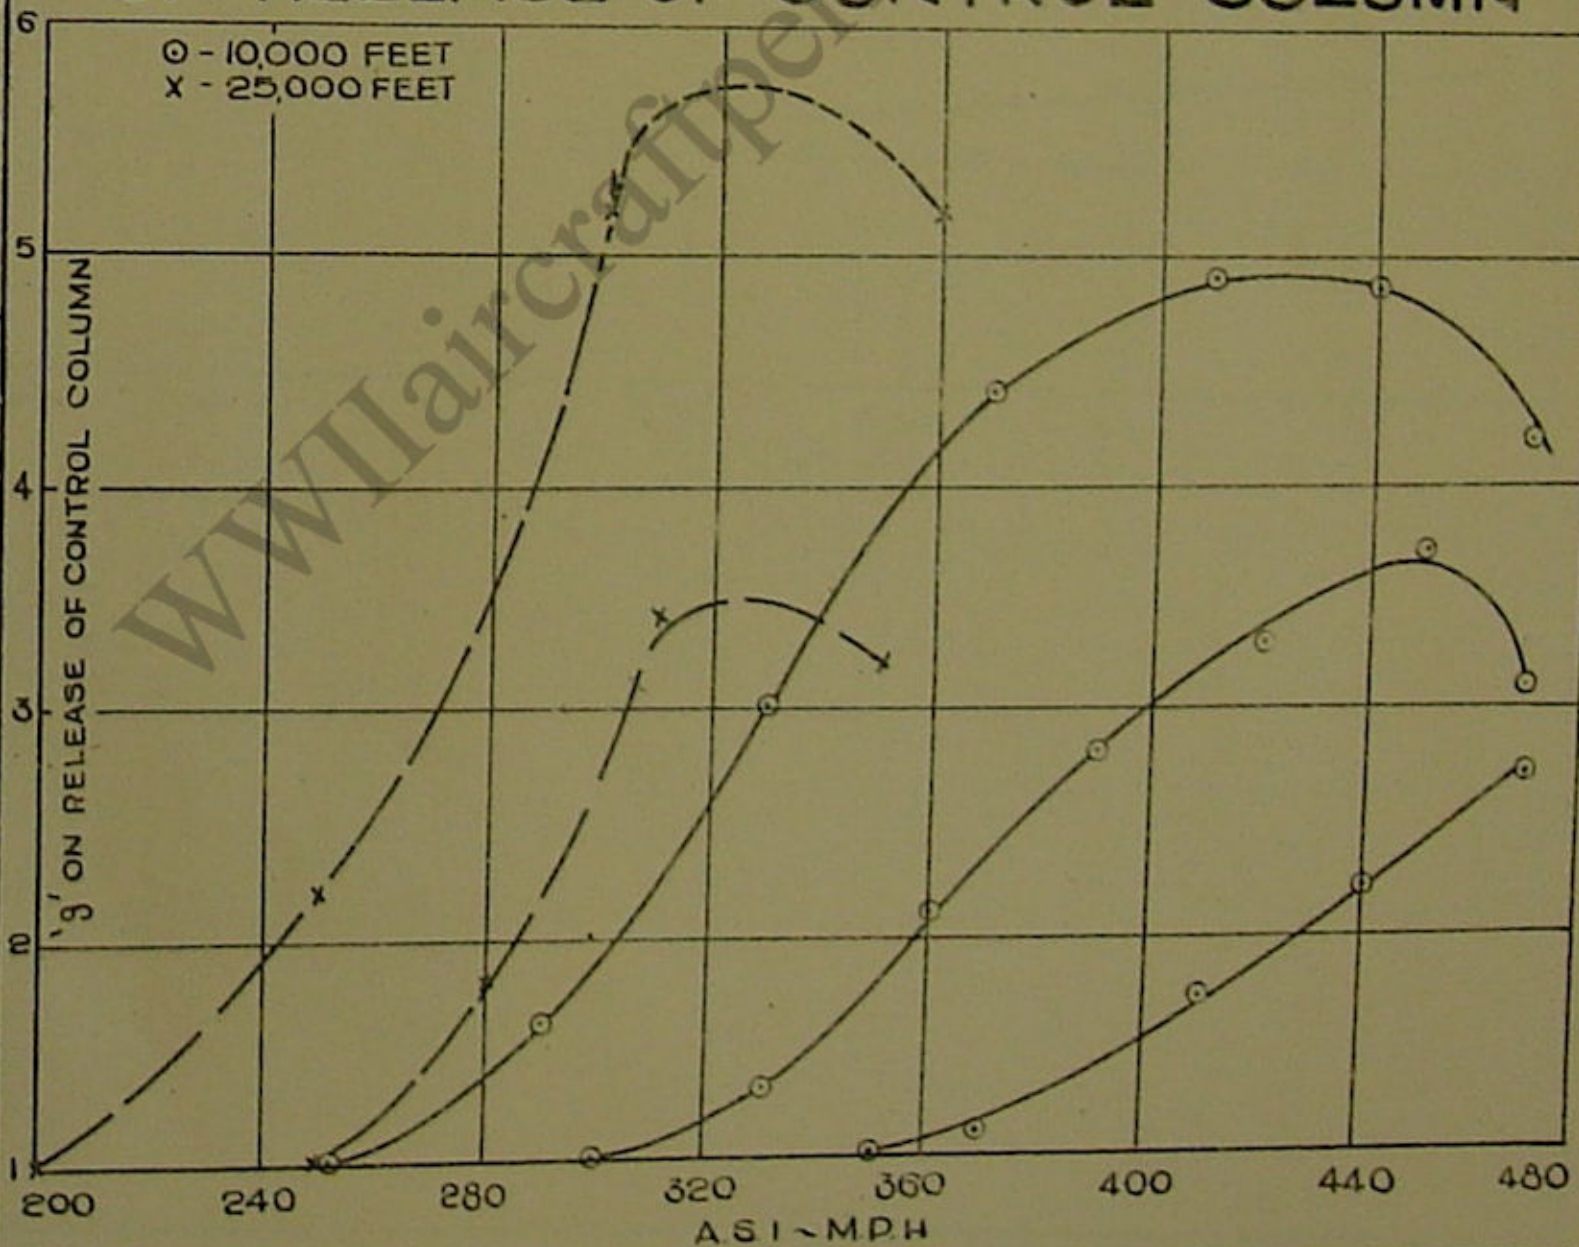
FIG 5

ACCELEROMETER READING
ON RELEASE OF CONTROL COLUMN

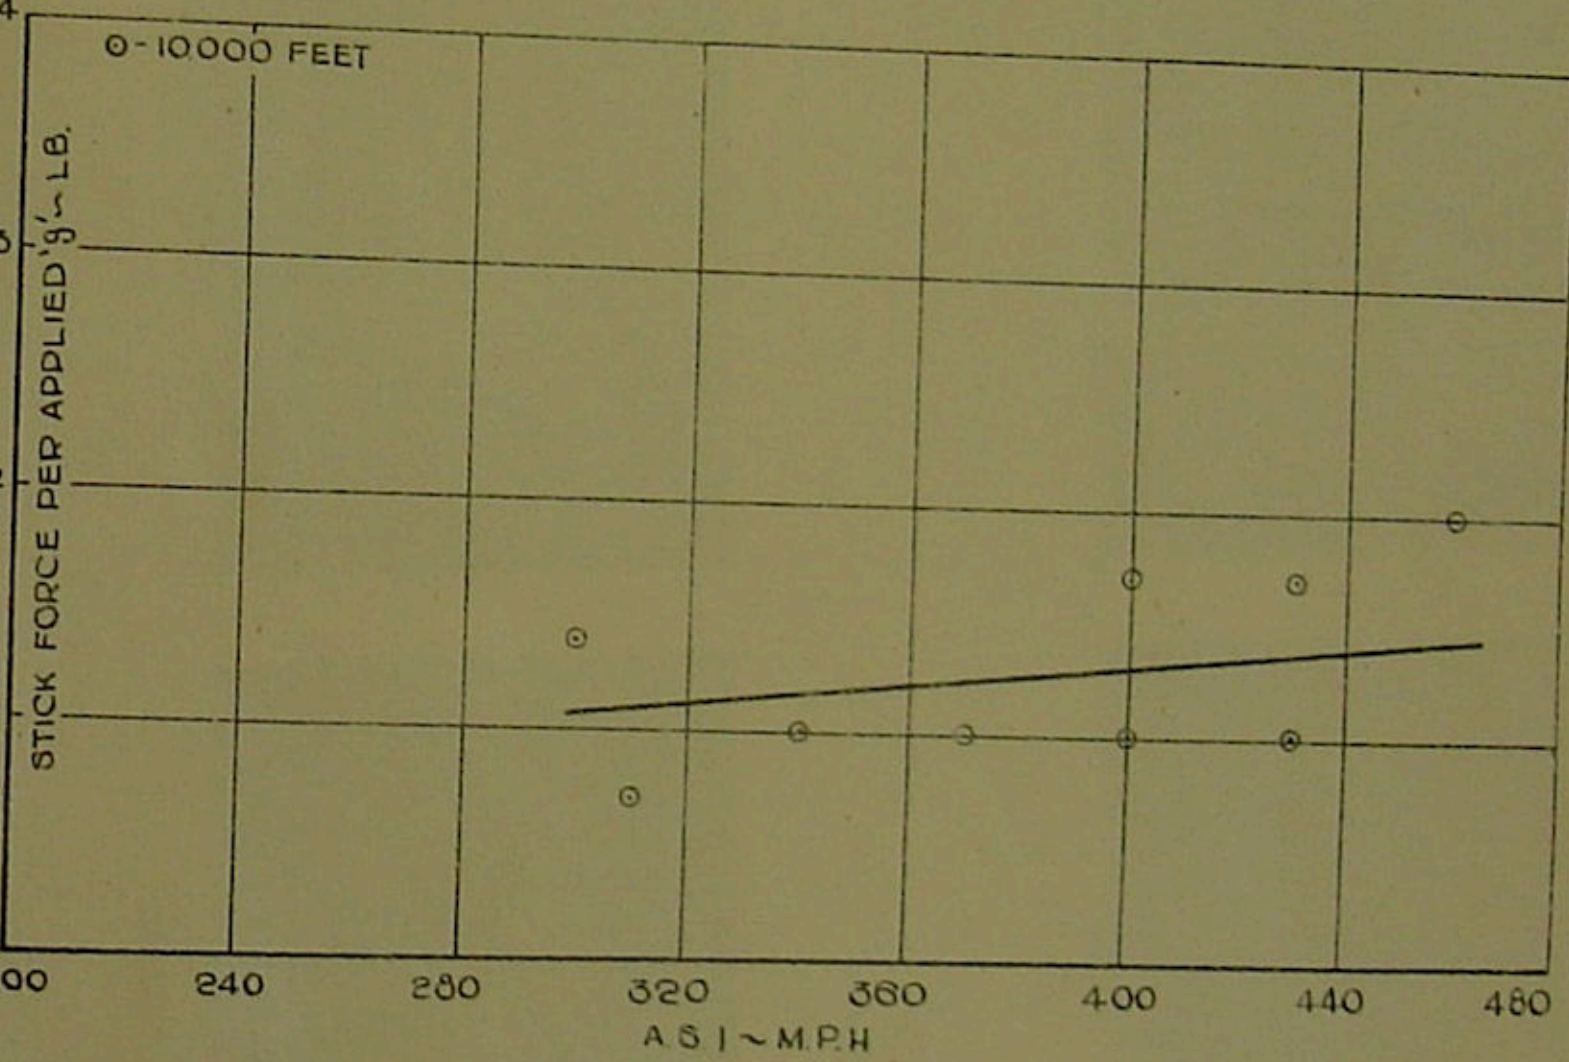
FIG. 6.

4.41 Longitudinal. It was considered that the degree of longitudinal stability was satisfactory at the loading tested. For all general flying and manoeuvres, the aircraft's longitudinal characteristics were considered satisfactory apart from the excessively light stick forces to manoeuvre in the looping plane. Some quantitative measurements (see Fig.6) showed that the stick force per 'g' was of the order of 1 to 2 lb. at 10,000 ft. Measurements were attempted at 25,000 ft., but these are not shown in Fig.6 as a reversal of stick force was required to restrict the normal acceleration at speeds below 320 mph ASI. A measurement made at 350 mph ASI gave a stick force per 'g' of $1\frac{1}{2}$ lb.

- (a) The stick forces to manoeuvre in the looping plane were too low.

STICK FORCE PER INCREMENT OF 'g'
