ORIGINALLY ISSUED  
September 1942 as  
Advance Confidential Report

MEASUREMENTS OF THE FLYING QUALITIES OF A  
SUPERMARINE SPITFIRE VA AIRPLANE

By William H. Phillips and Joseph R. Vensel

Langley Memorial Aeronautical Laboratory  
Langley Field, Va.

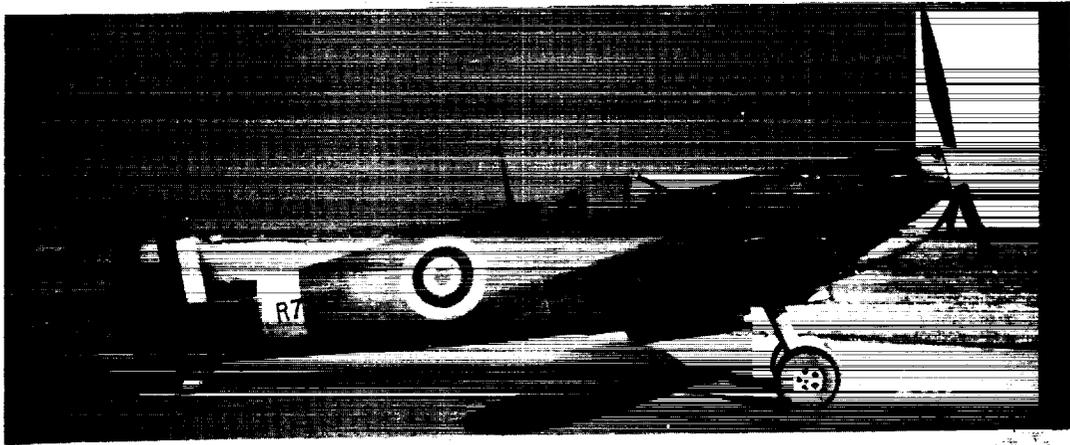
Figure 1.- Side view of the Supermarine Spitfire airplane.

The Supermarine Spitfire is a single-place, single-engine, low-wing, cantilever monoplane with retractable landing gear and partial-span split flaps (figs. 1, 2, 3, and 4). The general specifications of the airplane are as follows:

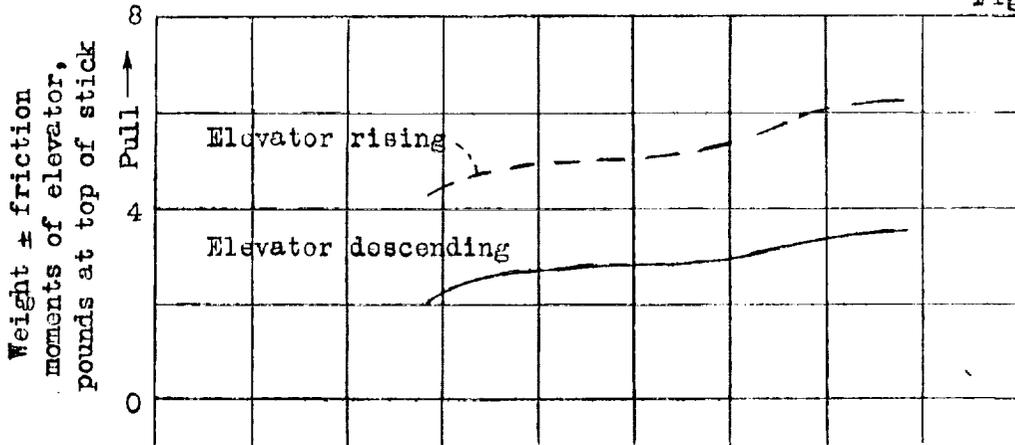
Figure 5.- Variation with control-stick angle of elevator angle and stick force caused by elevator friction and unbalance. Supermarine Spitfire airplane.

3. The friction in the elevator system was such that a force of 2 pounds was required to reverse the motion of the stick, as shown in figure 5. This friction was small enough that, in the flight conditions where a stable stick-force gradient existed, the control would return to its trim position.

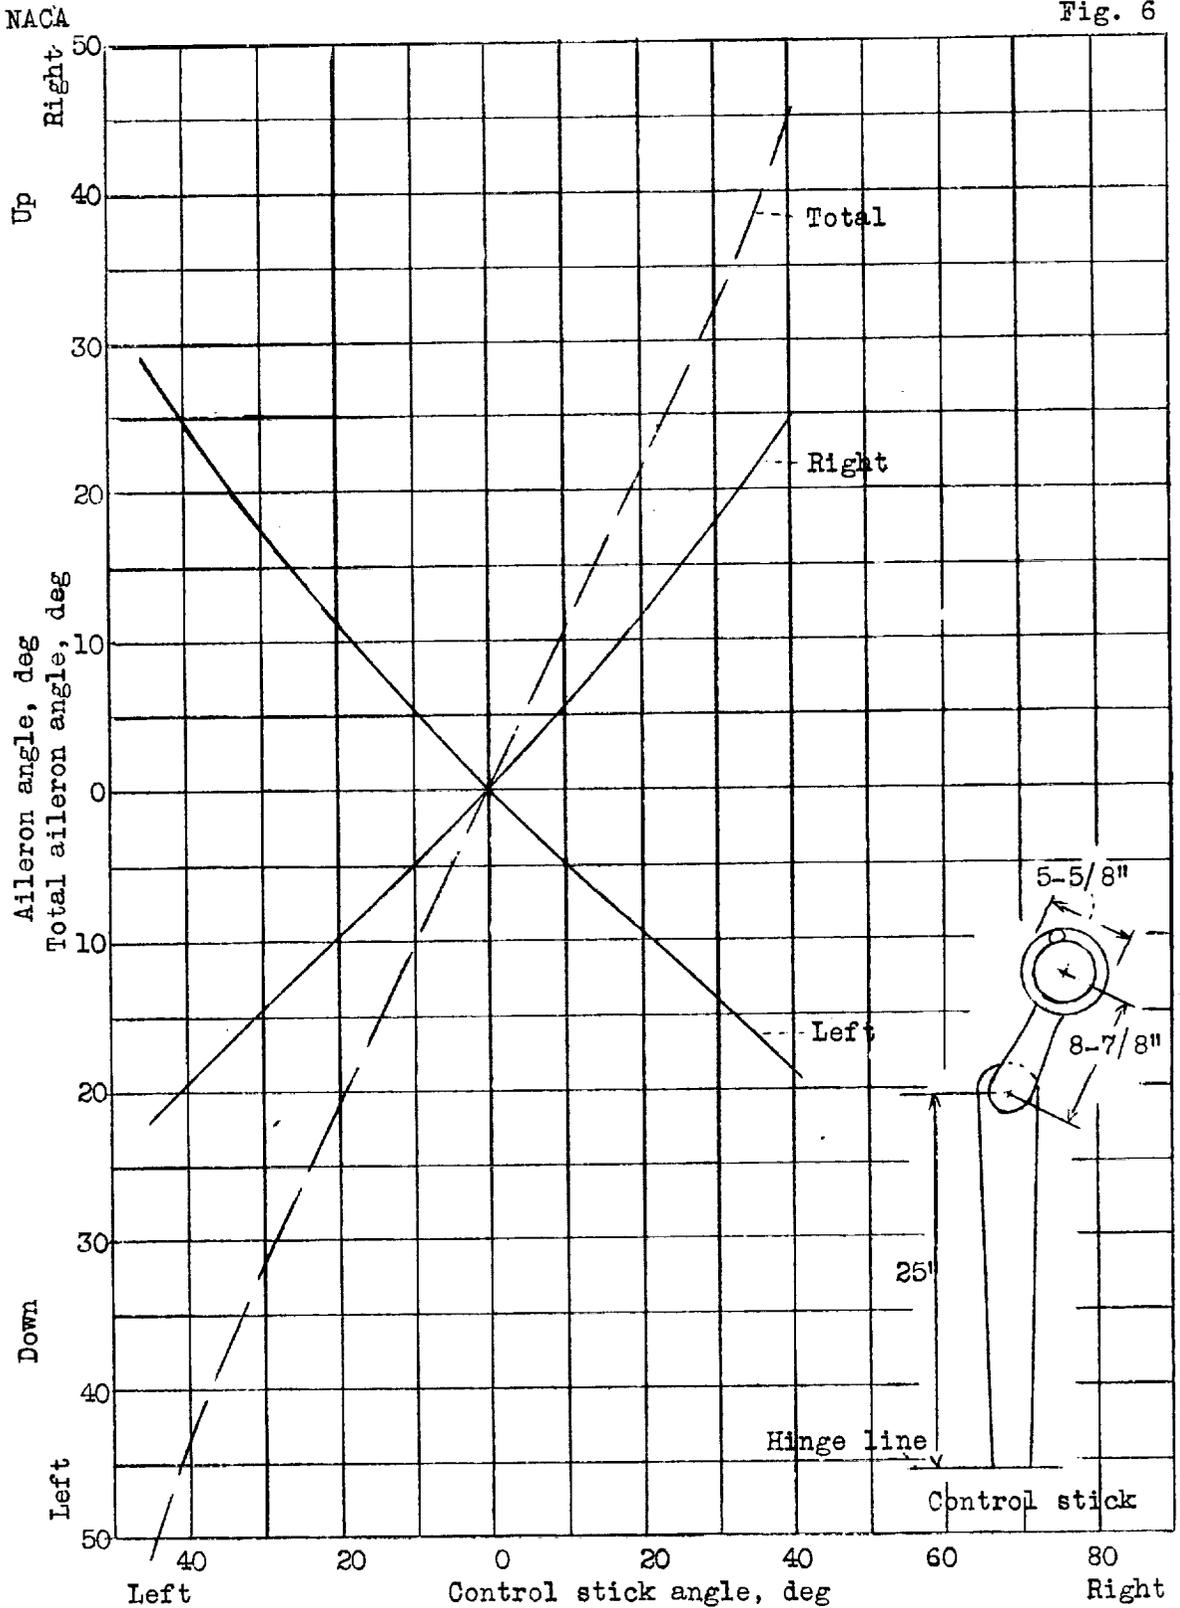
Figure 6.- Variation of left, right, and total-aileron angles with control stick angle. Supermarine Spitfire airplane.

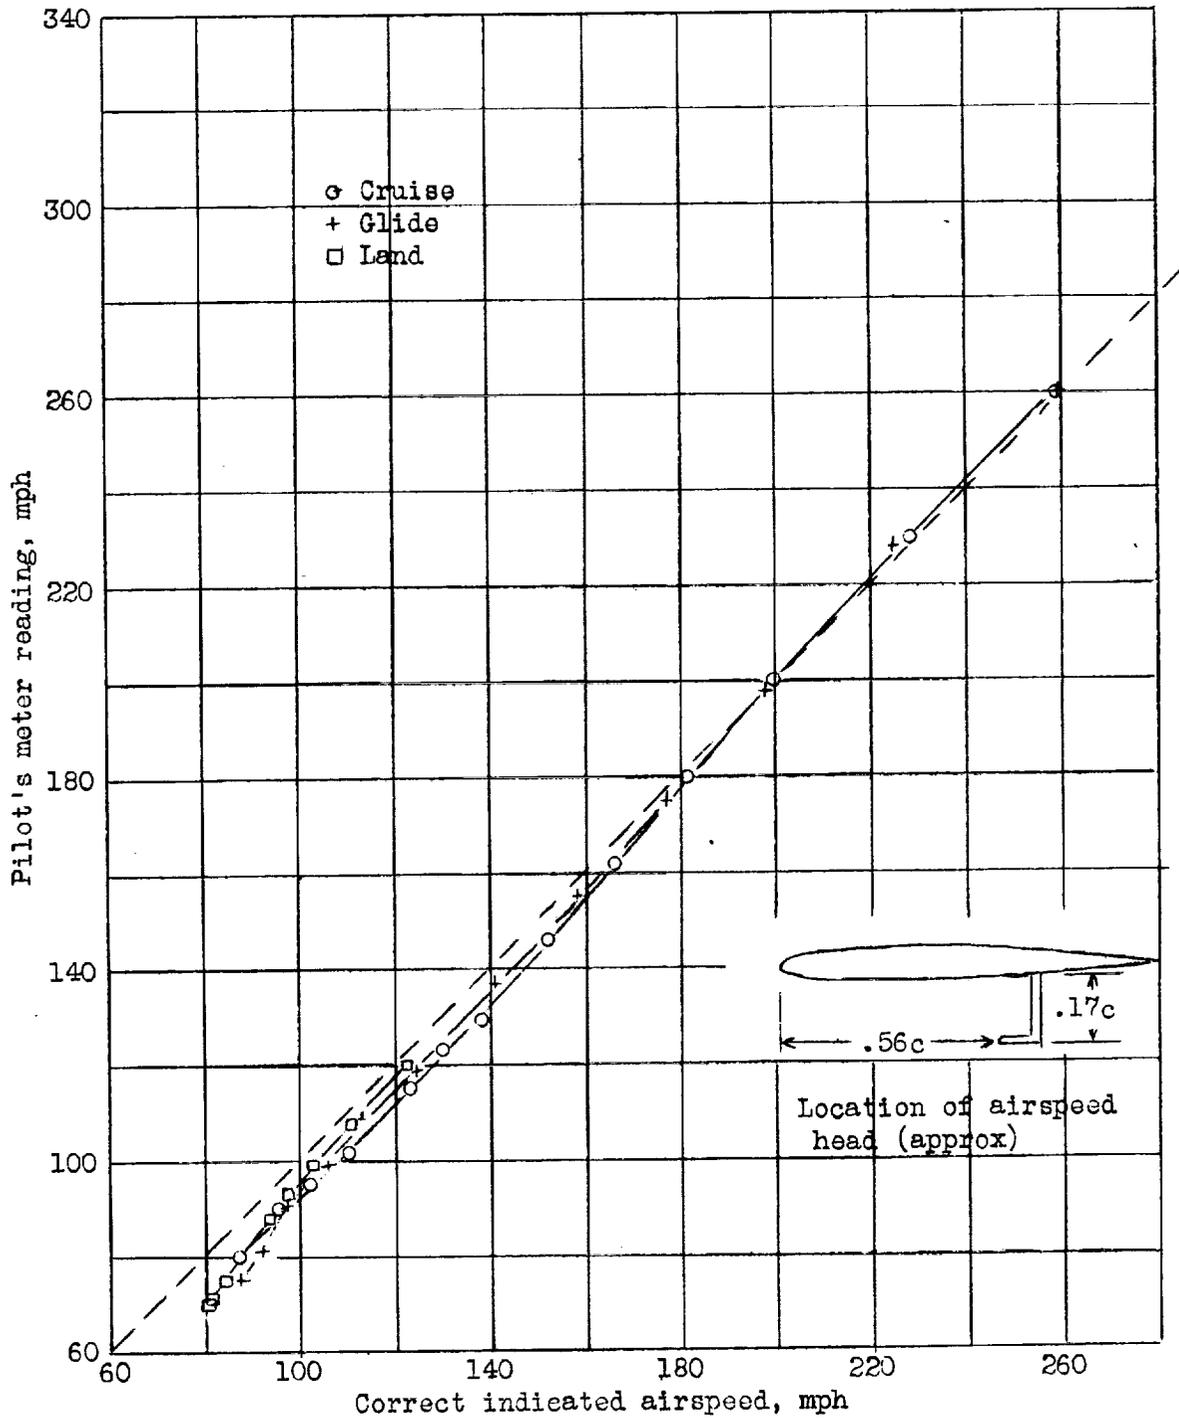
Figure 7.- Calibration of the pilot's airspeed indicator in the Supermarine Spitfire airplane.

The readings of the pilot's meter as compared to the correct indicated airspeed in the cruising, gliding, and landing conditions of flight are plotted on figure 7. The correct speed was determined by flying in formation with another airplane. The calibration of the airspeed recorder in the latter airplane was made by the use of a trailing airspeed head. The installation of the airspeed indicator in the Spitfire consisted of a pitot-static head

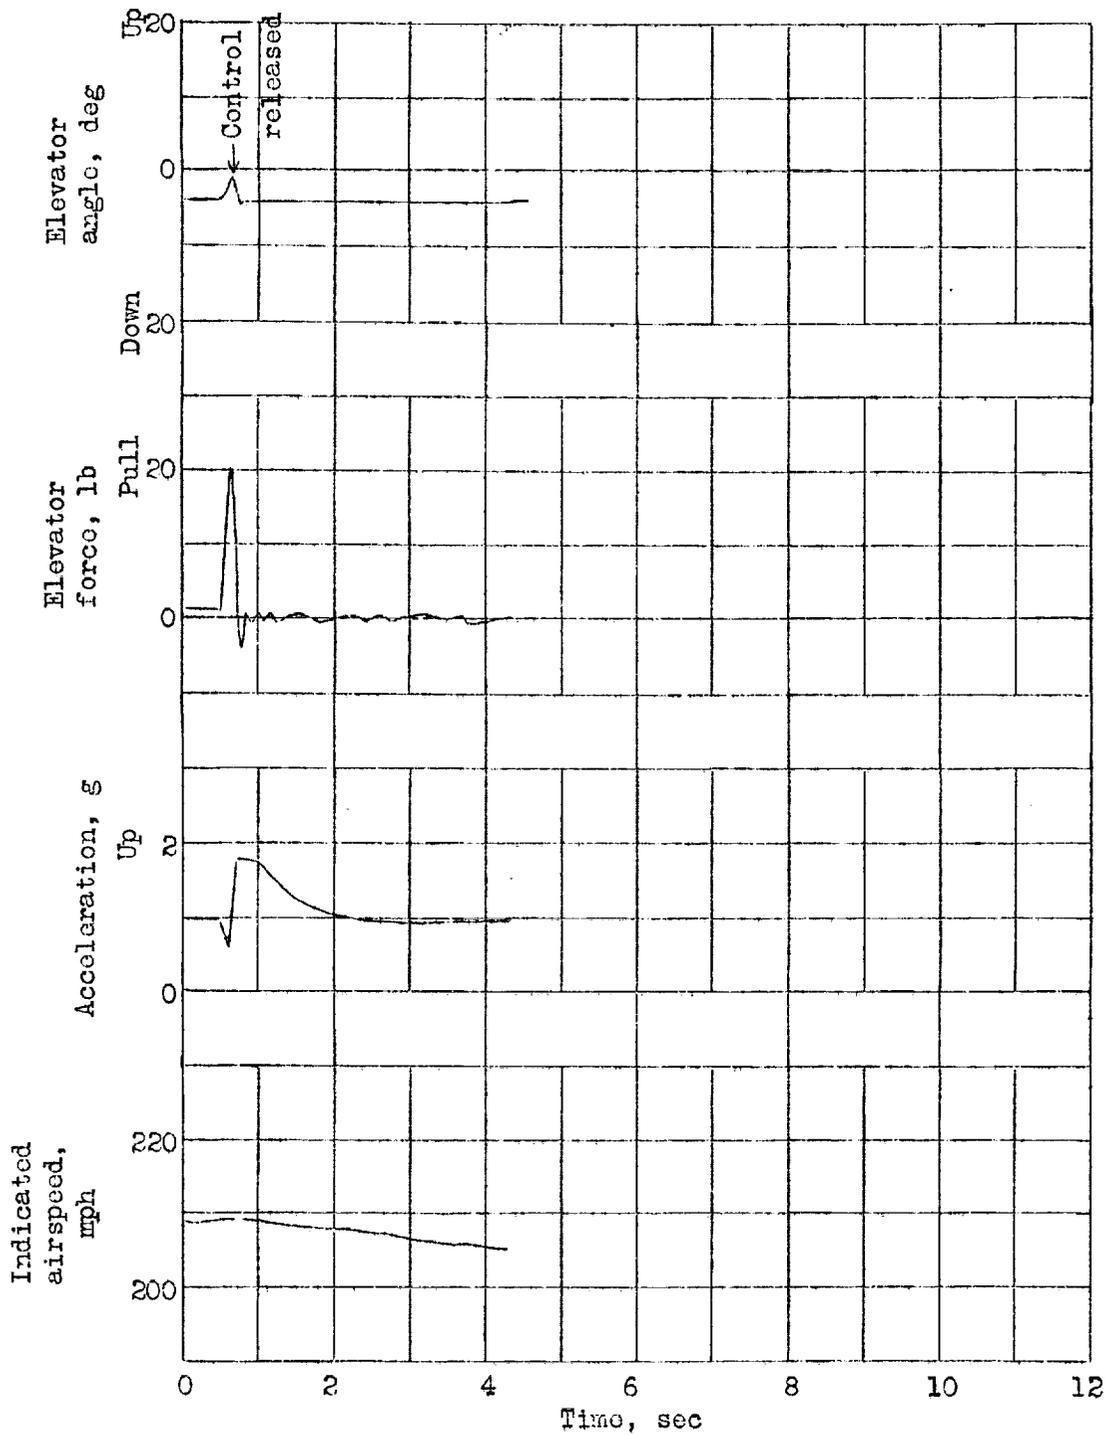
Figure 8.- Time history of a short-period oscillation started by suddenly pulling back the control stick and releasing it in level flight; flaps and gear up. Supermarine Spitfire airplane.

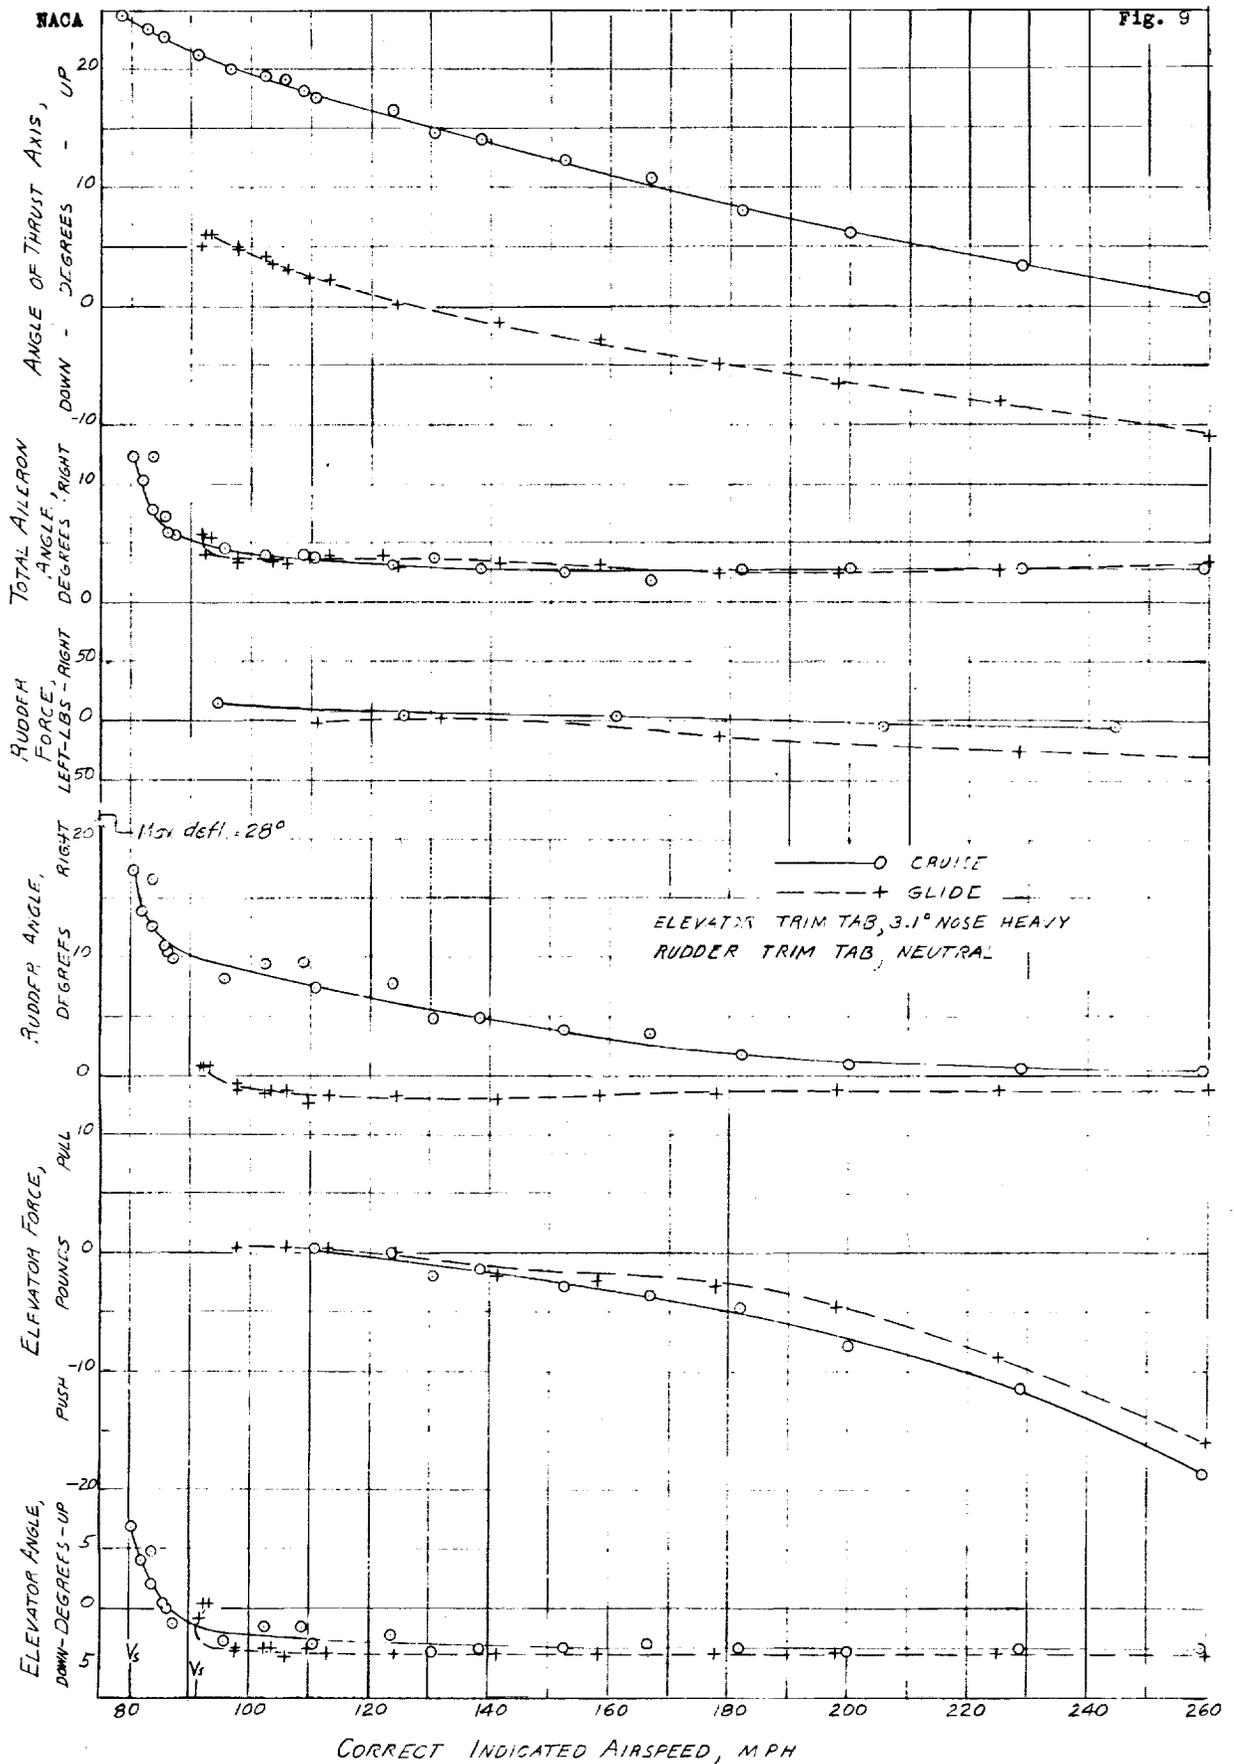
Figure 9. - Static longitudinal-stability characteristics of the Supermarine Spitfire airplane in the cruising and gliding conditions.

2. In spite of the neutral stick-fixed static stability with flaps up, the airplane had a slightly stable stick-force variation with airspeed throughout the speed range (fig. 9). This stable stick-force gradient is attributed to the unbalanced elevator. If a completely mass-balanced elevator had been employed, the stick-force variation would have been slightly unstable, a condition consistent with neutral stick-fixed stability. In the flap-down condition with power on, the stick-force variation for the trim-tab setting used was unstable and, with power off, the stick-free stability was neutral. If the airplane had been trimmed for zero stick force at low speed, the variation might have been slightly stable with

4. The limits of elevator motion were not reached in steady flight from the minimum speed to the highest speeds tested. Figures 9, 10, and 11 show that in all conditions only a few degrees of elevator motion were required to trim throughout the speed range.

Characteristics of longitudinal trimming device.- Because the trim changes required for the different flight conditions were so small, the elevator trim tabs had ample power to trim the airplane at any speed in any flight condition for the center-of-gravity location used in these tests. In order to determine the power of the elevator trim tabs, measurements of the elevator forces required for trim with different trim-tab settings were made at various speeds. The change in stick force per degree trim-tab change is plotted as a function of speed for three flight conditions in figure 24. The variation of stick force with speed for any trim-tab setting may be obtained by adding to the forces plotted on figures 9, 10, and 11 the force caused by the change in trim-tab angle.

Considerable deflection of the rudder to the right was required in the power-on conditions in steady flight near minimum speed as shown on figures 9, 10, and 11. The limits of rudder travel were never exceeded, however. The rudder deflection is needed partly to offset the yawing moment caused by angularity of the flow due to the slipstream, and partly to balance the left yawing moment of the propeller itself that results from the high angle of attack of the propeller axis. The side force on the rudder necessary to maintain equilibrium of yawing moments

The rudder forces required for trim throughout the speed range with the rudder trim tab neutral are plotted for the gliding and cruising conditions on figure 9. These rudder forces were unusually light.

Power of rudder and aileron trimming devices.- The trim tab provided on the rudder was sufficiently powerful to reduce the rudder force to zero in any flight condition. The rudder forces required for trim with the trim tab neutral are plotted on figure 9. No trim tab was provided on the ailerons, but the aileron forces for trim were light. The aileron angles required for trim throughout the speed range in the various flight conditions are plotted in figures 9, 10, and 11.

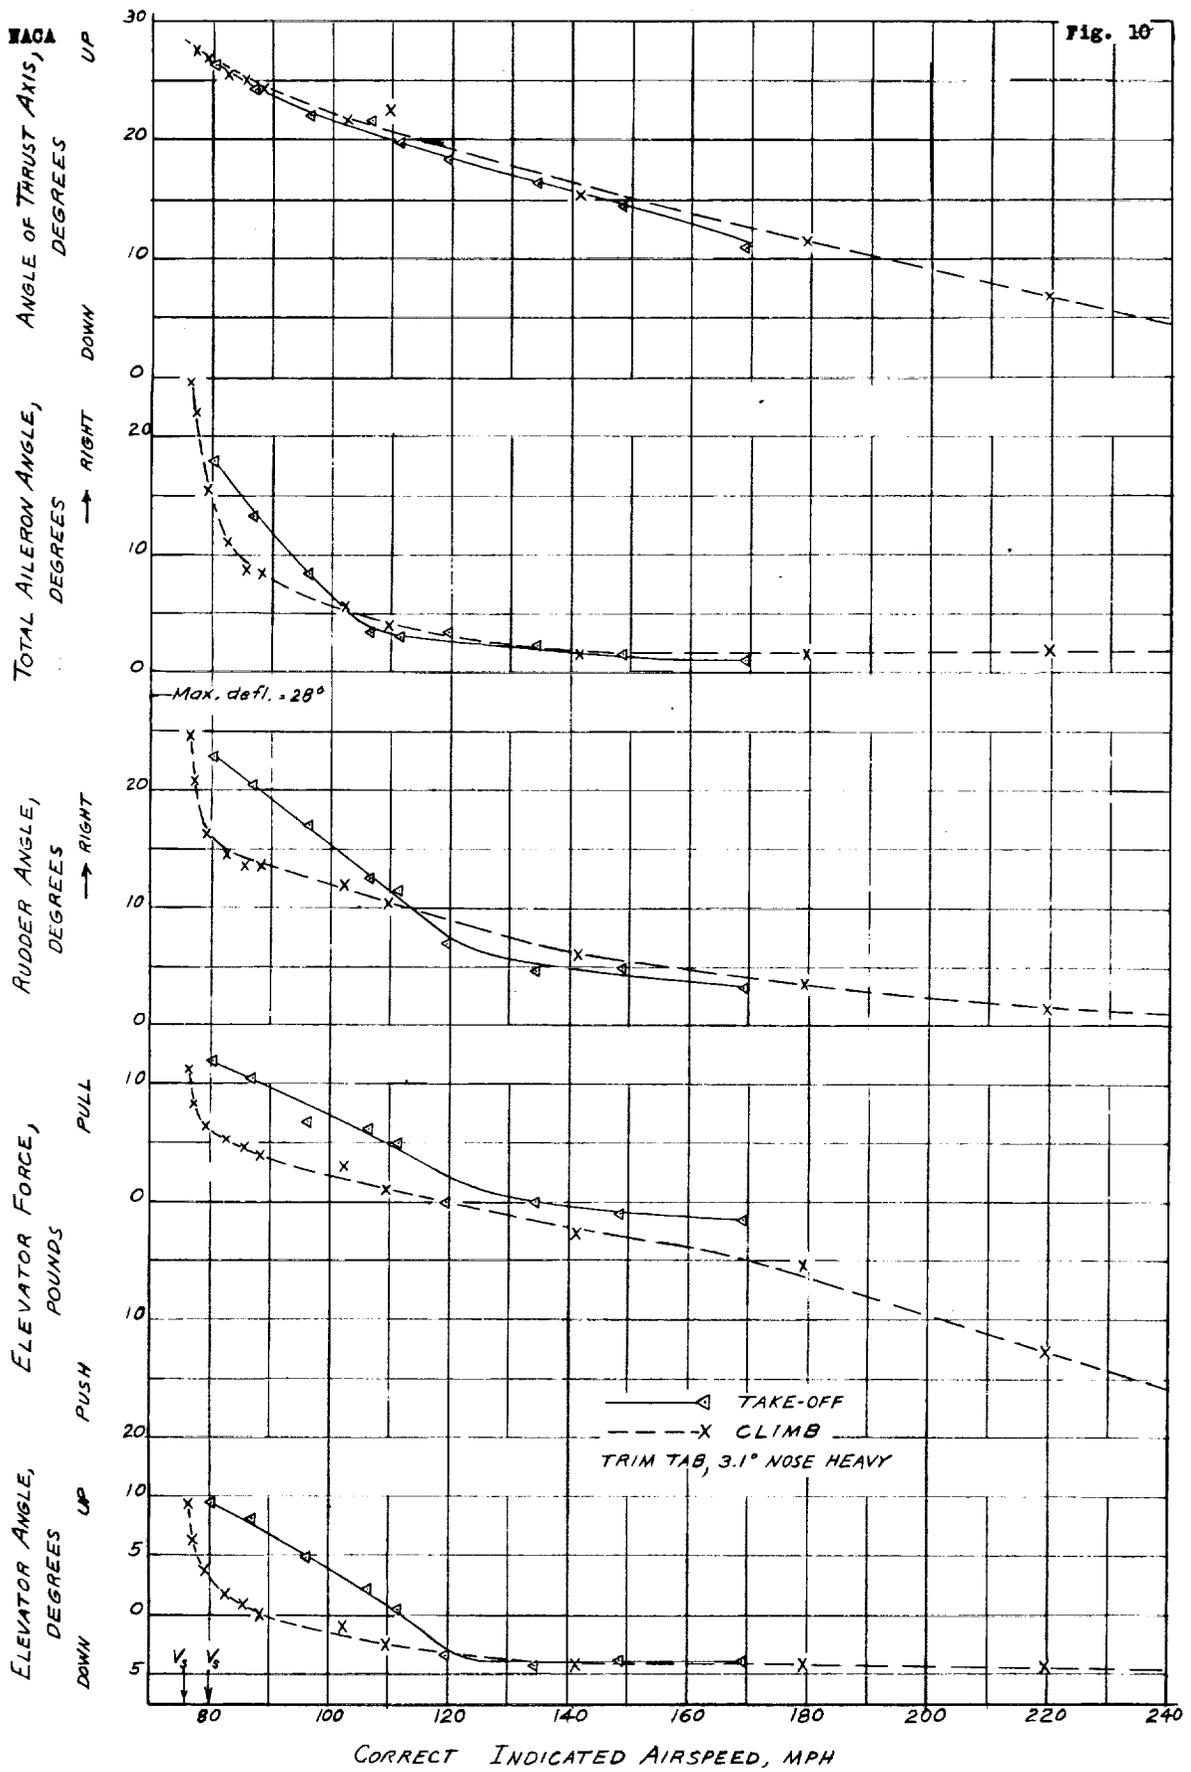
Figure 10. - Static longitudinal-stability characteristics of the Supermarine Spitfire airplane<sup>HM6</sup> in the climbing and take-off conditions.

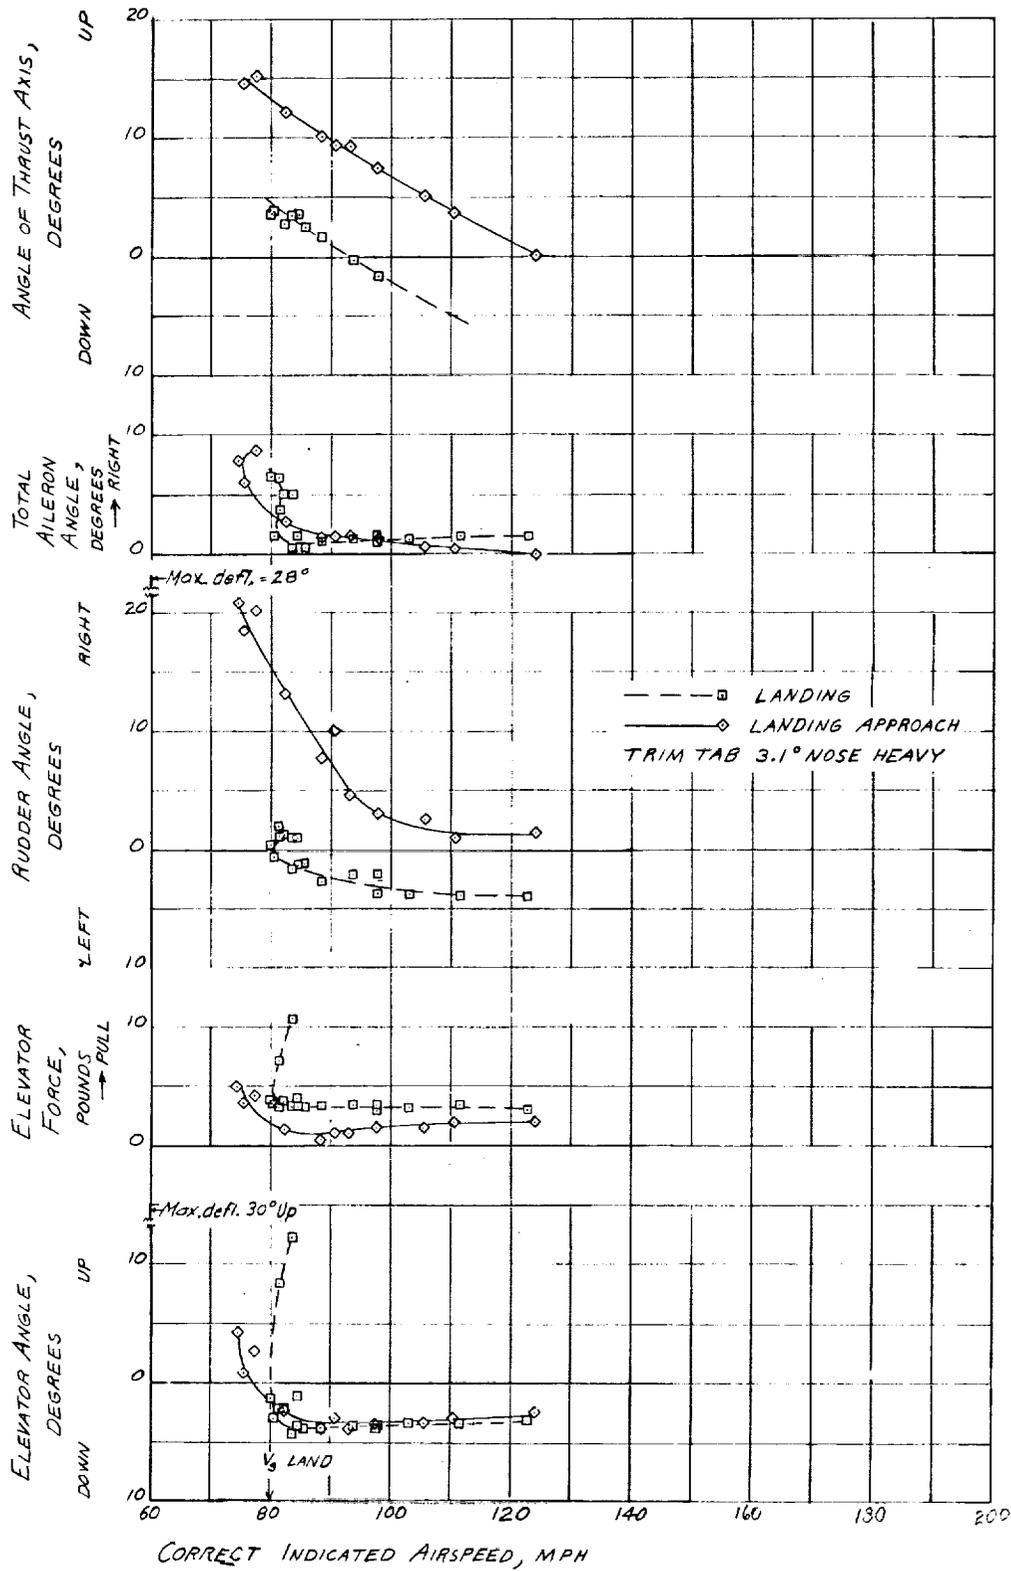
Figure 11. - Static longitudinal-stability characteristics of the Supermarine Spitfire airplane in the landing and landing-approach conditions.

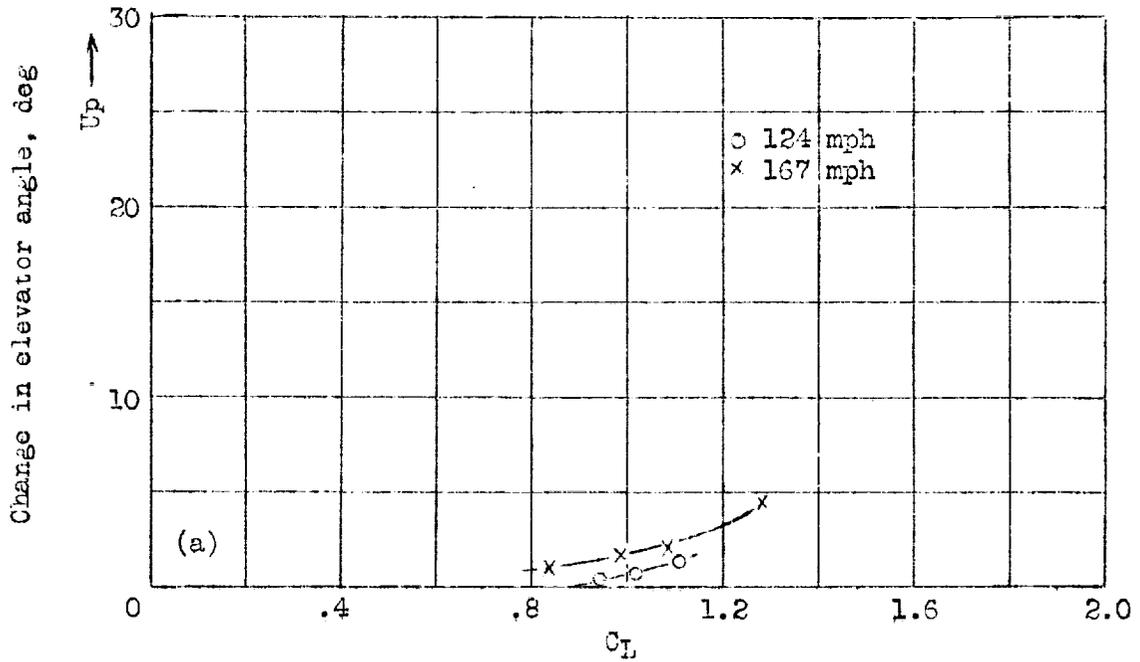
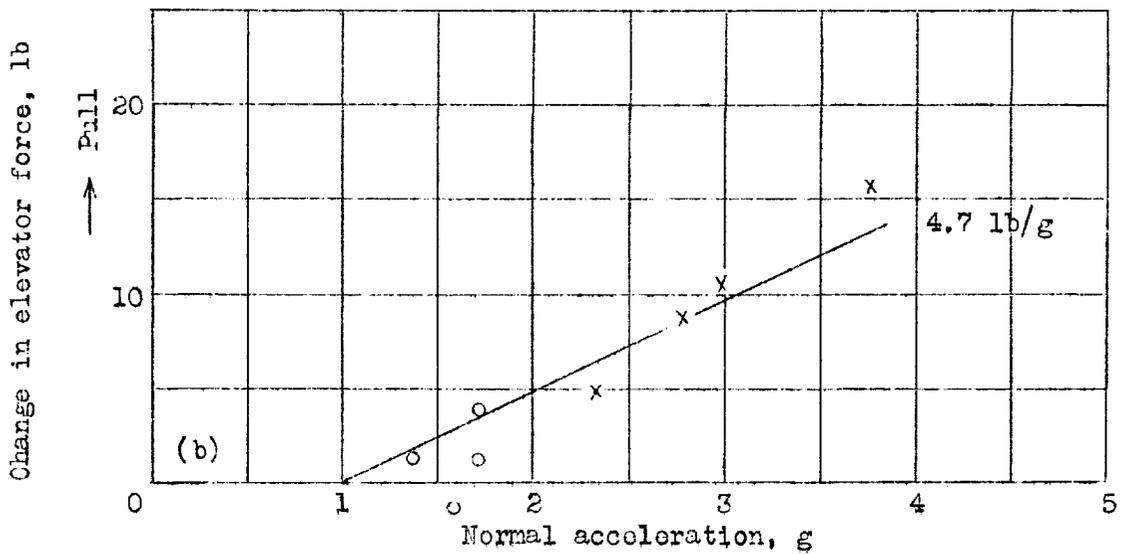
(a) Variation of change in elevator angle with lift coefficient in pull-ups.

(b) Variation of elevator force with normal acceleration in pull-ups.

Figure 12.- Elevator characteristics in pull-ups. Supermarine Spitfire airplane.

The elevator control was found to be powerful enough to develop either the maximum lift coefficient or the allowable load factor at any speed. As shown in figure 12(a), less than  $5^\circ$  movement of the elevator was used in reaching maximum lift coefficient in pull-ups from level flight. In these maneuvers, the elevator was abruptly deflected a small amount and then held fixed with the aid of a graduated tape in the cockpit. In pull-ups made at high speed, the elevator was always eased forward before maximum acceleration had been developed, in order to avoid overloading the structure.

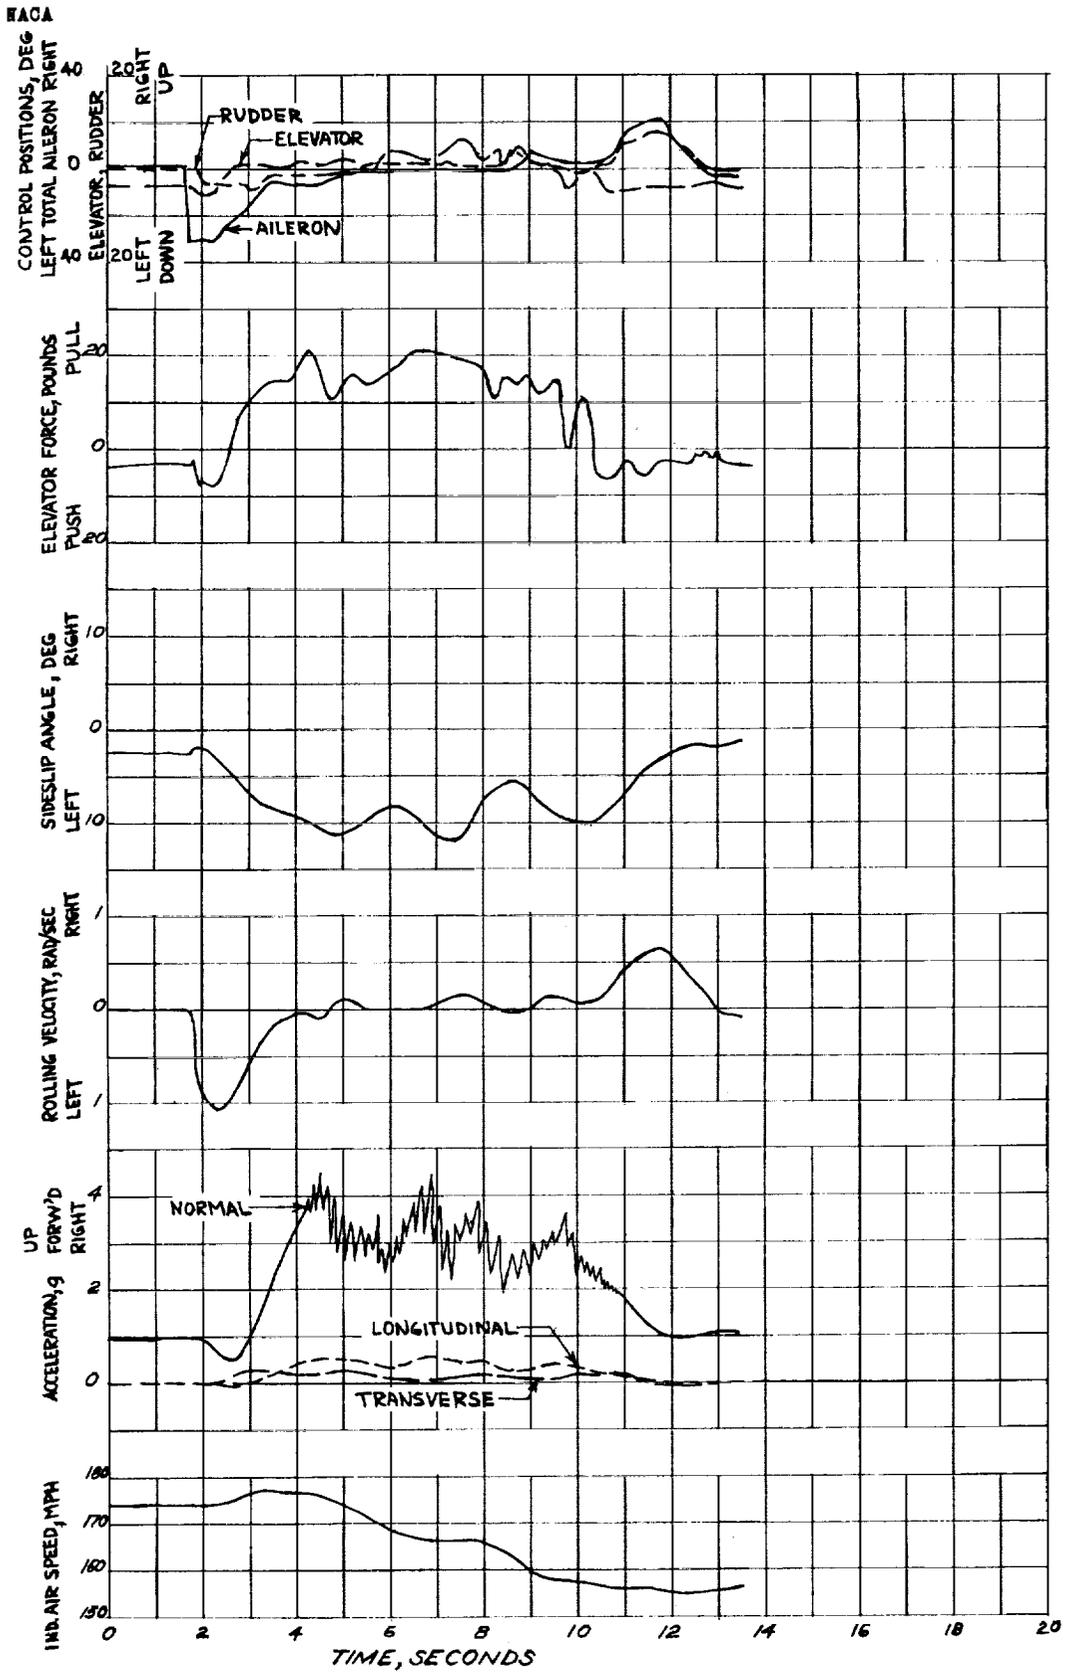
Figure 13. - Time history of a rapid 180° turn to the left started at 174 miles per hour, in which the stall was reached. Supermarine Spitfire airplane; gun parts covered.

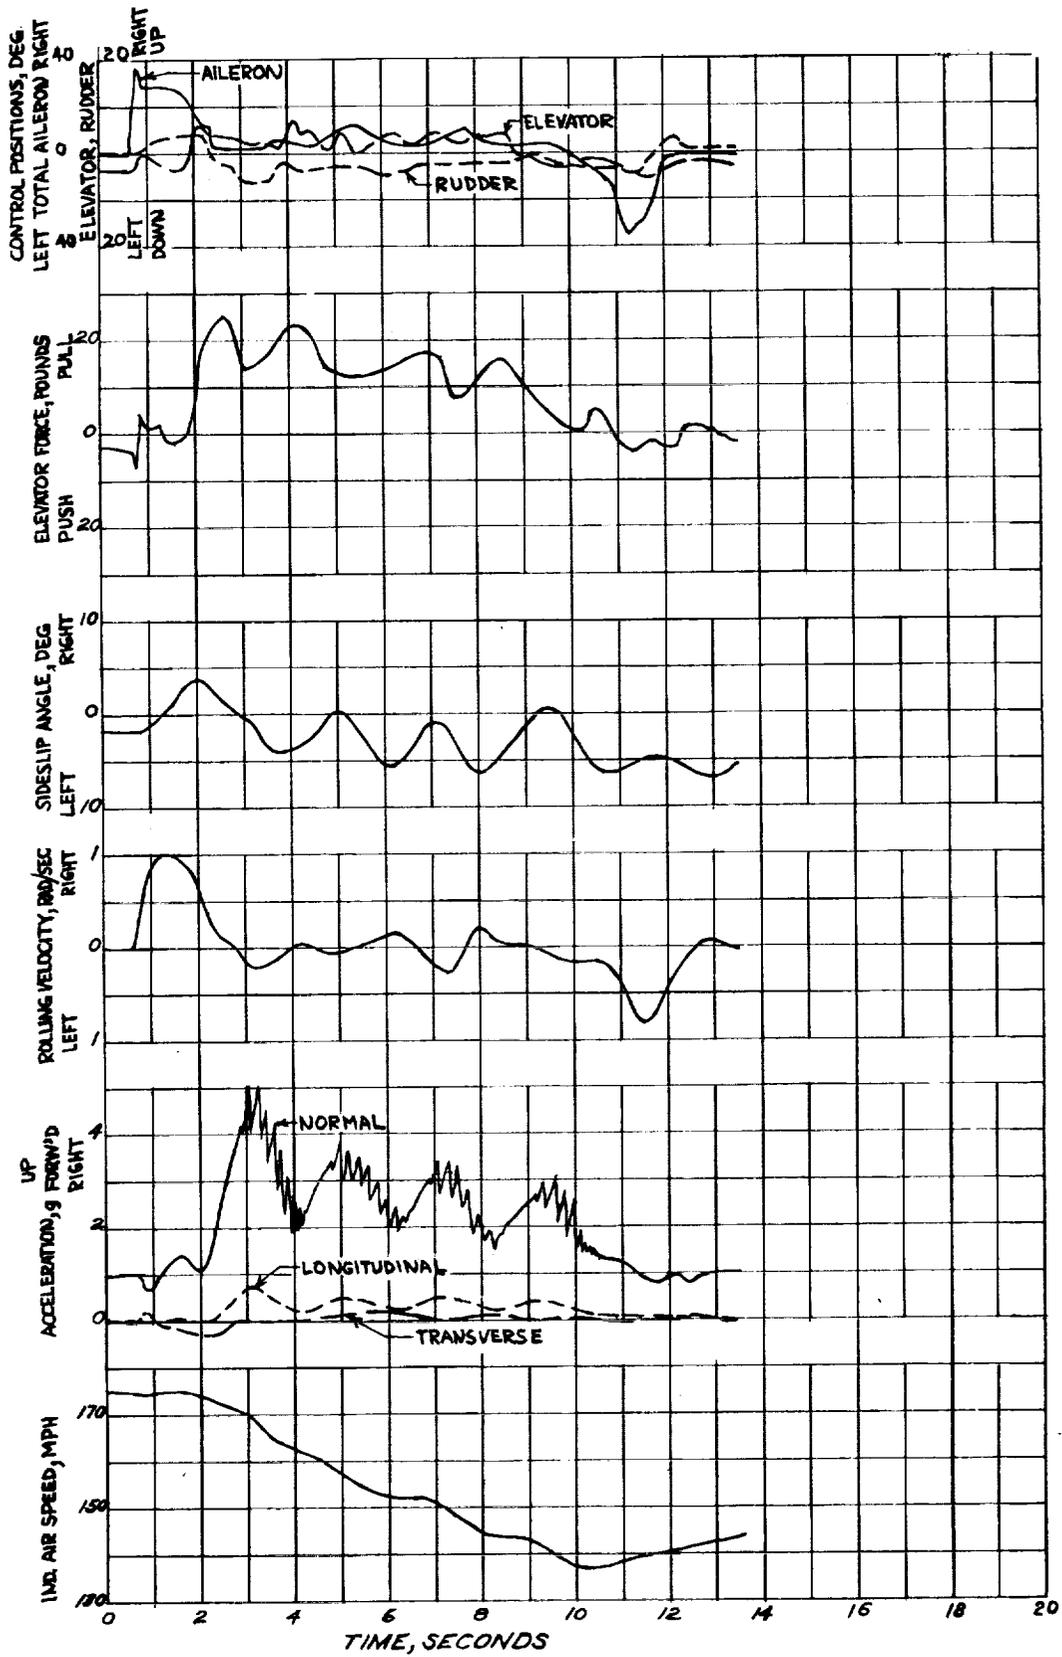
Figure 14. - Time history of a rapid 180° turn to the right started at 175 miles per hour, in which four stalls occurred. Supermarine Spitfire airplane with gun parts covered.

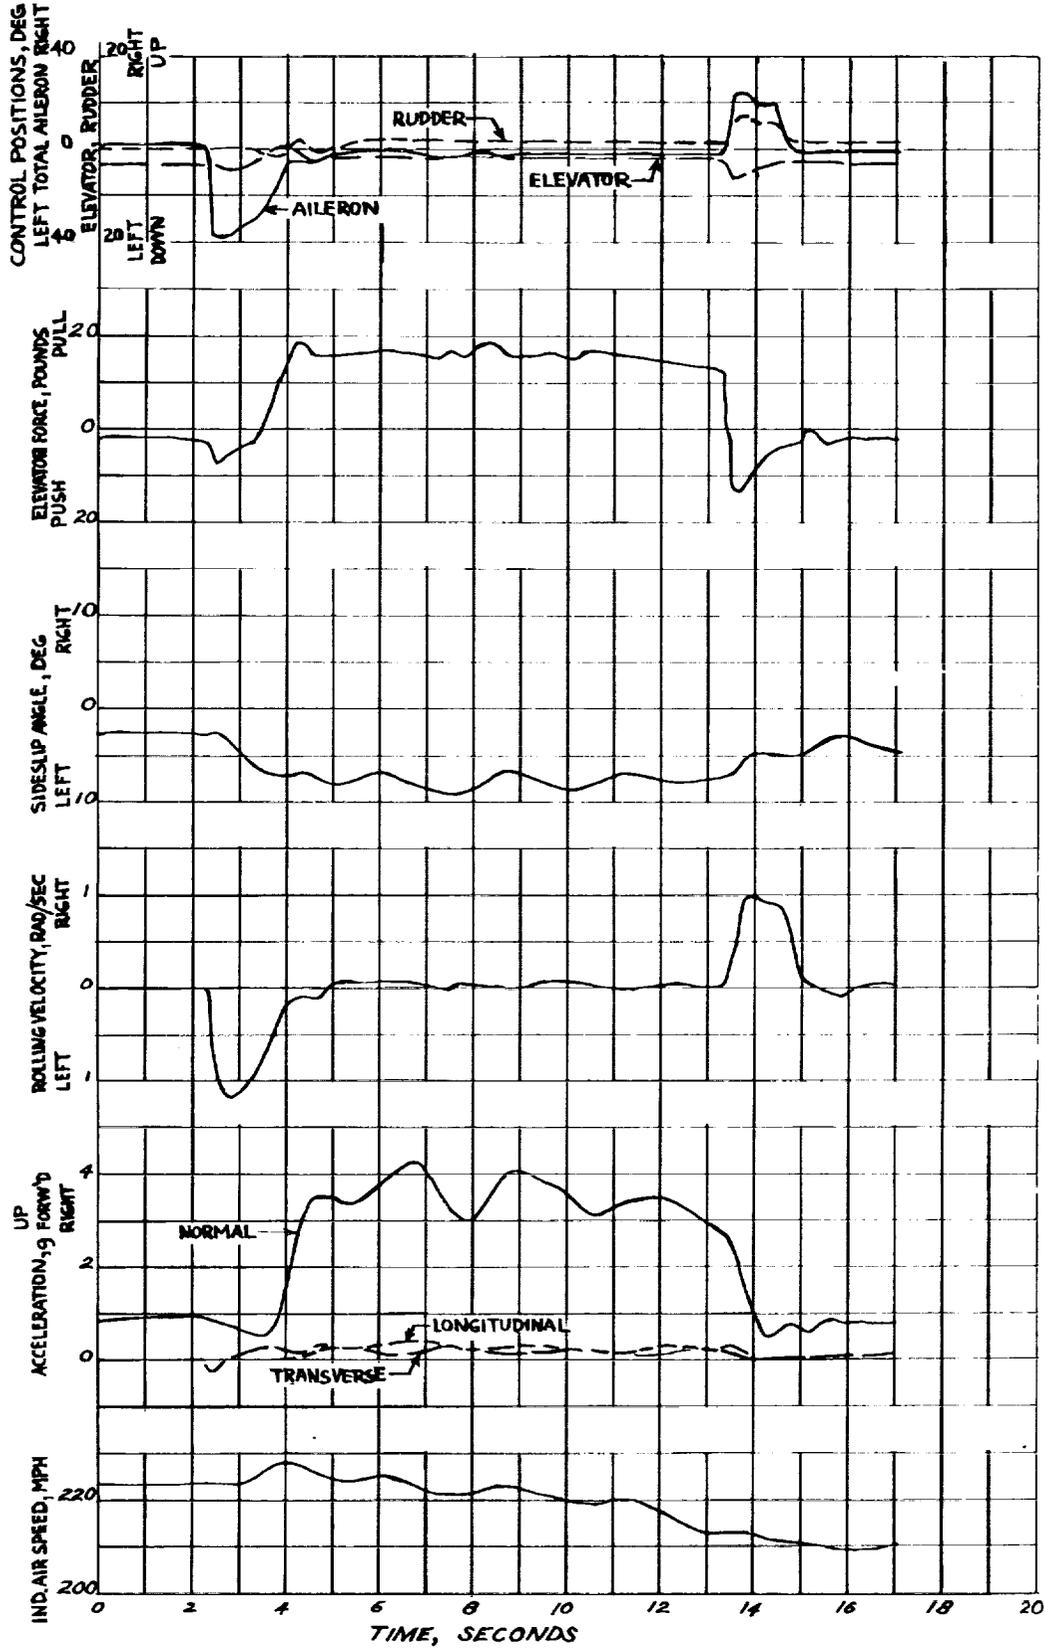
Figure 15. - Time history of a rapid 180° turn to the left started at 223 miles per hour. Supermarine Spitfire airplane with gun parts covered.

the static stability of an airplane is sufficiently large. By careful flying, the pilot was able to make smooth turns at high speed, as shown by figures 17 and 18. Ordinarily, however, small movements of the stick caused appreciable variations in the normal acceleration, as shown in figures 15 and 20.

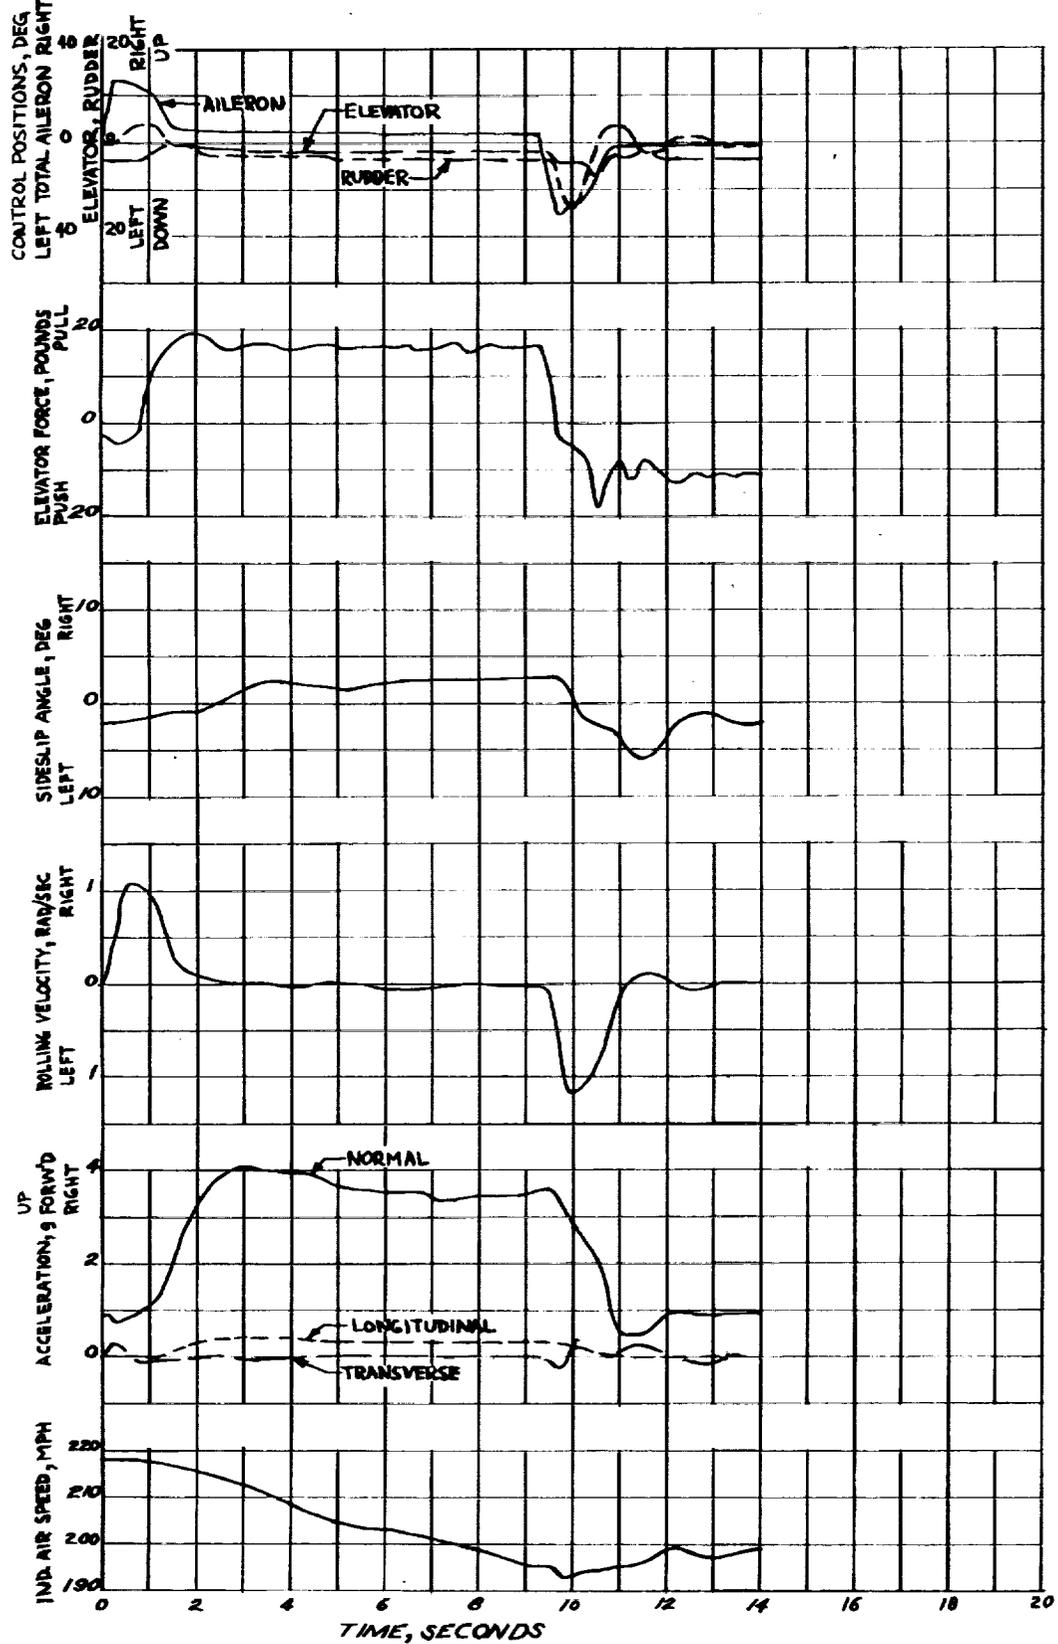
Figure 16. - Time history of a rapid 180° turn to the right started at 218 miles per hour. Supermarine Spitfire airplane with gun parts covered.
