ORIGINALLY ISSUED  
September 1942 as  
Advance Confidential Report

MEASUREMENTS OF THE FLYING QUALITIES OF A  
SUPERMARINE SPITFIRE VA AIRPLANE

By William H. Phillips and Joseph R. Vensel

Langley Memorial Aeronautical Laboratory  
Langley Field, Va.

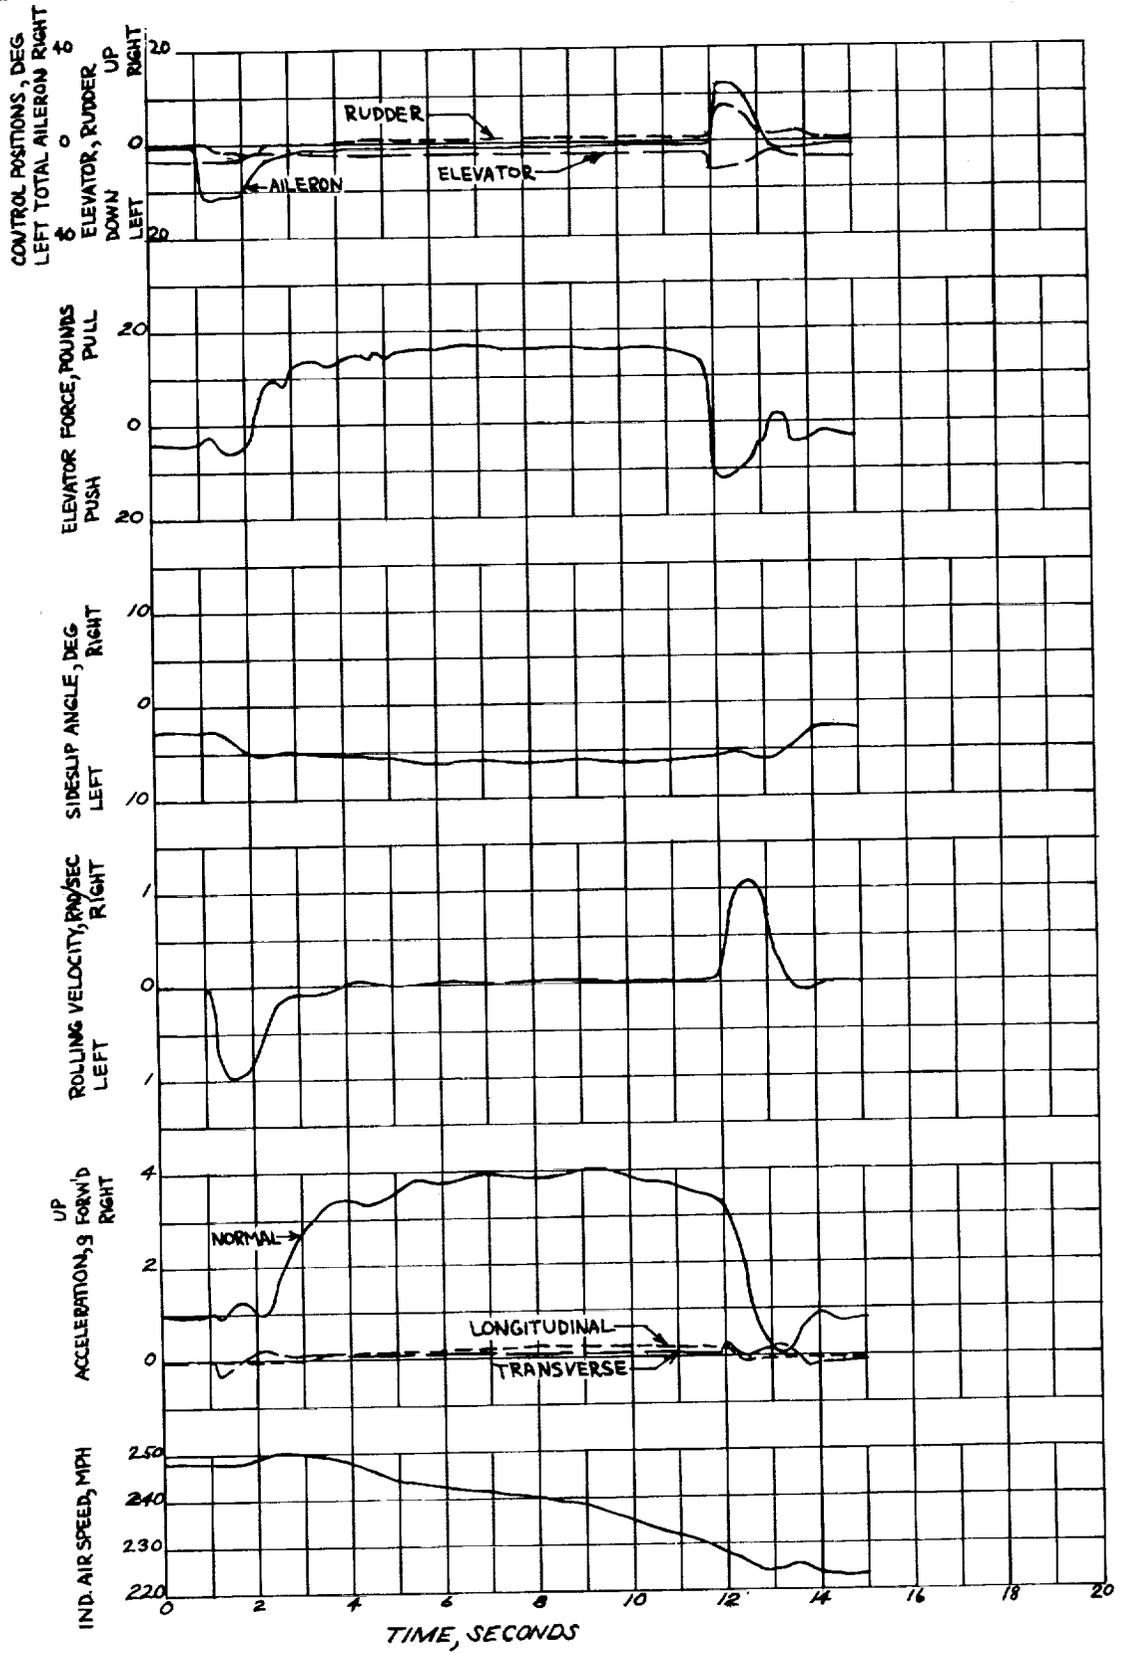
Figure 17. - Time history of a rapid 180° turn to the left started at 248 miles per hour. Supermarine Spitfire airplane with gun ports covered.

the static stability of an airplane is sufficiently large. By careful flying, the pilot was able to make smooth turns at high speed, as shown by figures 17 and 18. Ordinarily, however, small movements of the stick caused appreciable variations in the normal acceleration, as shown in figures 15 and 20.

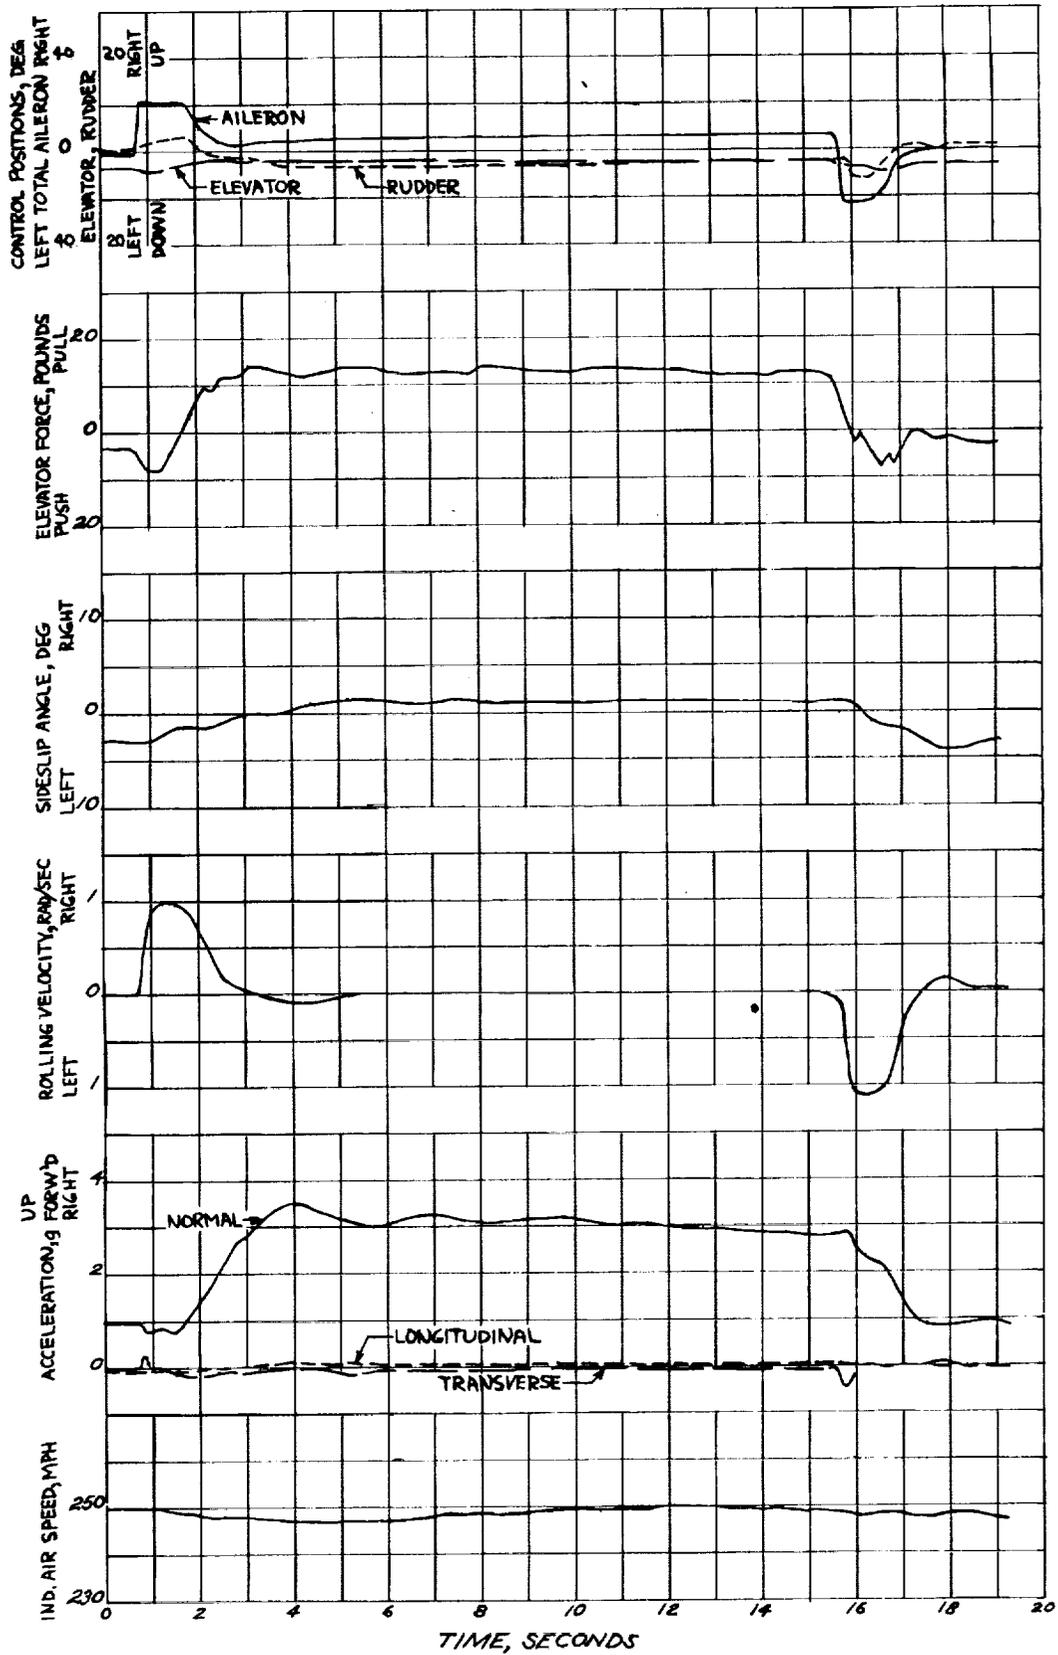
Figure 18. - Time history of a rapid 180° turn to the right started at 250 miles per hour. Supermarine Spitfire airplane with gun ports covered.

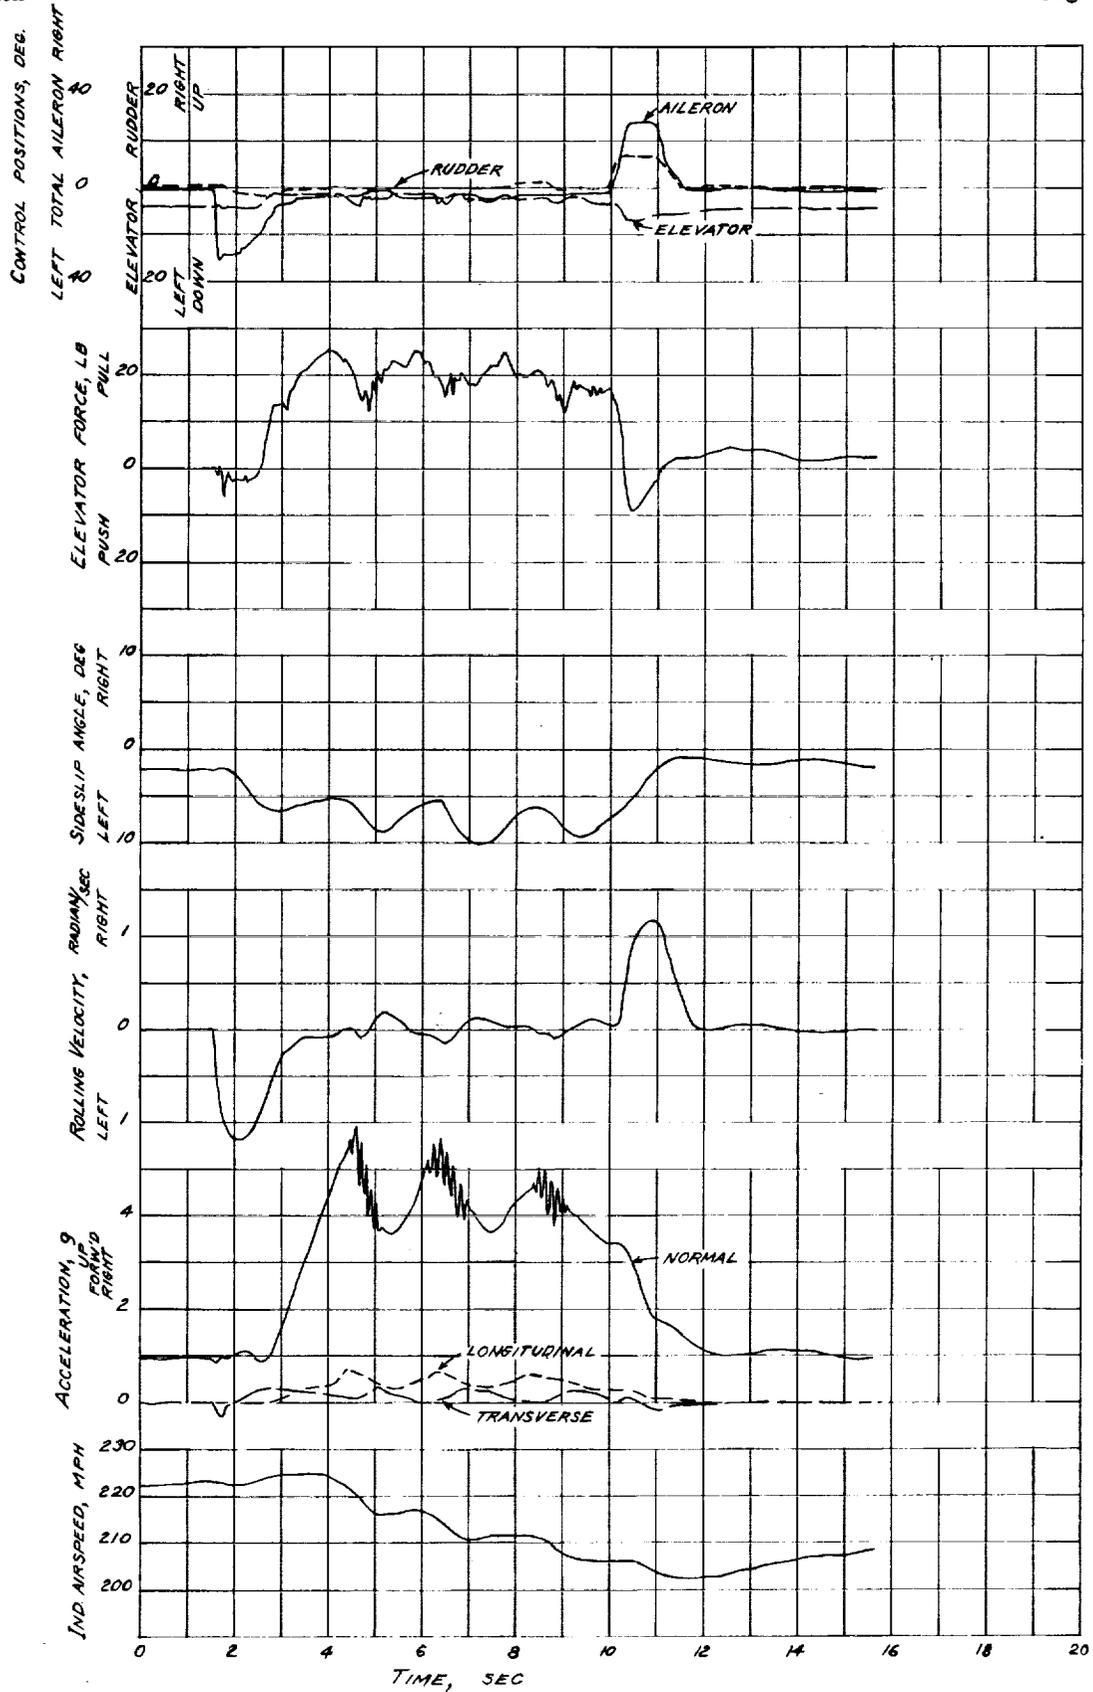
Figure 19. - Time history of a highly accelerated left turn in which the stall was reached three times. Supermarine Spitfire airplane with gun ports covered.

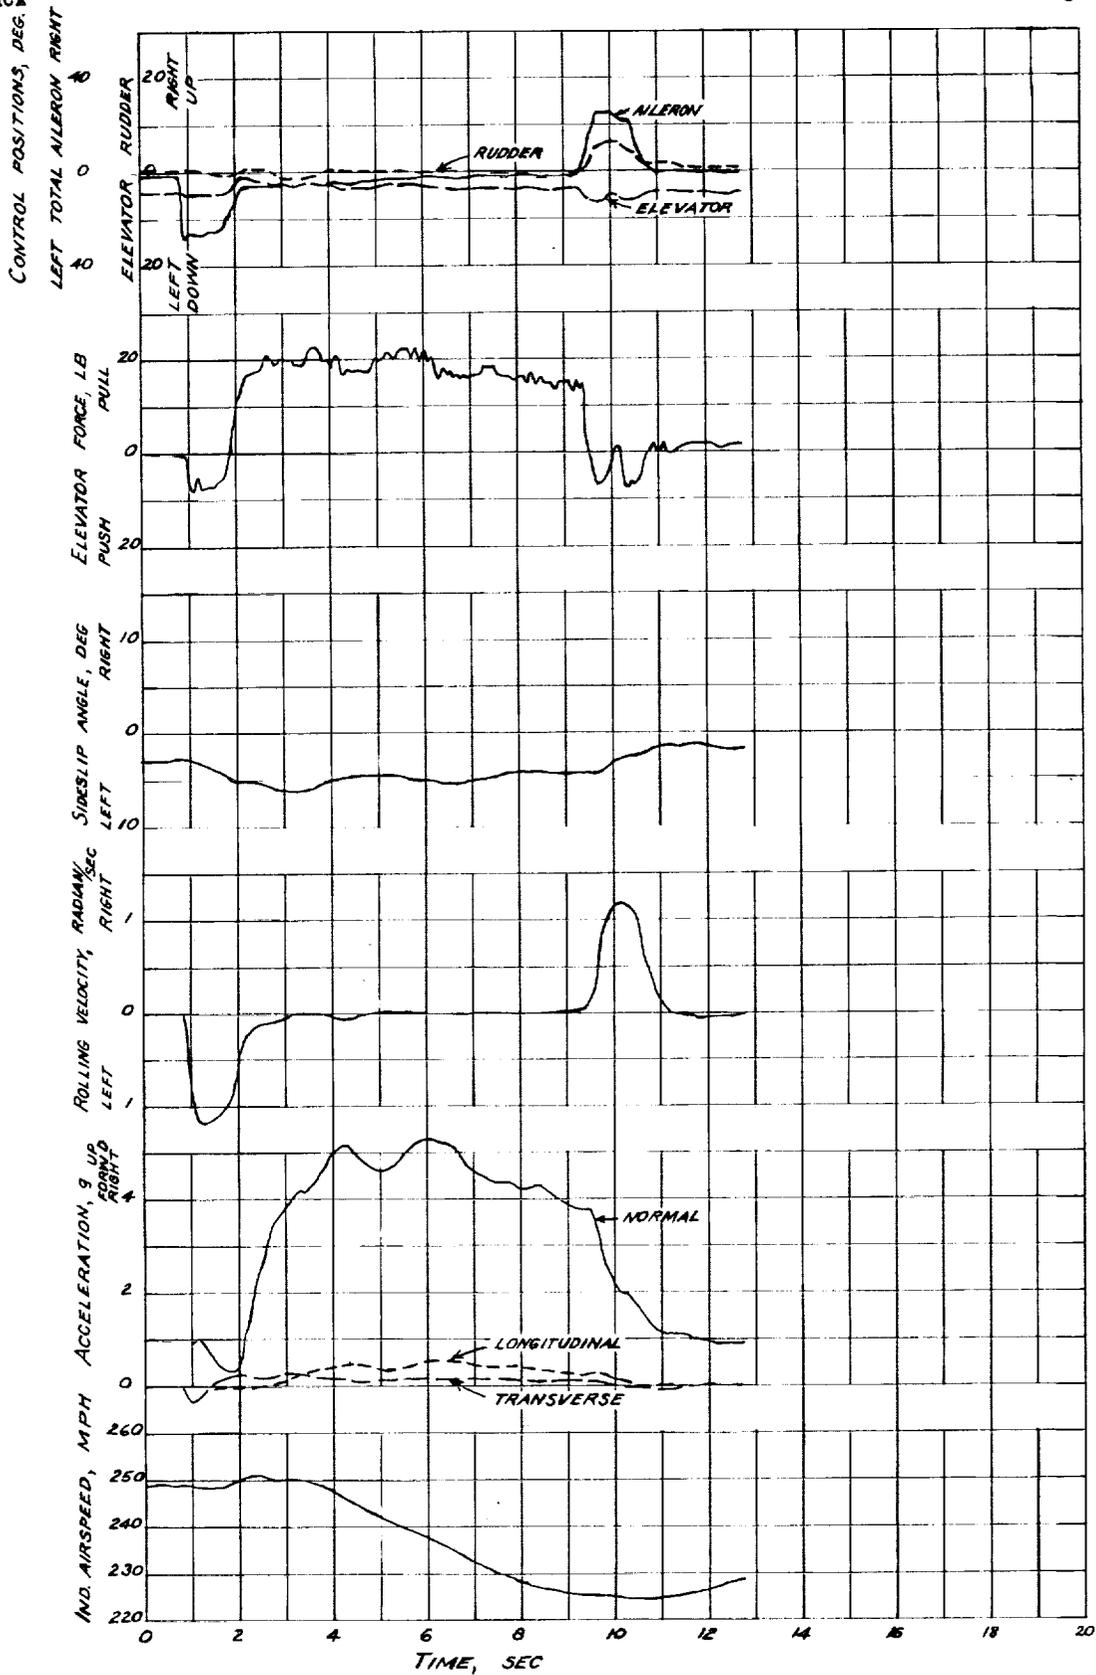
Figure 20. - Time history of a highly accelerated left turn started at 249 miles per hour. Supermarine Spitfire airplane with gun ports covered.

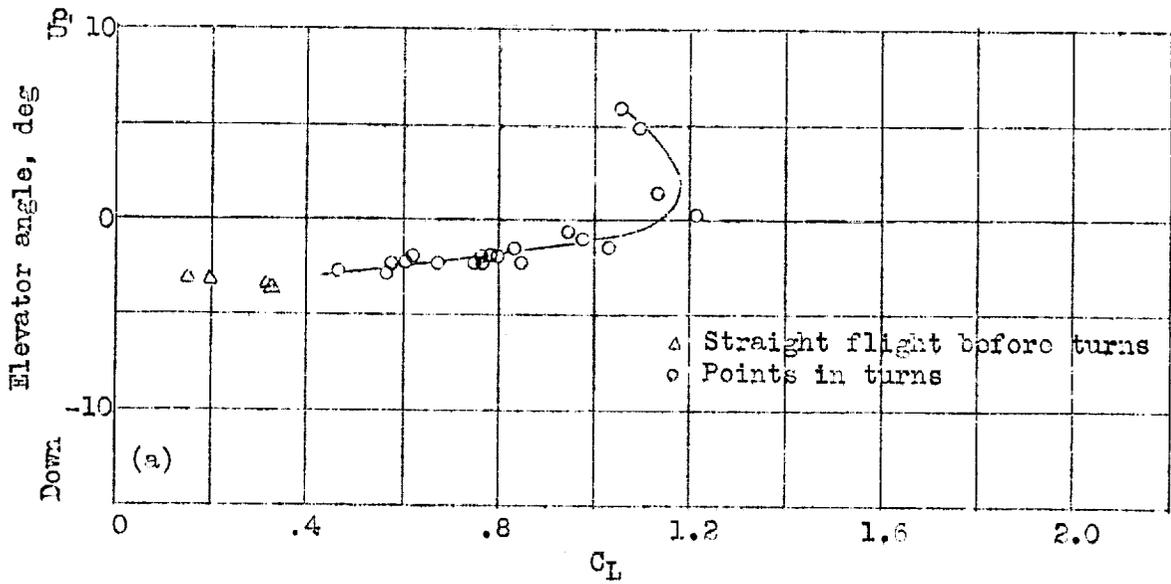
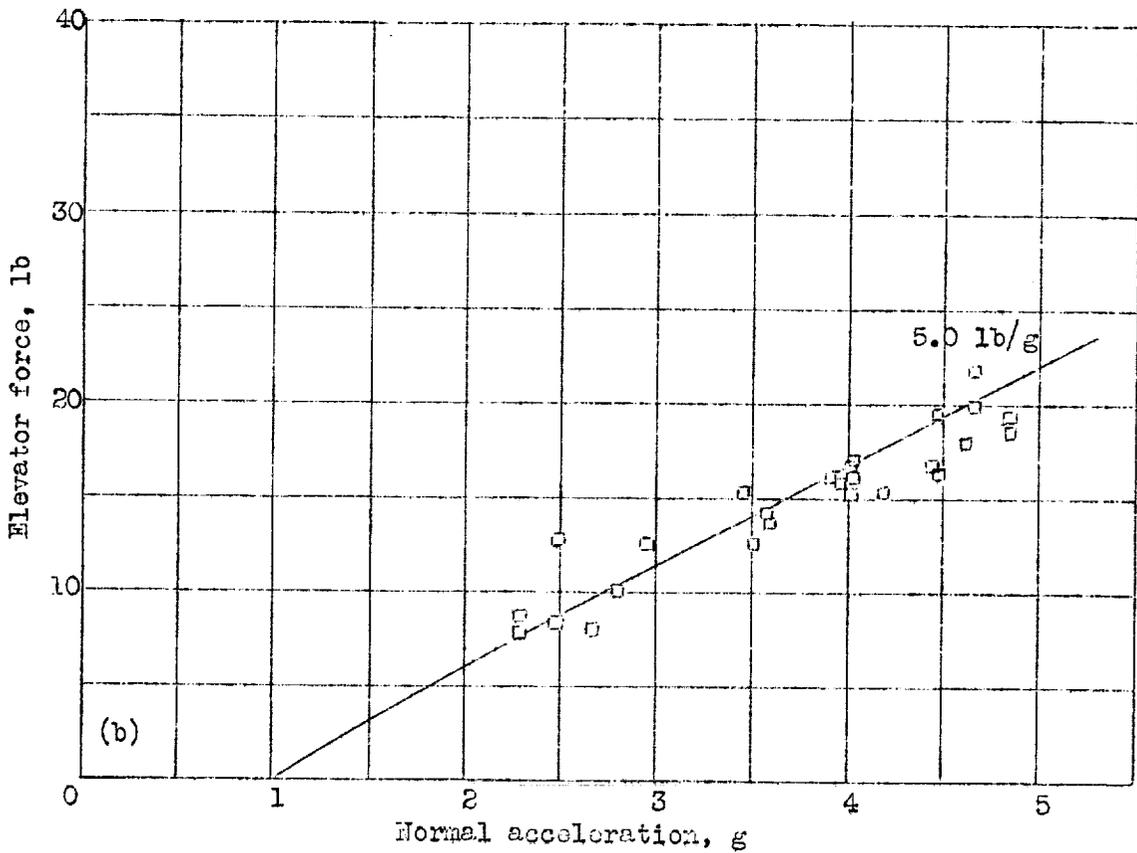
(a) Variation of elevator angle with lift coefficient in turns

(b) Variation of stick force with normal acceleration in turns.

Figure 21.- Elevator characteristics in turns. Supermarine Spitfire airplane.

The variation of stick force with normal acceleration in turns is plotted in figure 21(b). The stick-force gradient of 5.0 pounds per  $g$  was considered a little too light by most of the pilots. It is lower than the value of 6 pounds per  $g$  recommended as an upper limit in reference 1. Inasmuch as the elevator mass unbalance under static conditions gave a force of 4.0 pounds on the stick, it is apparent that the stick force required in accelerated flight came almost entirely from the statically unbalanced elevator. Practically no stick force would be required in turns if the elevator were mass balanced. This suggests that the airplane would appear definitely unstable in turns if the elevator were mass balanced, as is required for flutter prevention on American pursuit airplanes.

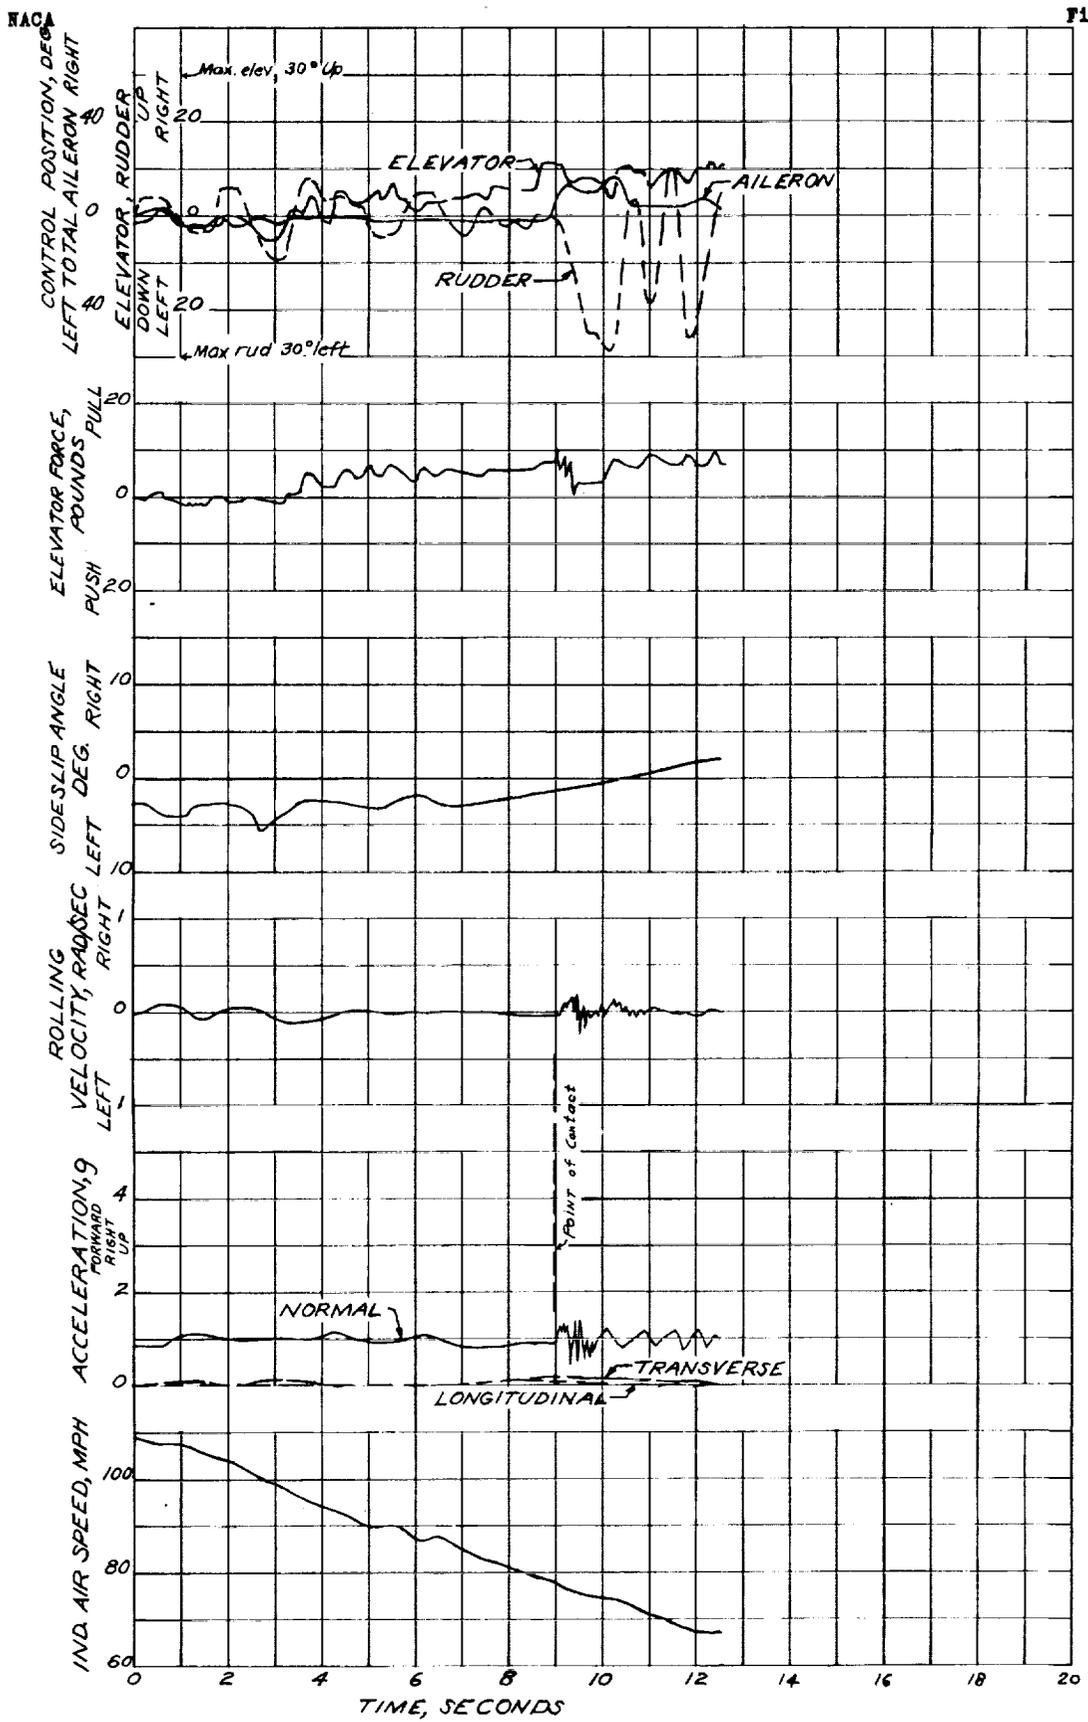
Figure 22. - Time history of a three-point landing (trim tab, 2.5° nose heavy). Note unsteadiness of airplane and controls caused by tail buffeting and instability in the approach. Supermarine Spitfire airplane.

wash at the tail caused by separation of the flow at the wing root was probably combined with that due to ground effect in the three-point landings. A time history of a three-point landing, shown in figure 22, illustrates the unsteadiness of the airplane and controls as the landing attitude was approached.

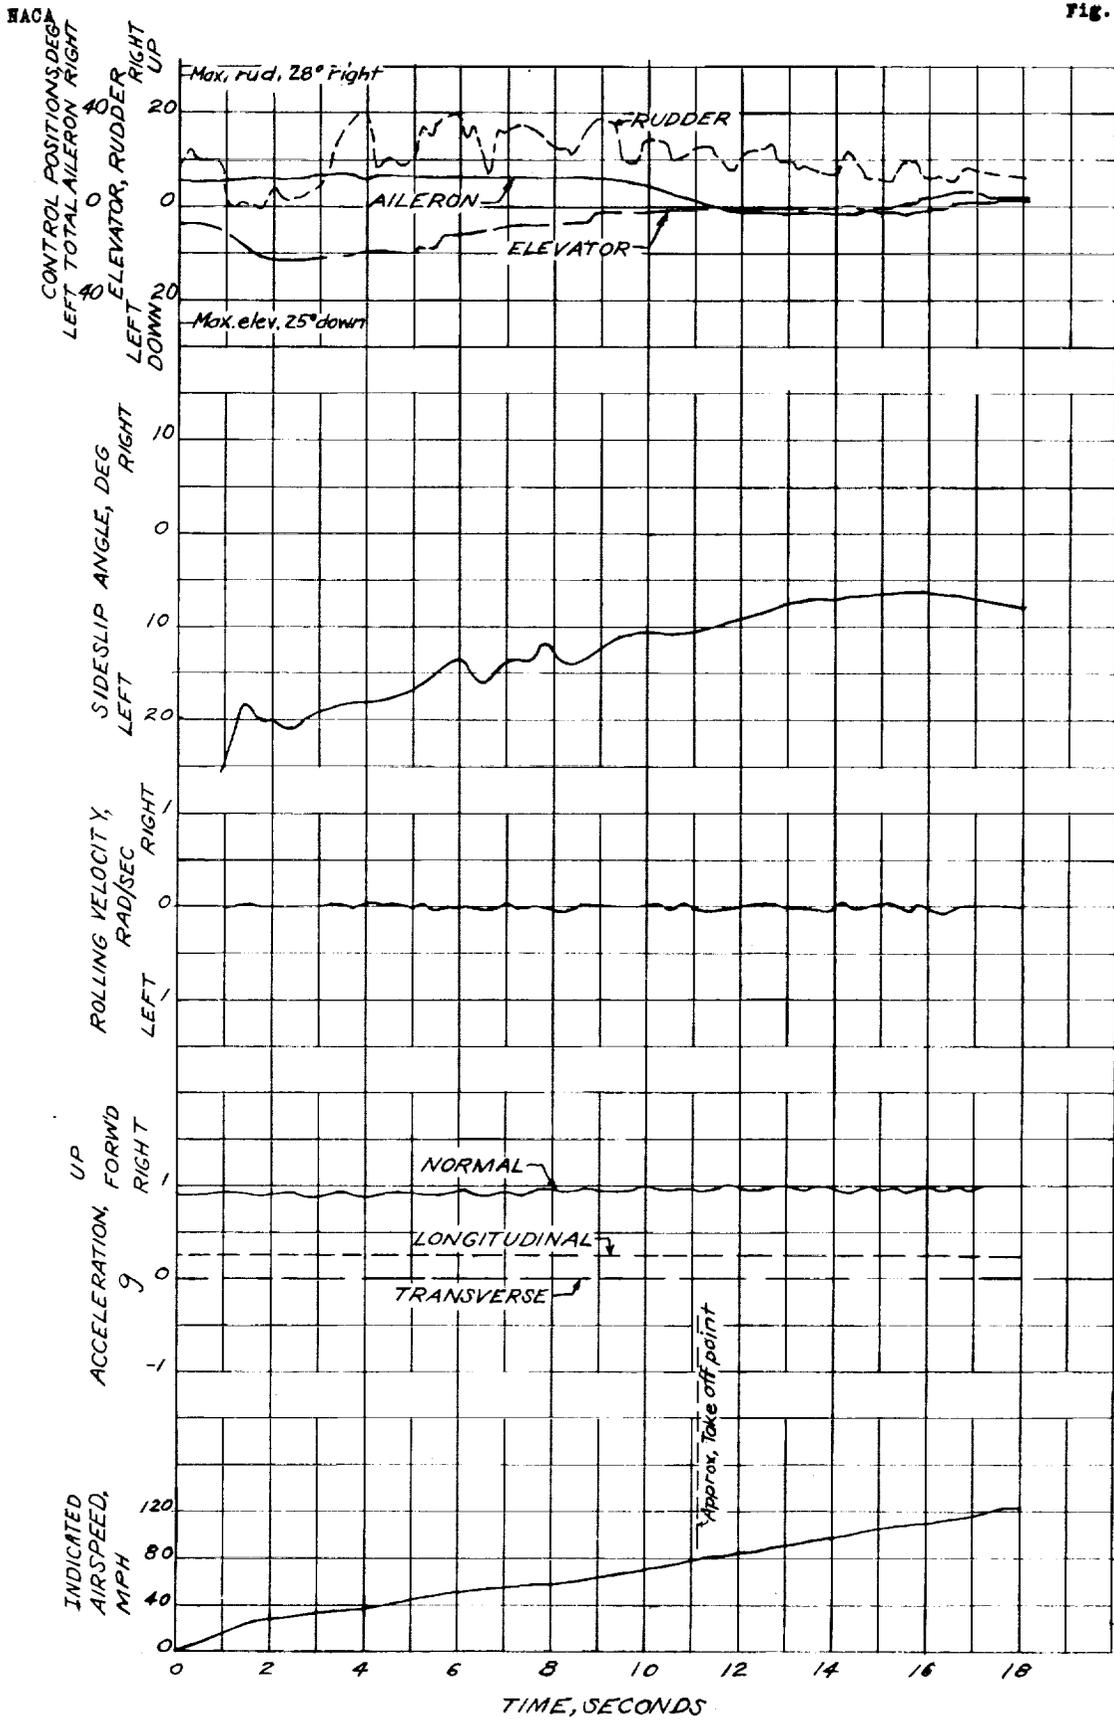
Figure 23. - Time history of a tail-high take-off made with 48 in. Hg manifold pressure. Supermarine Spitfire airplane.

The rudder control, in conjunction with the brakes, was sufficiently powerful to maintain directional control in take-off and landing. A time history of a take-off (fig. 23) shows that some rudder deflection was required to overcome a tendency to turn to the left. The rudder force required for this purpose, however, was observed to be relatively light.

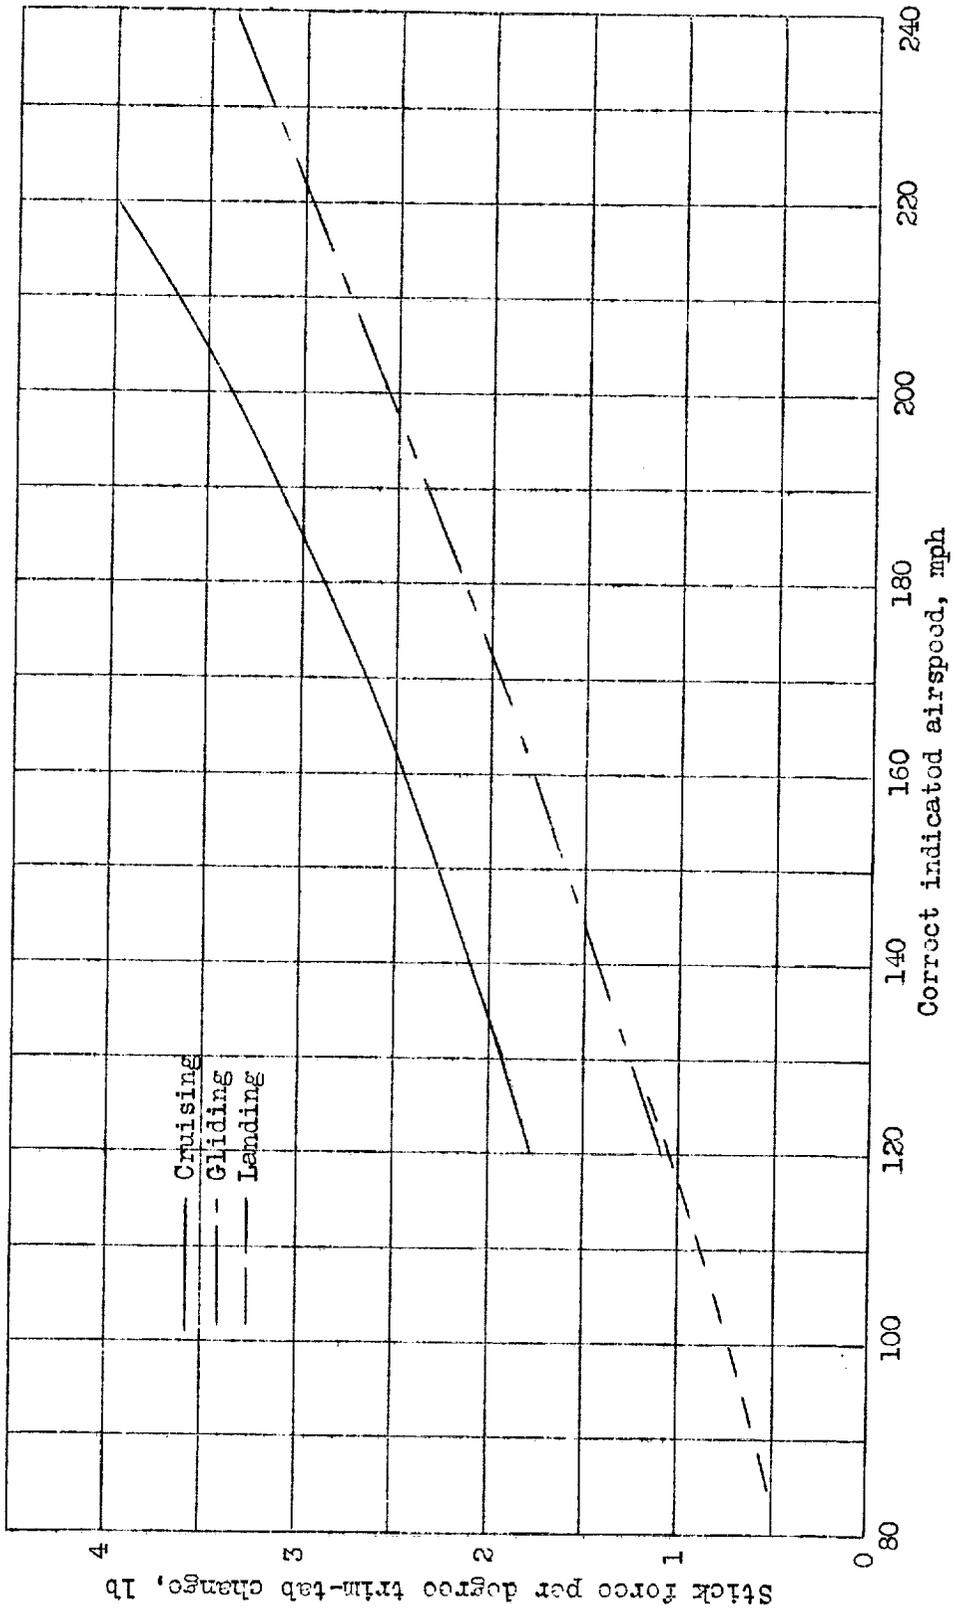
Figure 24.- Variation of power of the elevator trim tabs with indicated airspeed in the cruising, gliding, and landing conditions. Supermarine Spitfire airplane.

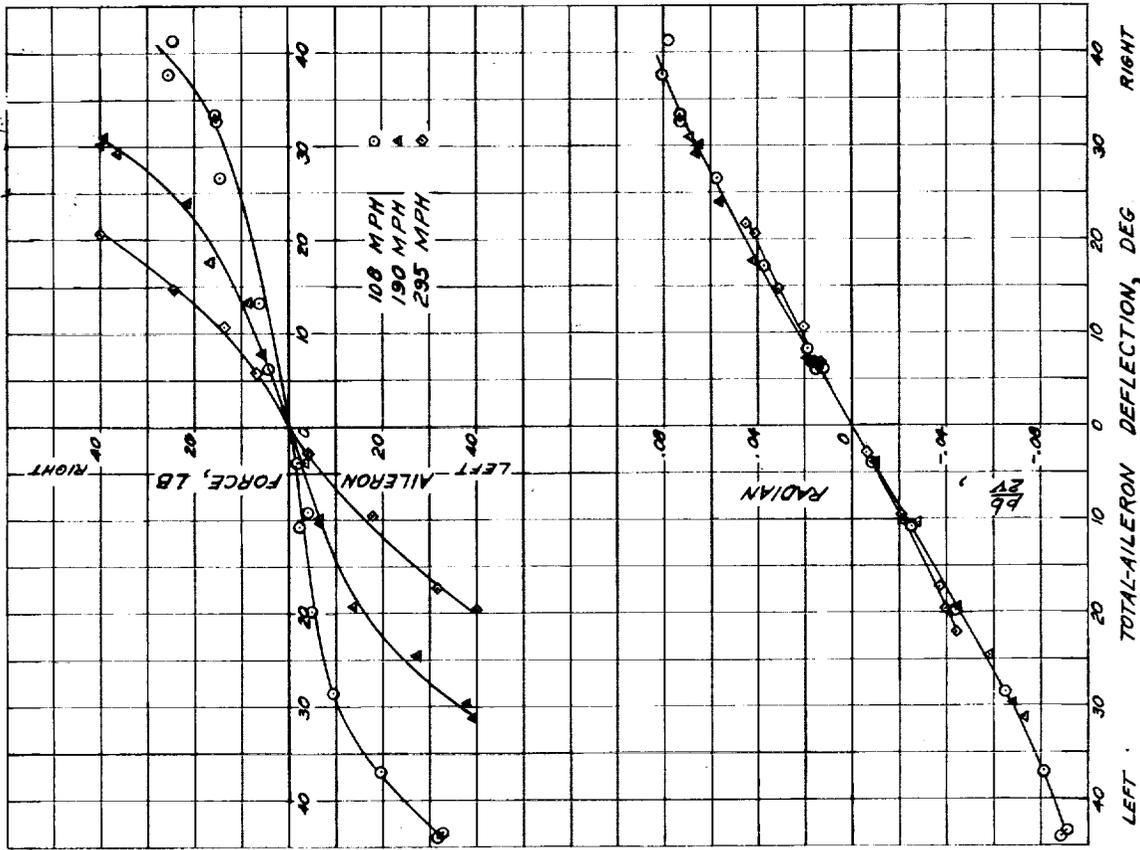
Figure 26. - Variation of aileron force and pb/2V with total aileron deflection in level flight (flaps up, gear up). Supermarine Spitfire airplane.

The results of these tests are presented in figures 25 to 28. Figure 25 shows the variation of  $pb/2V$  and aileron force with total aileron deflection in the landing condition, and figure 26 gives these curves for level flight with flaps and gear up at three speeds. Total aileron deflection is defined as the sum of the deflections of the right and left ailerons. The quantity  $pb/2V$  is the helix angle in radians described by the wing tip in a roll, where  $p$  is the rolling velocity in radians per second,  $b$  the wing span in feet, and  $V$  the true velocity in feet per second. A complete discussion of this criterion for aileron effectiveness is given in reference 3.

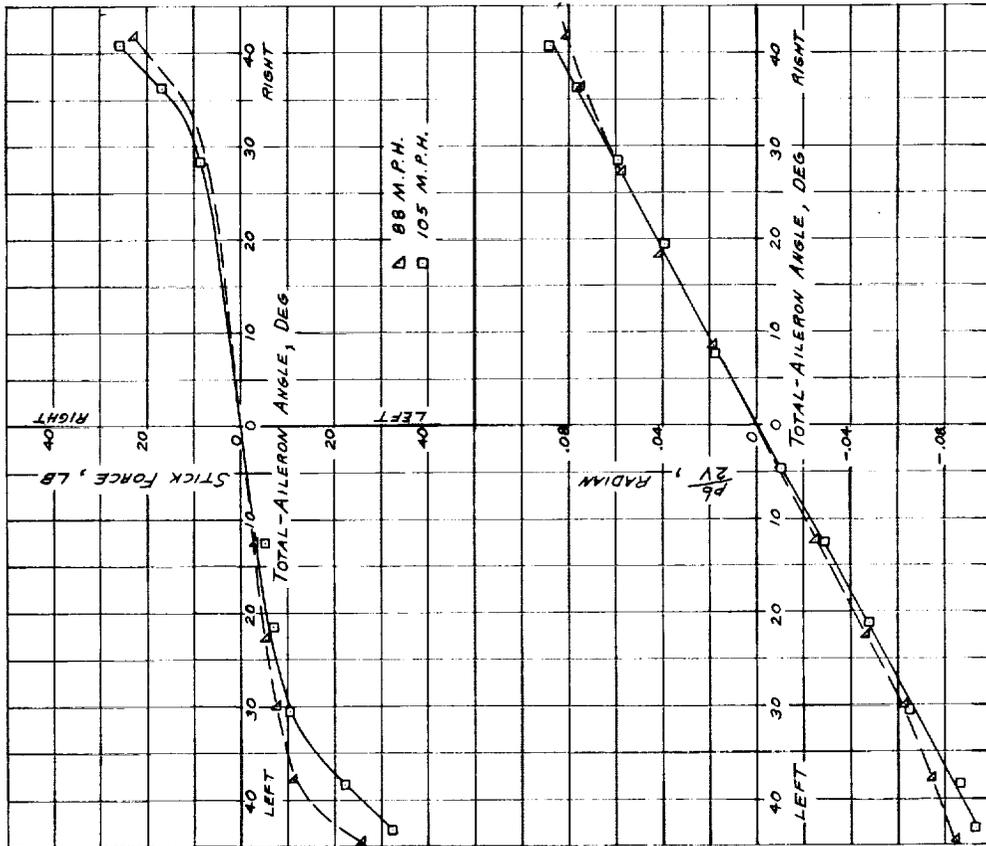
Figure 25. - Variation of aileron force and pb/2V with total aileron deflection in the landing condition (flaps down, gear down, power off). Supermarine Spitfire airplane.

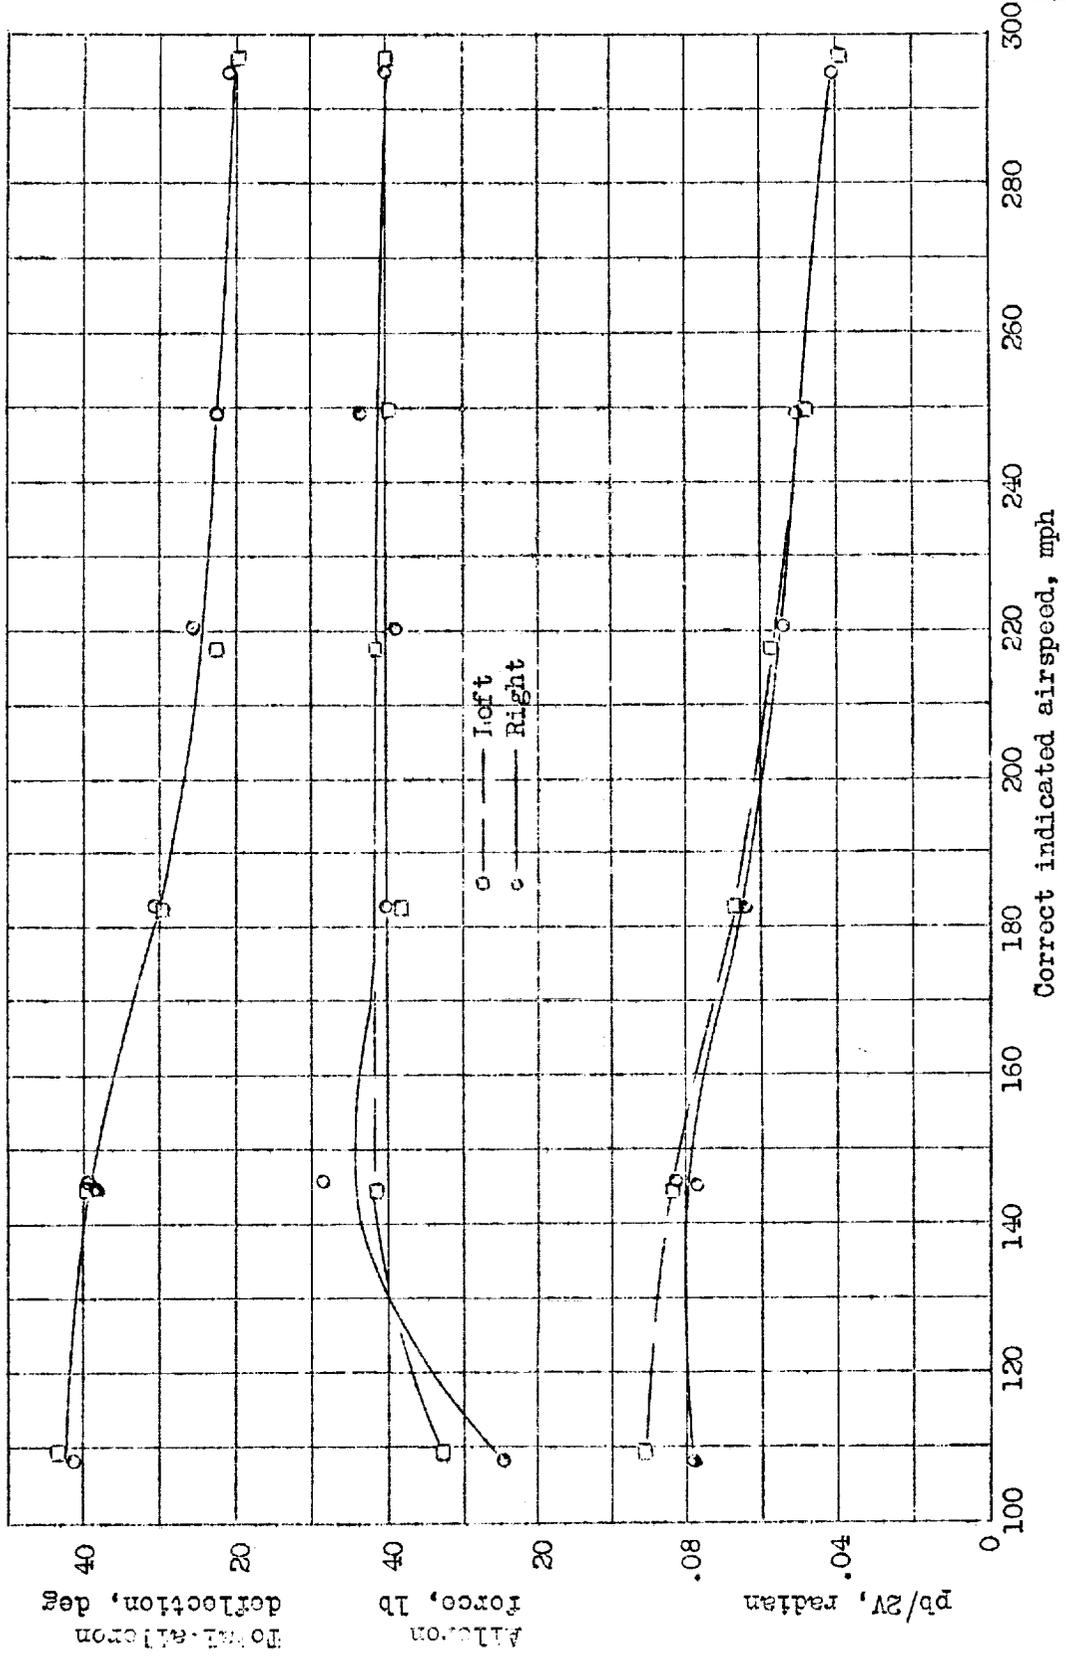
Fig. 27

Figure 27.- Variation of maximum obtainable aileron deflection, aileron force, and pb/2V with indicated airspeed in level flight (flaps up, gear up). Supermarine Spitfire airplane.

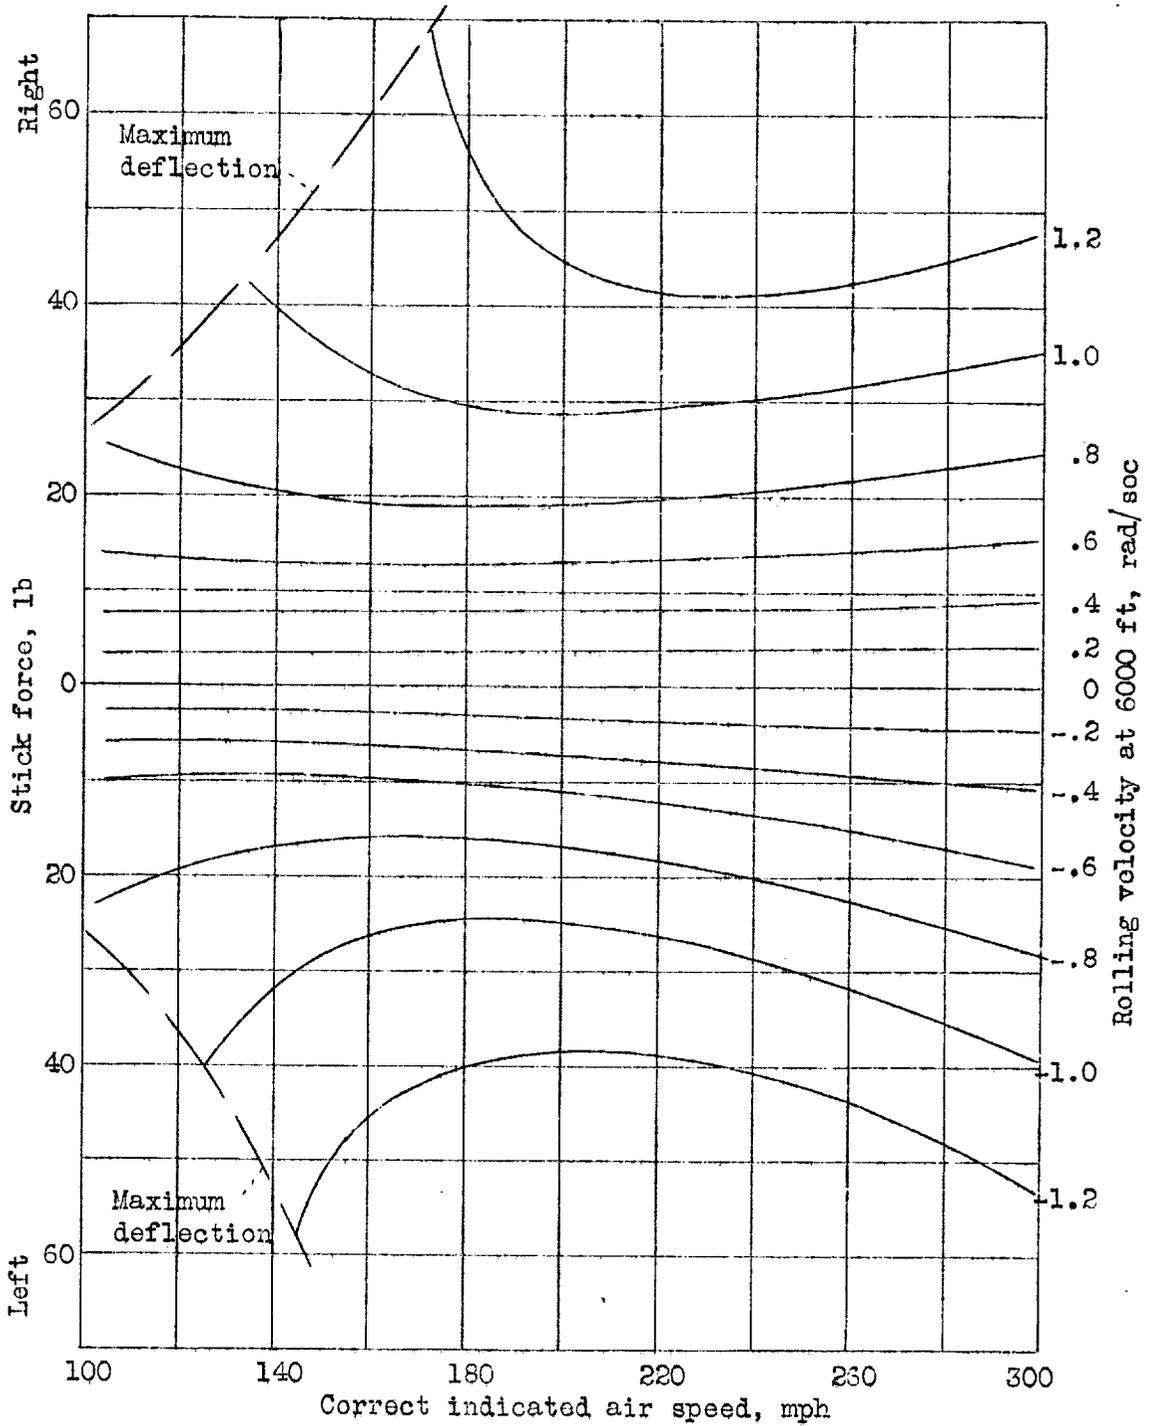
Figure 28.- Variation of aileron stick force with speed for different rolling velocities in level flight (flaps up, gear up). Supermarine Spitfire airplane.
