ORIGINALLY ISSUED  
September 1942 as  
Advance Confidential Report

MEASUREMENTS OF THE FLYING QUALITIES OF A  
SUPERMARINE SPITFIRE VA AIRPLANE

By William H. Phillips and Joseph R. Vensel

Langley Memorial Aeronautical Laboratory  
Langley Field, Va.

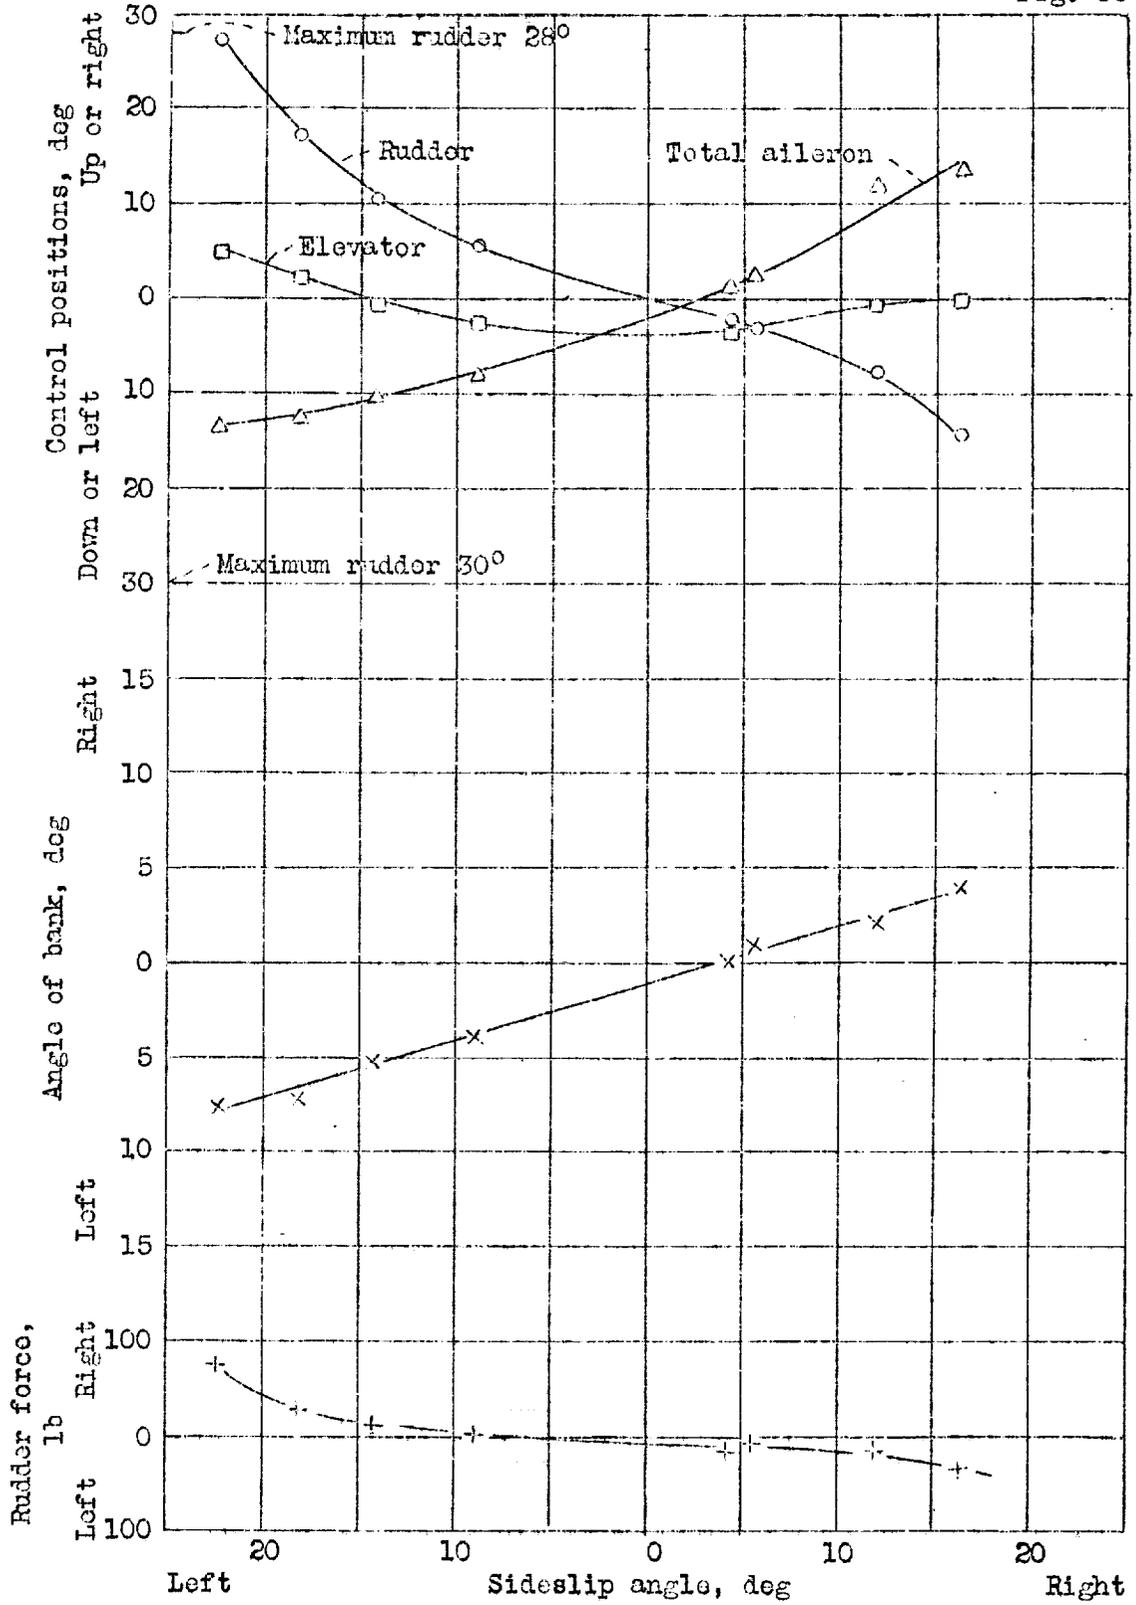
Figure 30.- Steady sideslip characteristics in the gliding condition (flaps up, gear up, power off) at 107 miles per hour, Supermarine Spitfire airplane.

Rolling moment due to sideslip.— The rolling moment due to sideslip of the Spitfire airplane was determined by recording the aileron angles required in steady sideslips. The results of these measurements are presented in figures 29 to 34, where the rudder, elevator and aileron angles, angle of bank, and rudder force are plotted as functions of the sideslip angle. The dihedral effect was stable in all conditions, with the exception that in left sideslips in the cruising condition the dihedral effect was practically neutral. The requirement of reference 1 was therefore met in all conditions except in left sideslips with power on.

angles of bank required to hold steady sideslips in the various flight conditions (figs. 29 to 34). The angles of bank were small at low speeds, but they increased rapidly with speed because the side force for a given sideslip angle varies approximately as the square of the speed. The Spitfire showed a slightly smaller side-force gradient than any other pursuit-type airplane tested previously. A larger side-force gradient would seem to be desirable because the pilot would find it easier to maintain unyawed flight if a large angle of bank were required to sideslip.

Pitching moment due to sideslip.— The pitching moment due to sideslip is shown by the variation of elevator angle with angle of sideslip in the steady sideslip measurements (figs. 29 to 33) and by the variation of normal acceleration with rudder angle in the rudder kicks (figs. 35 and 36). The Spitfire showed a tendency to pitch down both in left and right sideslips. In power-on flight, this airplane failed to meet the requirement (reference 1) that less than  $1^\circ$  change in elevator angle should accompany  $5^\circ$  deflection of rudder. As shown on figure 29, left sideslip occurred in the trim condition with wings level, and at this sideslip angle the elevator angle increased approximately linearly with the left sideslip angle. The static longitudinal-stability measurements indicated that the sideslip increased as the speed was reduced until it reached about  $10^\circ$  at the stall. The elevator angle required for this sideslip completely overshadowed any elevator motion required to change speed in unyawed flight. The increased up-elevator angles encountered at low speeds in the cruising condition therefore do not represent static longitudinal stability. It is doubtful that this type of variation of elevator angle with speed is helpful to the pilot in maintaining a fixed trim speed. Furthermore, the static longitudinal-stability characteristics recorded by two pilots might disagree considerably, because slight errors in holding the wings level would result in appreciable differences in sideslip angle.

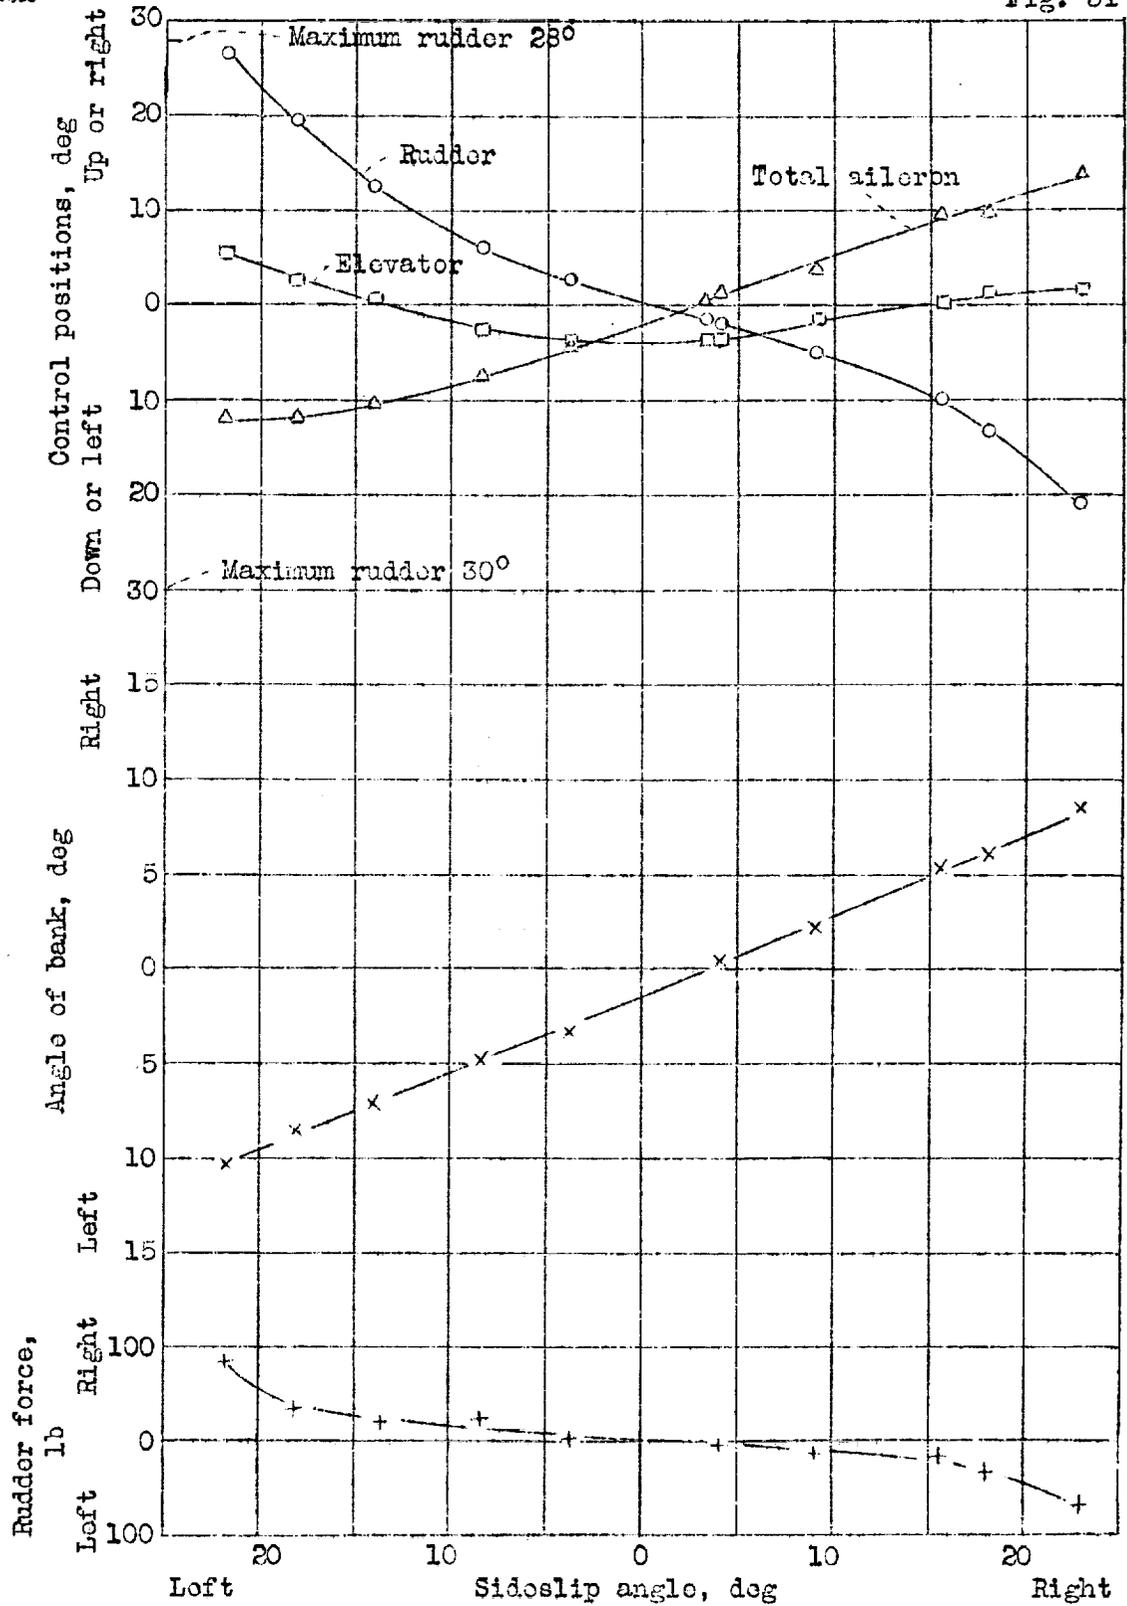
Figure 31.- Steady sideslip characteristics in the gliding condition (flaps up, gear up, power off) at 122 miles per hour. Supermarine Spitfire airplane.

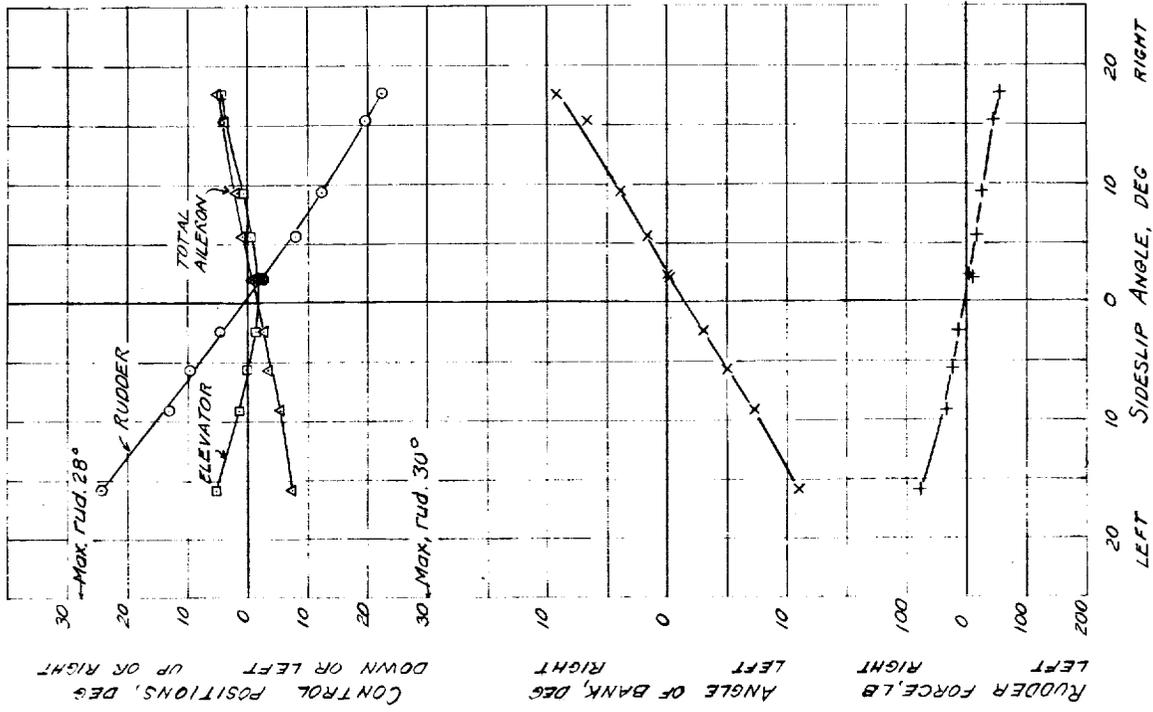
Figure 32. - Steady sideslip characteristics in the landing condition (flaps down, gear down, power off) at 95 miles per hour. Supermarine Spitfire airplane.

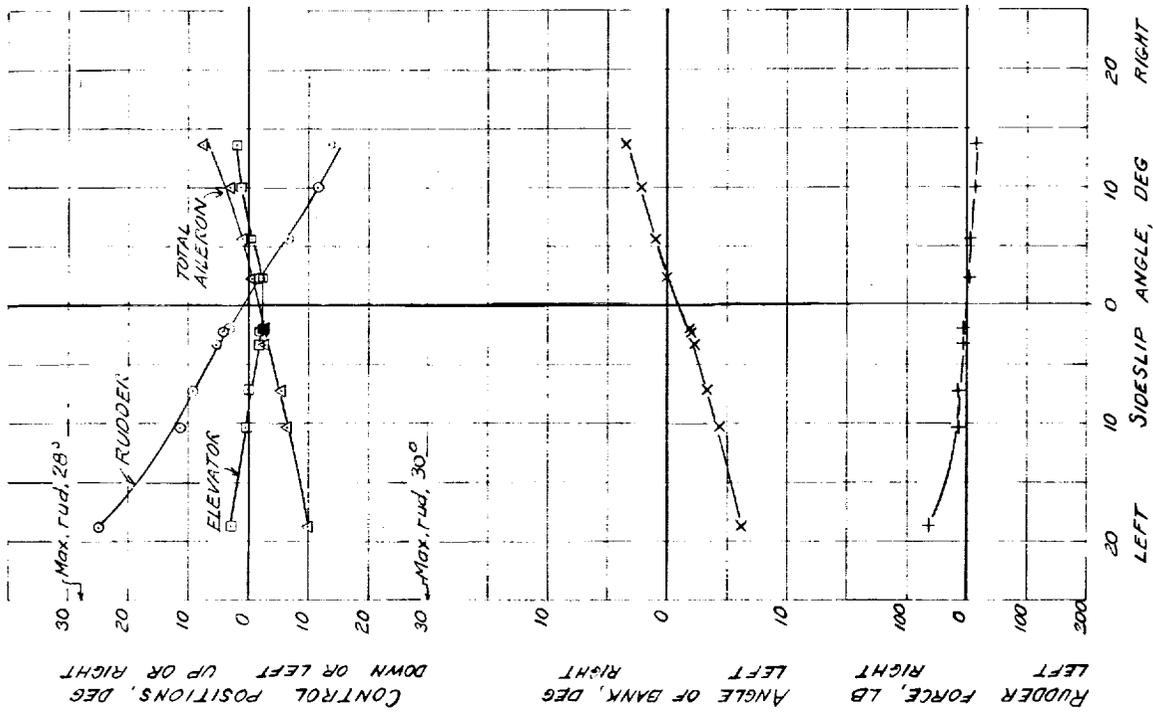
Figure 33. - Steady sideslip characteristics in the landing condition (flaps down, gear down, power off) at 124 miles per hour. Supermarine Spitfire airplane.

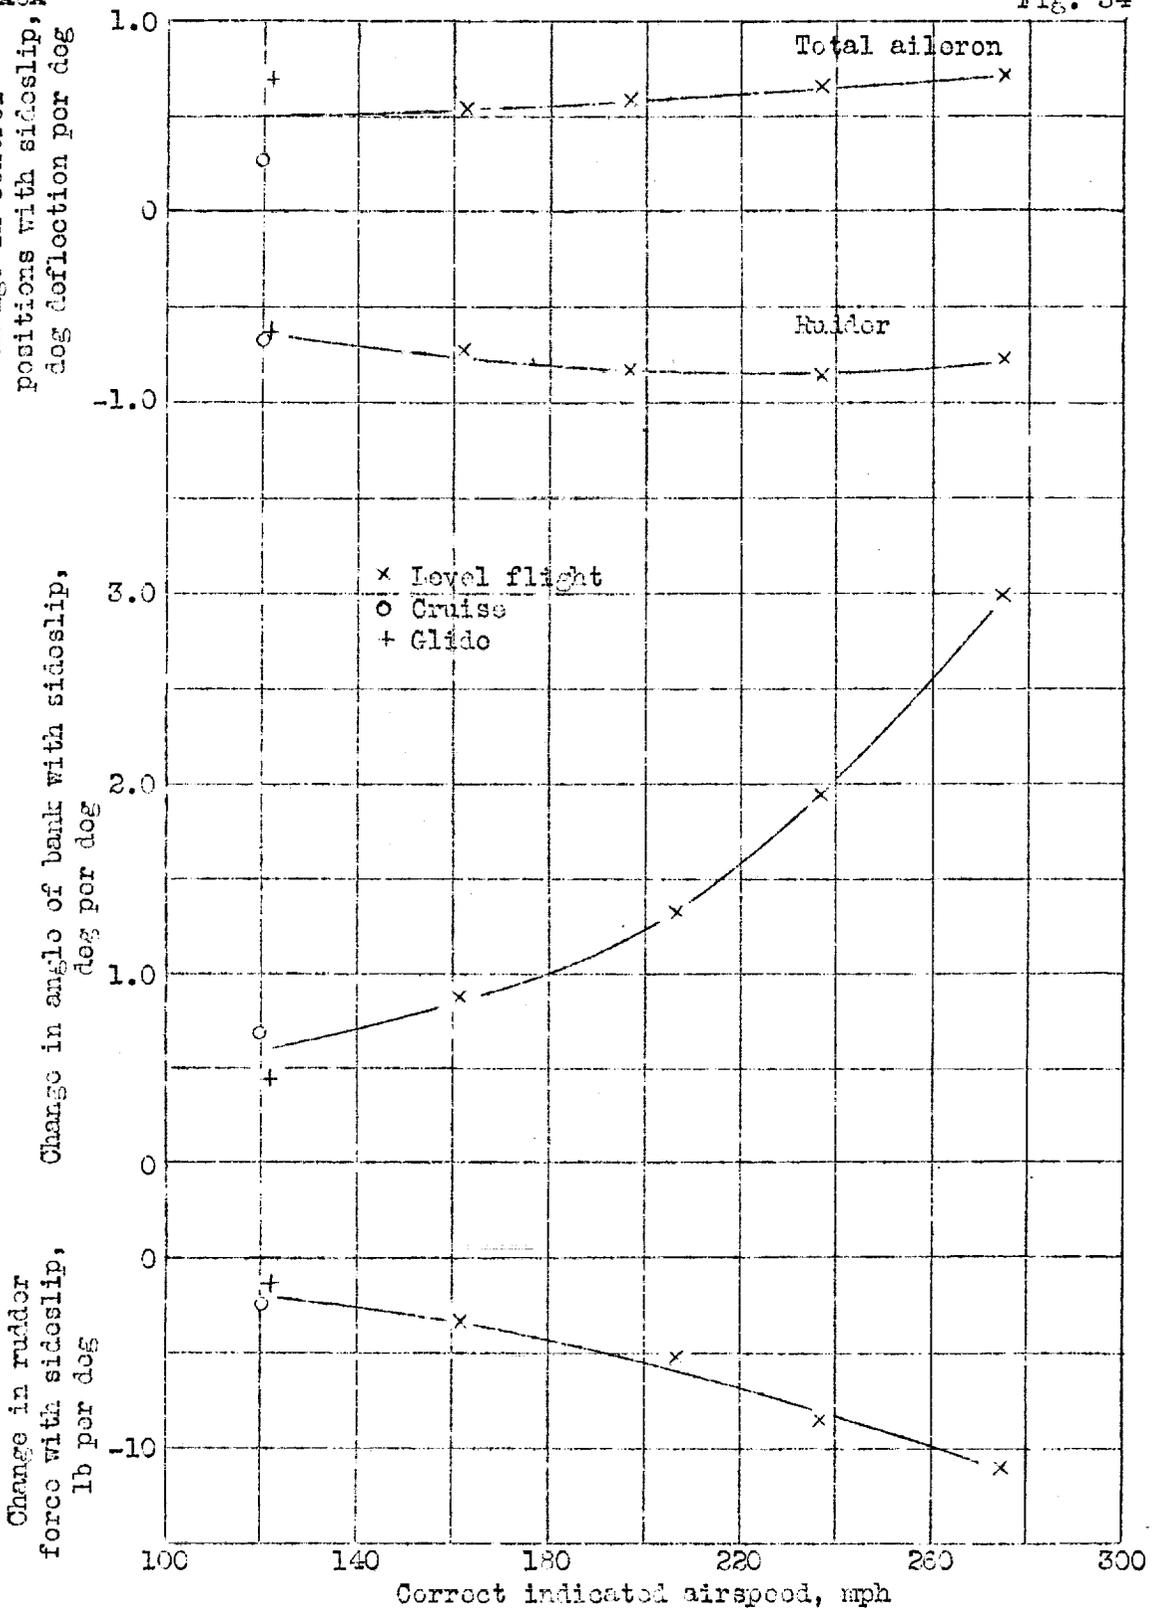
Fig. 34

Figure 34.- Steady sideslip characteristics for small rudder deflections at various speeds in level flight with flaps and gear up, hood closed. Supermarine Spitfire airplane.

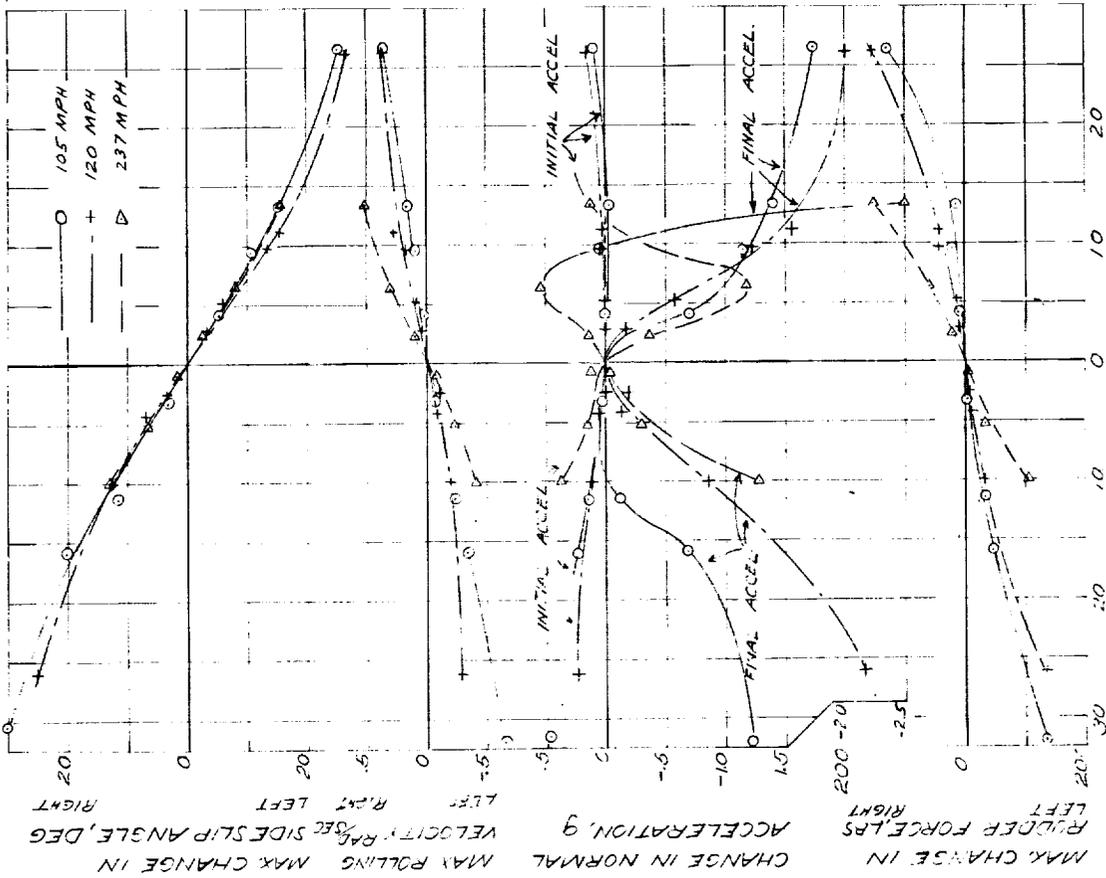
Figure 35. - Variation of maximum change in sideslip angle, rolling velocity, change in normal acceleration, and change in rudder force, with rudder deflection in abrupt rudder kicks in the landing condition. Supermarine Spitfire airplane.

A further indication of the rolling moment due to sideslip is given by the rolling velocities caused by abrupt deflections of the rudder (figs. 35 and 36). The airplane always rolled in the correct direction. The rolling moment due to yawing velocity is combined with that due to sideslip in these tests.

The initial values of rudder force in rudder kicks, plotted in figures 35 and 36, show that the rudder was desirably light. The floating tendency of the rudder caused the pedal force to drop to about one-third of its initial value after the sideslip had built up. No reversal of rudder force ever occurred, however. The requirement of reference 1, which states that left rudder force should always be required for left rudder deflections and right rudder force for right rudder deflections, was therefore satisfied.

The violence of the pitching motions of the airplane in rudder kicks is shown by the variation of normal acceleration with rudder angle (figs. 35 and 36). Because the large accelerations made it difficult for the pilot to hold the elevator angle constant, the normal acceleration plotted on these figures may be partly the result of elevator motion. Nevertheless, the plotted values give a qualitative idea of the pitching motions caused by rudder

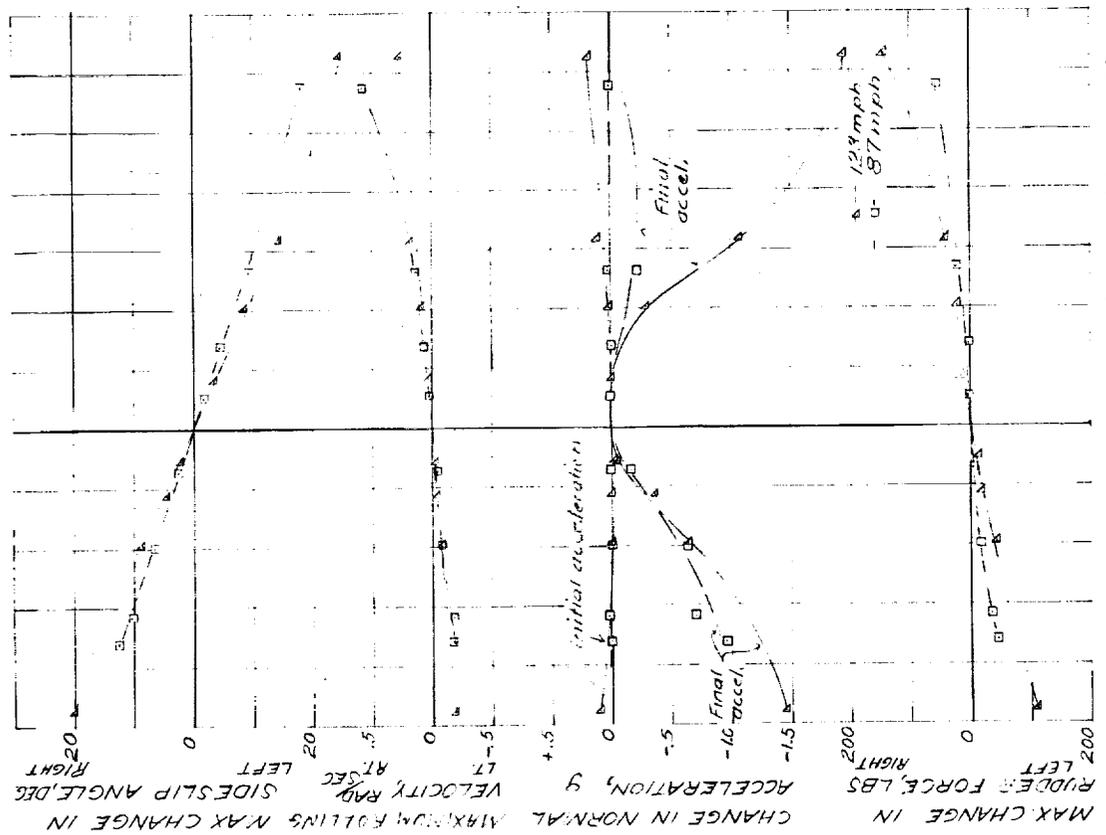
Figure 36. - Variation of maximum change in sideslip angle, rolling velocity, change in normal acceleration, and change in rudder force, with rudder deflection in abrupt rudder kicks in level flight. Supermarine Spitfire airplane.
