CONFIDENTIAL
IN83/44177
VP6F-5
PTR 2125

INTRODUCTION - Performance tests on an F6F-5 airplane were requested by reference (a) in accordance with the program established for the periodic performance check of each 1000th F6F-3 airplane by reference (b). The model designation -3 has been changed to -5 because of an accumulation of modifications, some of which are discussed later in this report.

PURPOSE - The purpose of these tests was to check the performance of the first F6F-5 airplane submitted, particularly on a comparative basis with an F6F-3 production model in view of the aforementioned modifications.

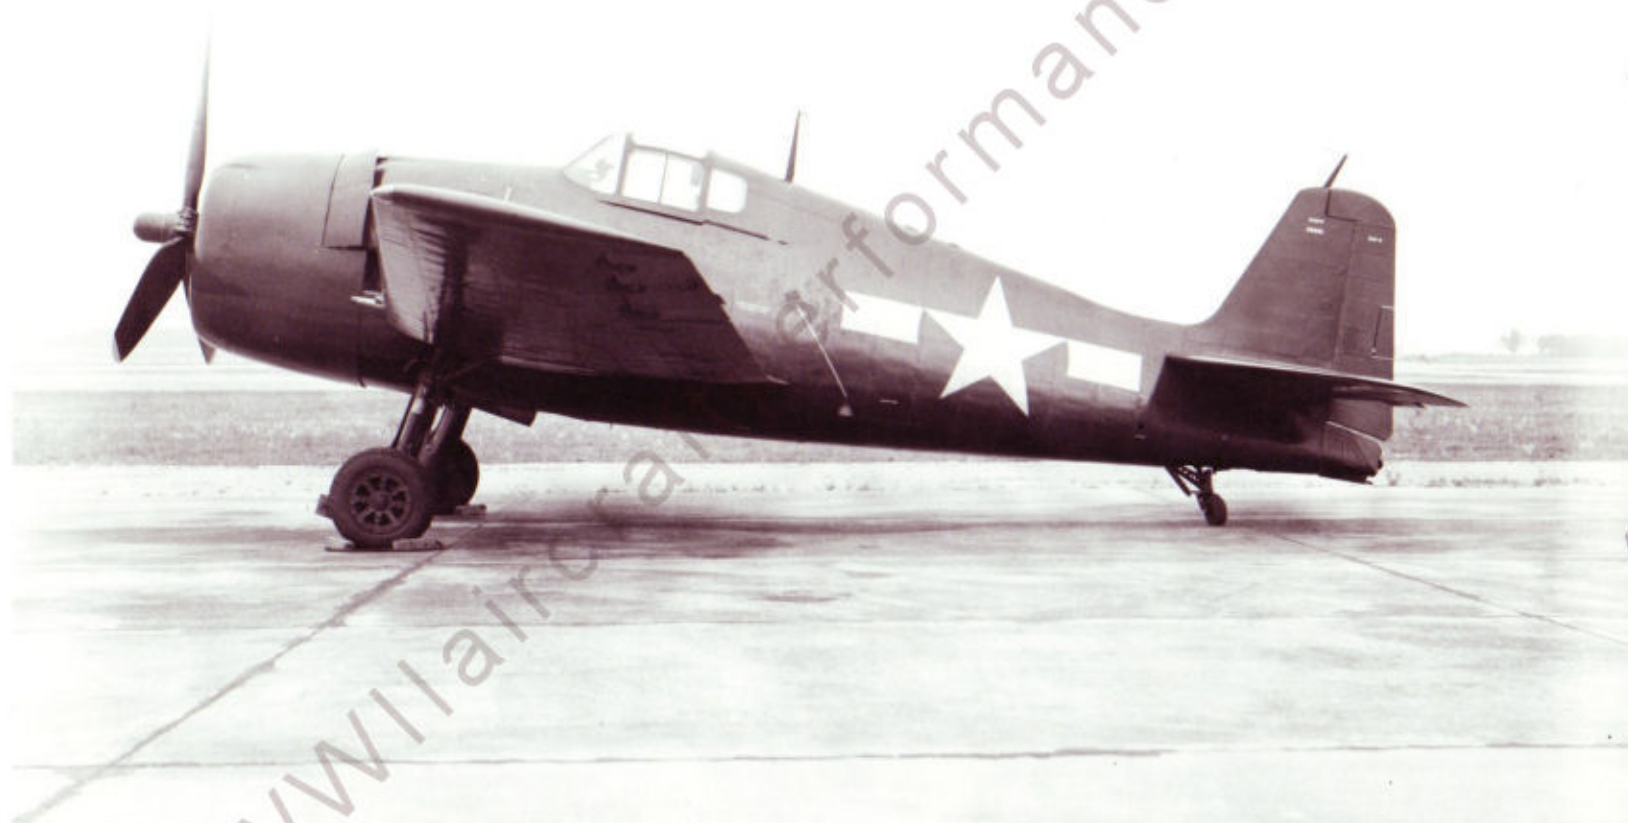
Photo PTR 7748
5-25-44

PTR 2125 - Model F6F-5 No. 58310
Left Side View

Enclosure (1) contains photographs of the airplane as flown during the tests. More detailed information regarding the configuration of the subject airplane during these tests follows:

- (a) The shell ejection chutes on the underside of both wing panels were open.
- (b) The six .50 caliber gun barrel openings were sealed over with tape. There were no blast tube fairings.
- (c) The pitot tube was located on the underside of the right wing leading edge near the wing tip.

- (d) A faired bomb rack was supported beneath the right wing panel-inboard.
- (e) An outside air temperature gage of the electrical resistance type was installed for test purposes on the topside of the right wing panel.
- (f) An aerial mast was located behind the pilot's cabin. The aerial extended from the right side of the fuselage, aft of the cockpit hood, to the mast and thence to the rudder.
- (g) I. F. F. antenna was located on top of the fuselage behind the aerial mast.

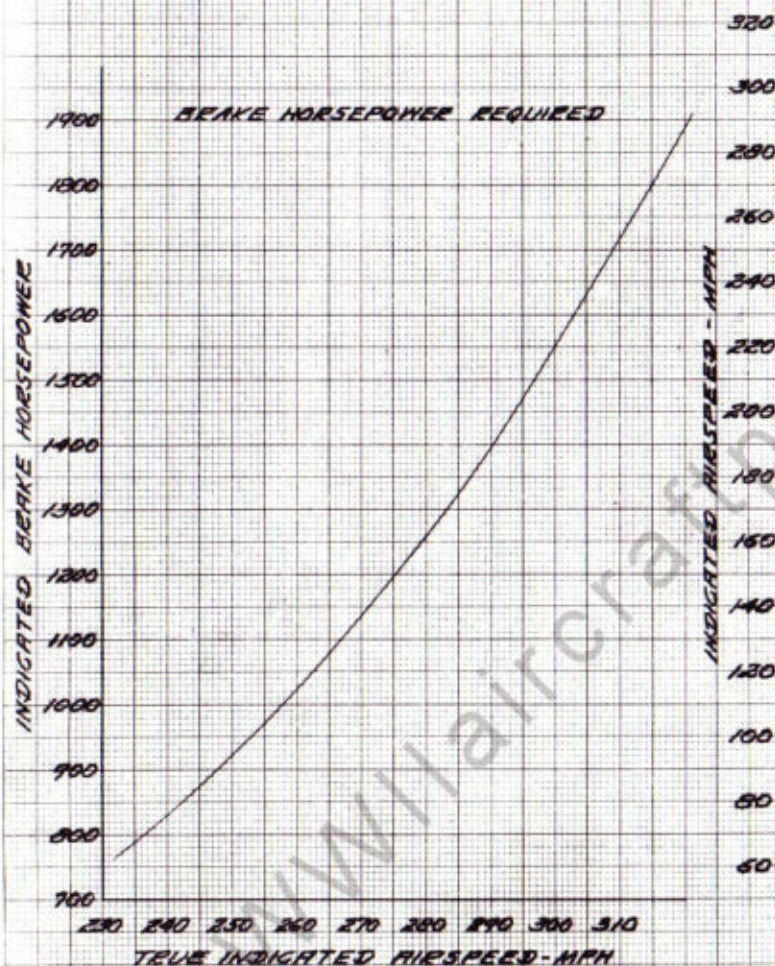
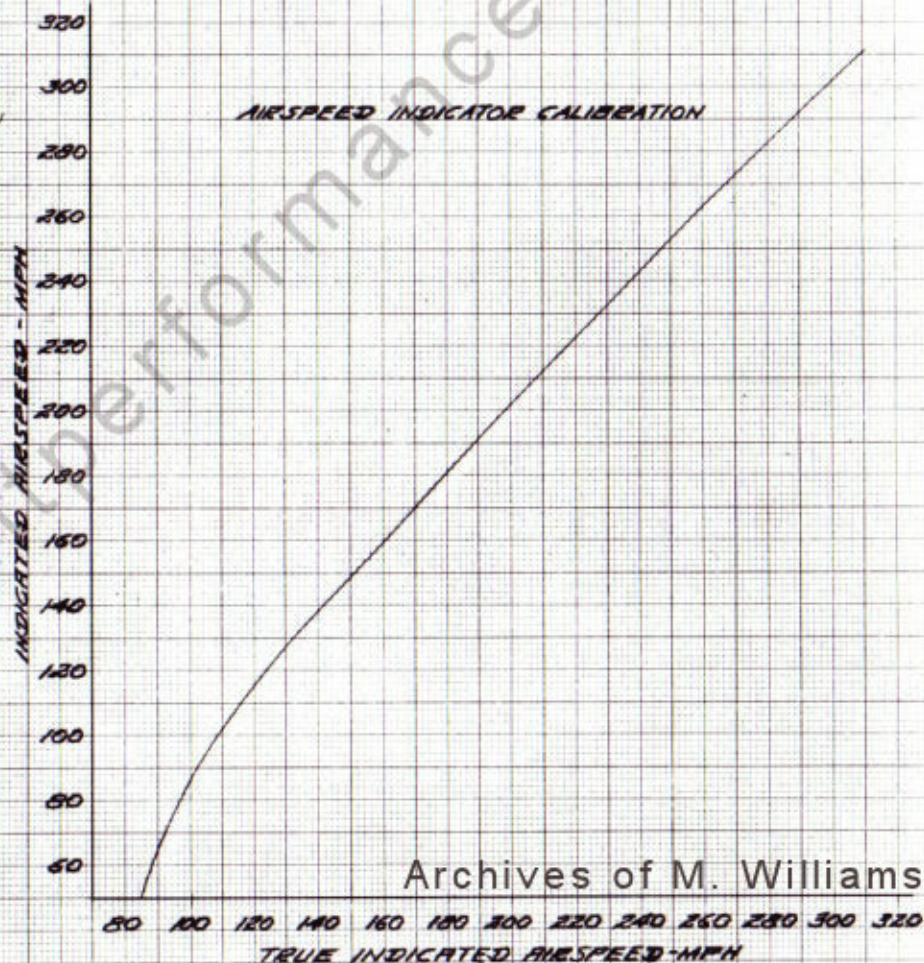
PHOTO PTR 9906

MODEL FGF-5, AIRPLANE NO. 58310
 PERFORMANCE CHARACTERISTICS
 OVERLOAD FIGHTER GROSS WEIGHT = 12,420 LBS.

The performance curve of Horsepower Available at Altitude in enclosure (2) indicates a decided loss in neutral blower power below engine rated while operating at engine rated manifold pressure for both normal and military operation, with no difference noted between "auto-rich" and "auto-lean" mixture settings. Whether this loss of power can be attributed to

The fact that military and normal powers were low in neutral blower is also manifest upon inspection of the Rate of Climb performance curves in enclosure (2). Since it was known that full rated powers were not being developed in all blowers, climbs were conducted in "steps" for each blower. These individual climbs were made through an altitude band which was known to be of considerable distance below and above a preestimated critical altitude for respective blowers. Data collected from the three separate blower climbs were then correlated to represent one continuous climb from sea level to absolute ceiling. The Time to climb to service ceiling is computed only for the "auto-lean" operation.

RESULTS - Enclosure (2) contains charts which show graphically the performance obtained during the tests, using both "auto-lean" and "auto-rich" operation. Due to faulty adjustment of the auxiliary stage regulator, it was possible to exceed the military rated manifold pressure of 53.5" Hg. in low blower. However, manifold pressures in excess of rated are purposely not shown on the plot of manifold pressure at altitude contained in enclosure (2). BHP developed was determined on the basis of

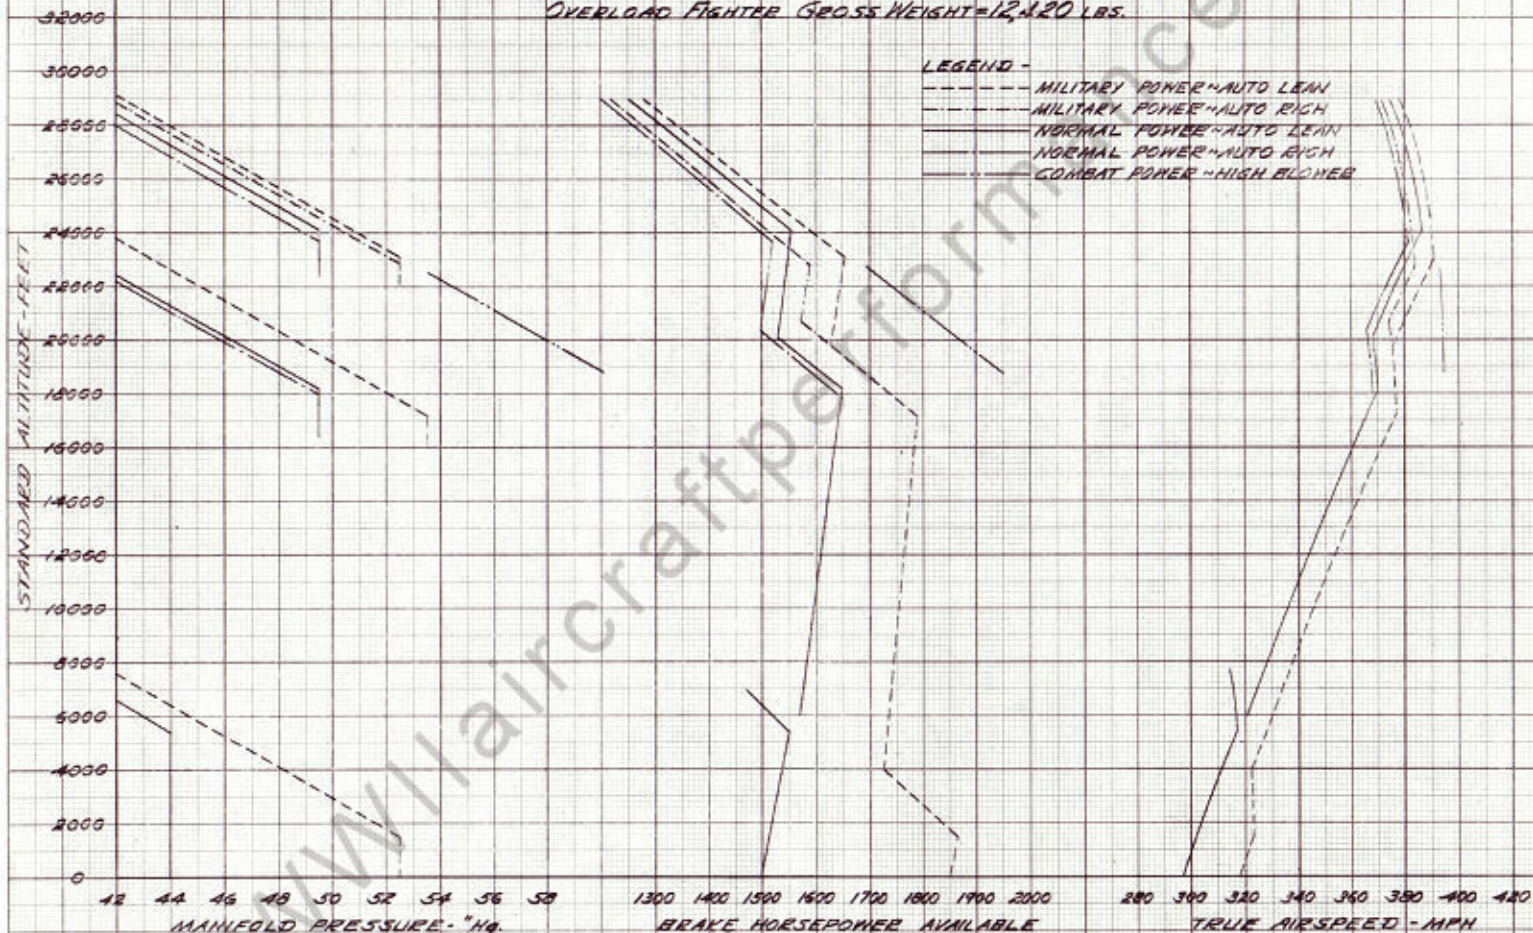
MODEL F6F-5, AIRPLANE NO. 58310
PERFORMANCE CHARACTERISTICS
OVERLOAD FIGHTER GROSS WEIGHT=12,120 LBS.

- MILITARY POWER-AUTO LEAN
- MILITARY POWER-AUTO RICH
- NORMAL POWER-AUTO LEAN
- NORMAL POWER-AUTO RICH
- COMBAT POWER-HIGH BLUNDER
