NATIONAL ADVISORY COMMITTEE FOR AERONAUTICS

TECHNICAL NOTE 2675

MEASUREMENTS OF FLYING QUALITIES OF AN F-47D-30 AIRPLANE

TO DETERMINE LATERAL AND DIRECTIONAL STABILITY

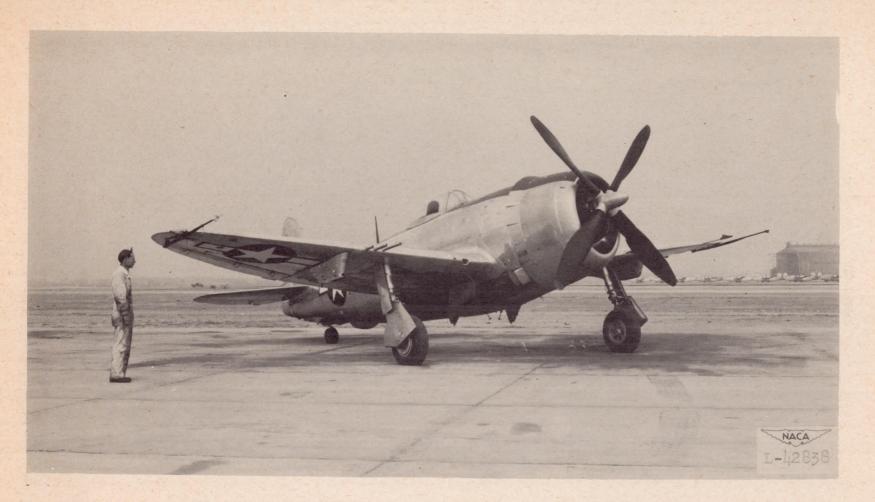
Figure 2.- Three-quarter front view of F-47D-30 test airplane.

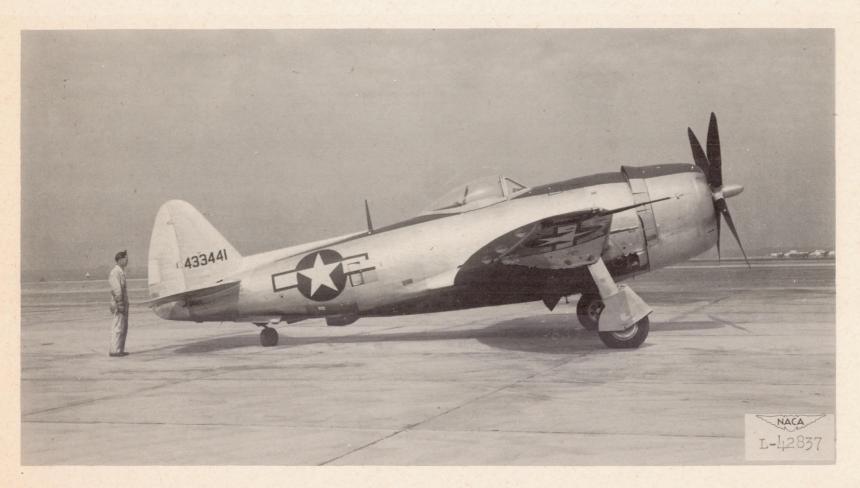
Figure 3.- Side view of F-47D-30 test airplane.

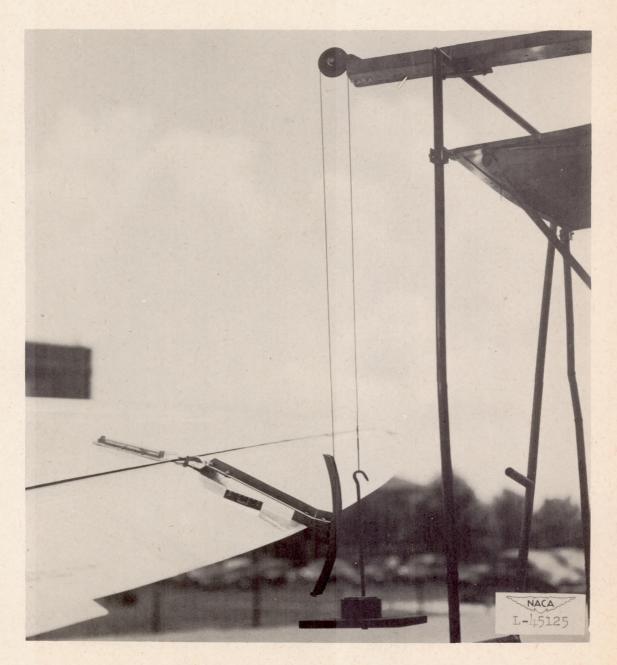
Figure 6.- Setup for calibrating aileron hinge-moment recorders.

The apparatus used to calibrate the strain gages in the ailerons that measured the aileron hinge moments is shown in figure 6.

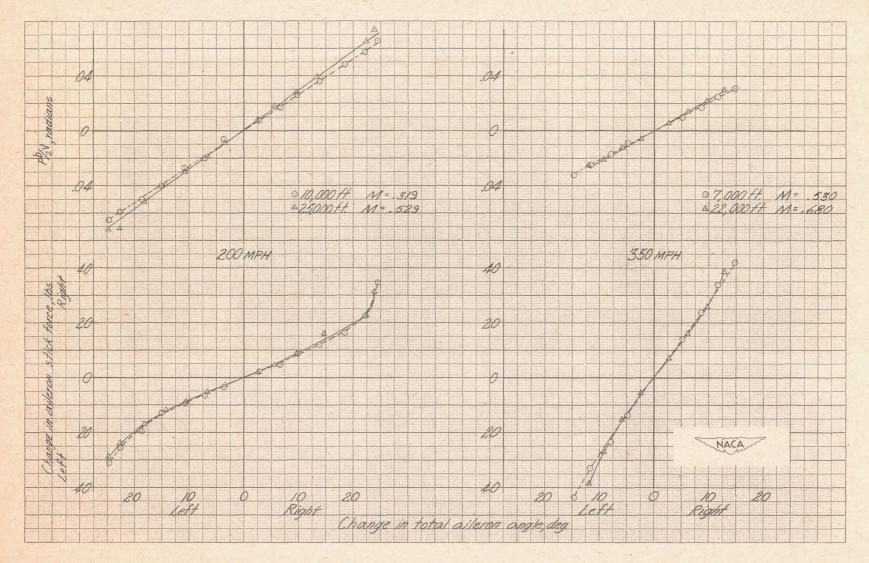
Figure 29.- Effect of altitude on variation of helix angle pb/2V and change in sileron stick force with change in total aileron angle at 200 miles per hour and 350 miles per hour. F-47D-30 airplane.
