3rd Part of Report No. A. & A.E.E./819, a.

RESTRICTED
AIRCRAFT AND ARMAMENT EXPERIMENTAL ESTABLISHMENT
DOSCOMBE DOWN

Vampire I TG.274
(Goblin I)

Preliminary handling trials of first
production aircraft

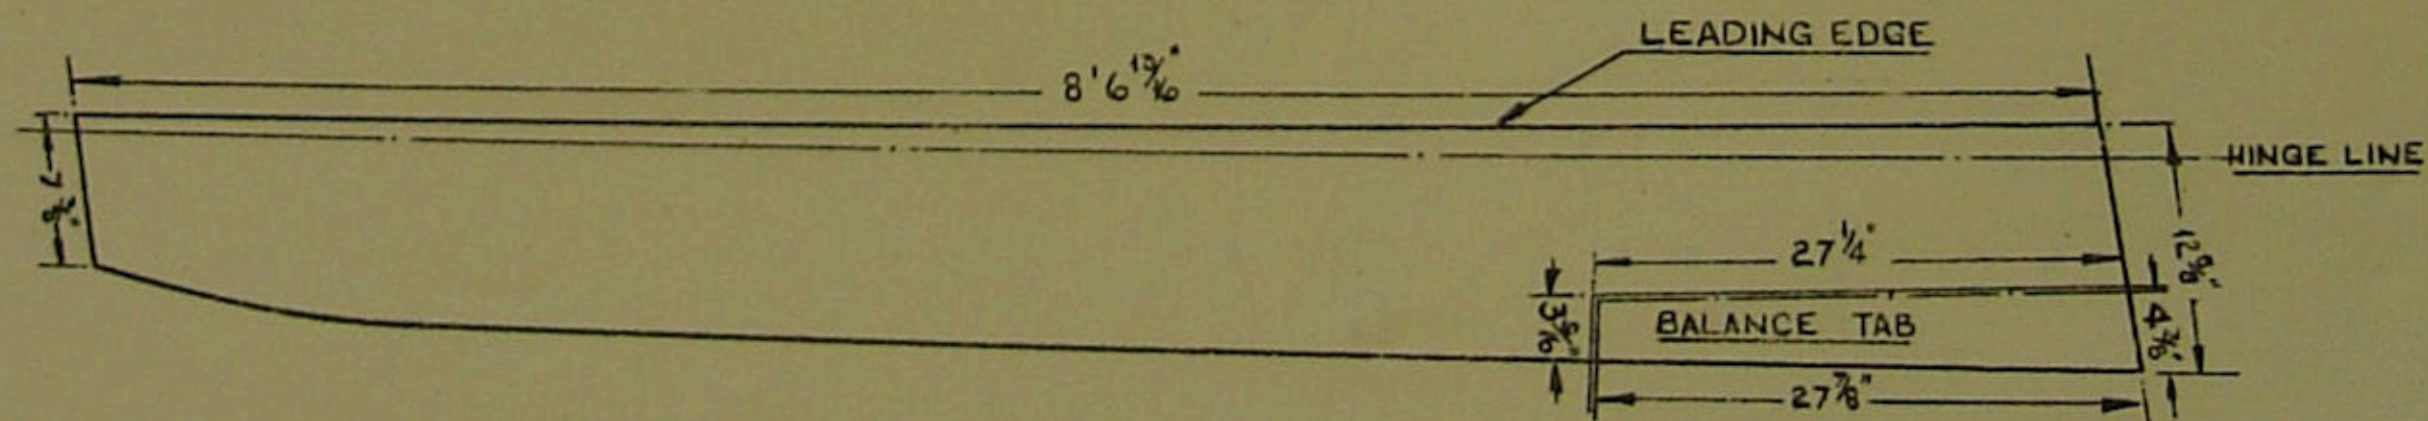
FIG. 2.

2.22 Ailerons. The ailerons were of approximate constant chord except at the outboard end, and were fitted with geared balance tabs. Fig.2 shows a plan view of the port aileron and balance tab.

At high altitudes and Mach numbers, and at low altitudes when acceleration was applied, the amount of travel obtainable by moving the control column sideways appeared to be limited to about $\frac{1}{3}$ of the normal travel, but by exerting a force of 50-60 lb. the control column could be moved to half of the normal travel. The travel appeared to be limited by a stop and the cause of this is unknown.
