MEMORANDUM REPORT ON

German Fighter - Focke-Wulf 190

SUBJECT: Pilot's Comments

SERIAL No. Eng-47-1658-D

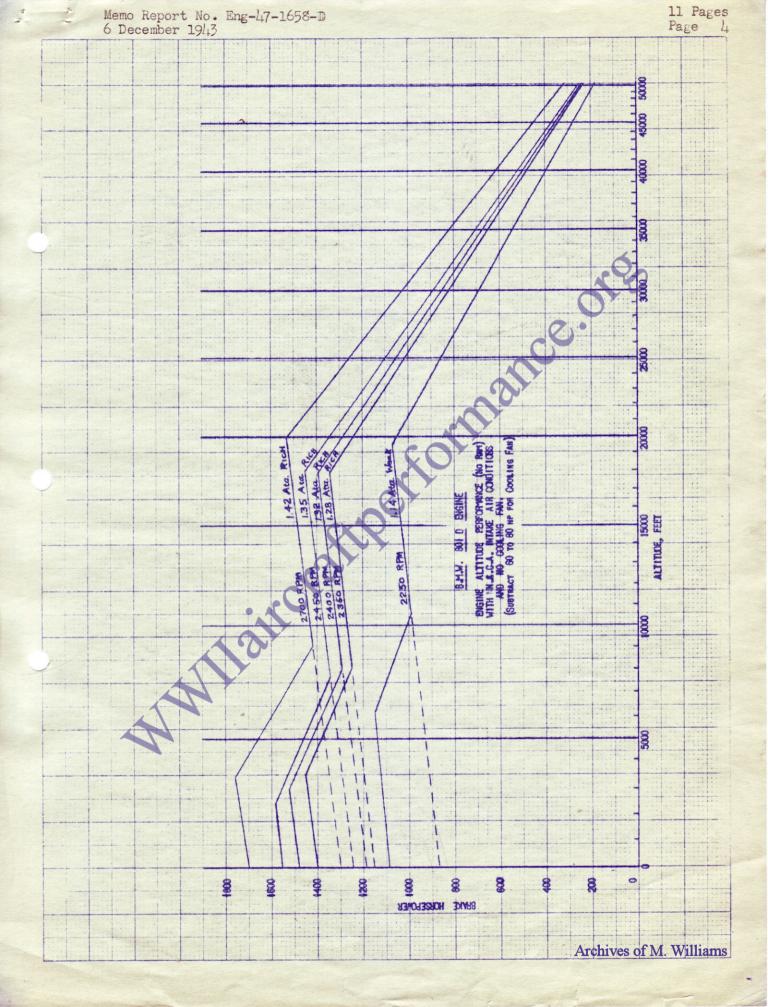
A B.M.W. 801D2 engine was installed. A Farnborough power curve for this engine is attached. The simplified engine control is commendable for pursuit work. With the propeller selector in the automatic position, one control operates the propeller, mixture and throttle. In the manual position, the propeller rpm is selected by a
